Main decommissioning works and steps

All fuel had been removed from Unit 4 SFP by December 22, 2014. Work continues toward fuel removal and debris (Note 1) retrieval from Unit 1-3.

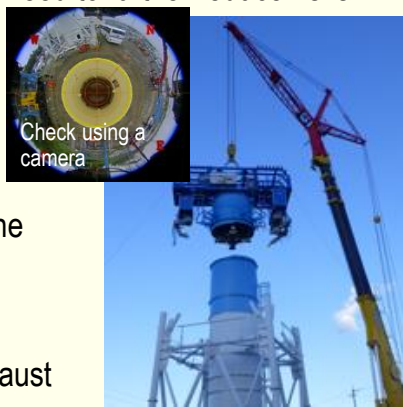
Installation of the equipment

The test will shift to STEP 2 (verification of the implementation plan) in early November.

Insights obtained from these steps will be reflected in STEP 3 (confirmation of work procedures) and onsite dismantling of the exhaust stack will start from March 2019.

- Progress status toward dismantling the Unit 1/2 exhaust stack
- For the Unit 1/2 exhaust stack, in which damage and breakage were detected, the upper half will be dismantled reflecting the need to further reduce risks.

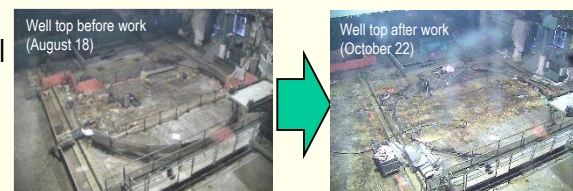
Investigative work steps on the operating floor

Before this investigation, work to move and contain the remaining objects within the operating floor started from August 23 and will be completed in early November.

Following the work, an investigation into the contamination status and facilities status on the entire operating floor including the well top will start from November.

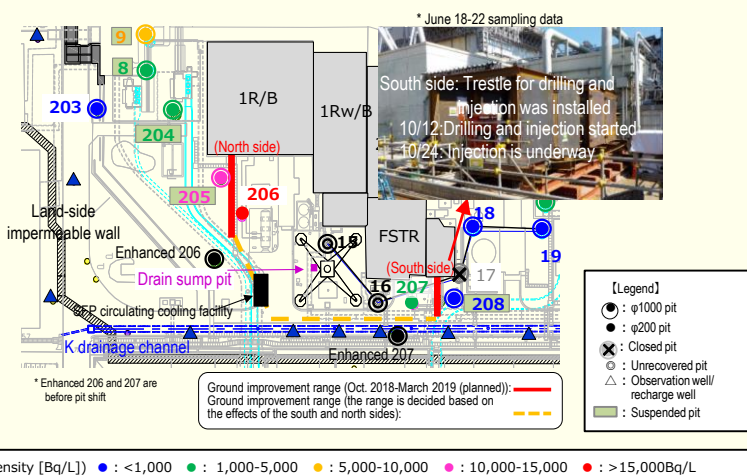
Start of ground improvement to suppress any increase in tritium density

To suppress any increase in tritium density of the subdrain pit around the Unit 1/2 mountain side, which was detected during the period March-June 2018, the water-level difference was monitored as an operational measure. As a facility measure, ground improvement started (on the south side) from October 12 and will start (on the north side) from the end of October. All measures will be completed by around March.

These measures are expected to suppress advection and spreading of tritium, help stable subdrain operation and reduce the inflow of groundwater to buildings.

- **Status of ground improvement to suppress increase in tritium density of the Unit 1/2 mountain-side subdrain**
 - To suppress any increase in tritium density of the subdrain pit around the Unit 1/2 mountain side, which was detected during the period March-June 2018, the water-level difference was monitored as an operational measure.

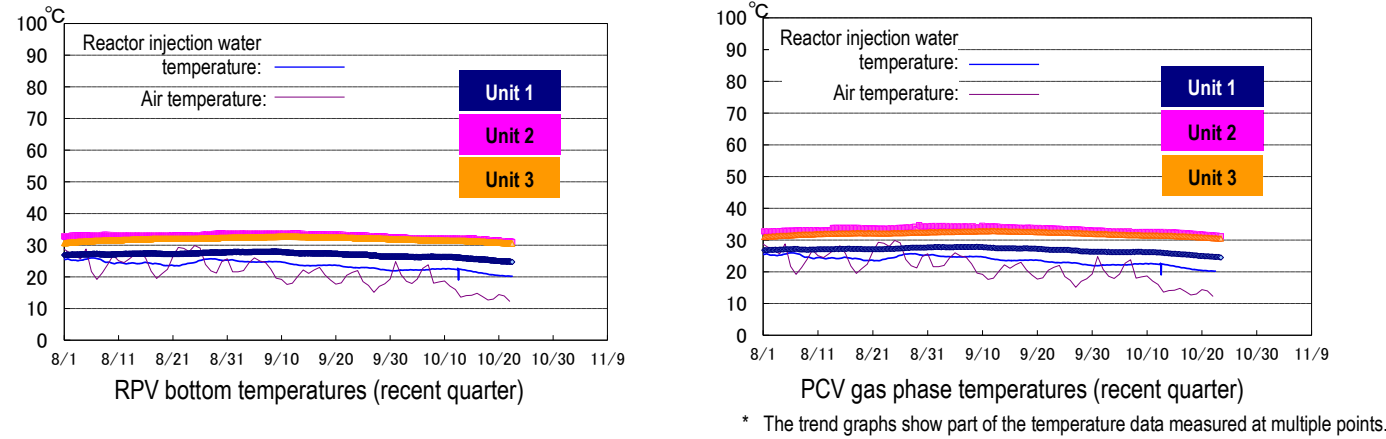
Through continuous reactor cooling by water injection, the temperatures of the Reactor Pressure Vessel (RPV) bottom and the Primary Containment Vessel (PCV) gas phase were maintained within the range of approx. 25 to 35°C for the past month, though it varied depending on the unit and location of the thermometer.

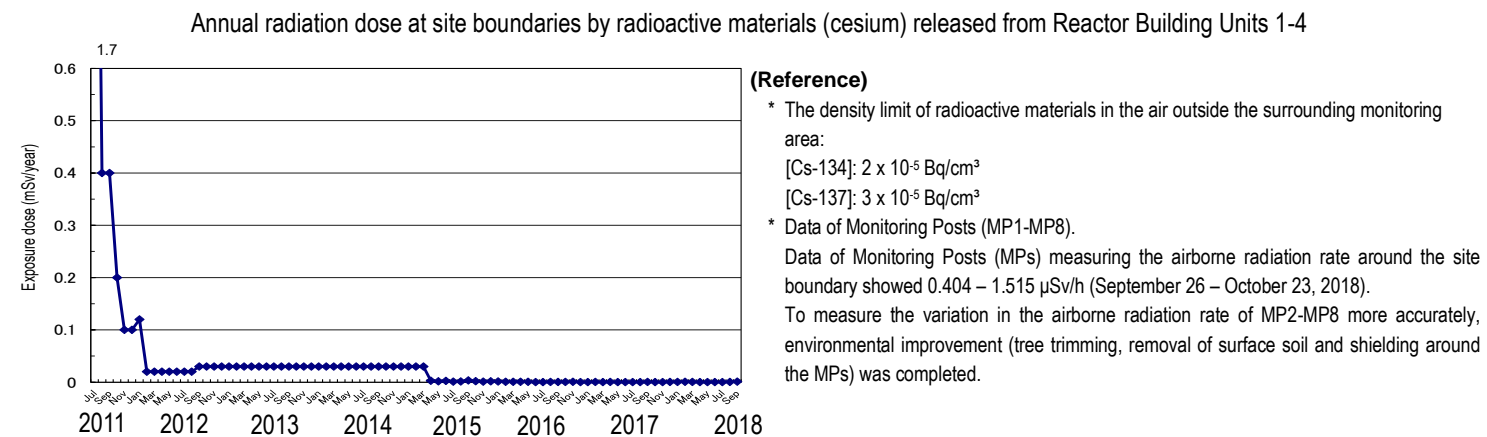
As of September 2018, the density of radioactive materials newly released from Reactor Building Units 1-4 in the air and measured at the site boundary was evaluated at approx. 1.4×10^{-11} Bq/cm³ for Cs-134 and 1.1×10^{-10} Bq/cm³ for Cs-137, while the radiation exposure dose due to the release of radioactive materials there was less than 0.0011 mSv/year.

Note: Different formulas and coefficients were used to evaluate the radiation dose in the facility operation plan and monthly report. The evaluation methods were integrated in September 2012. As the fuel removal from the spent fuel pool (SFP) commenced for Unit 4, the radiation exposure dose from Unit 4 was added to the items subject to evaluation since November 2013. The evaluation has been changed to a method considering the values of continuous dust monitors since FY2015, with data to be evaluated monthly and announced the following month.

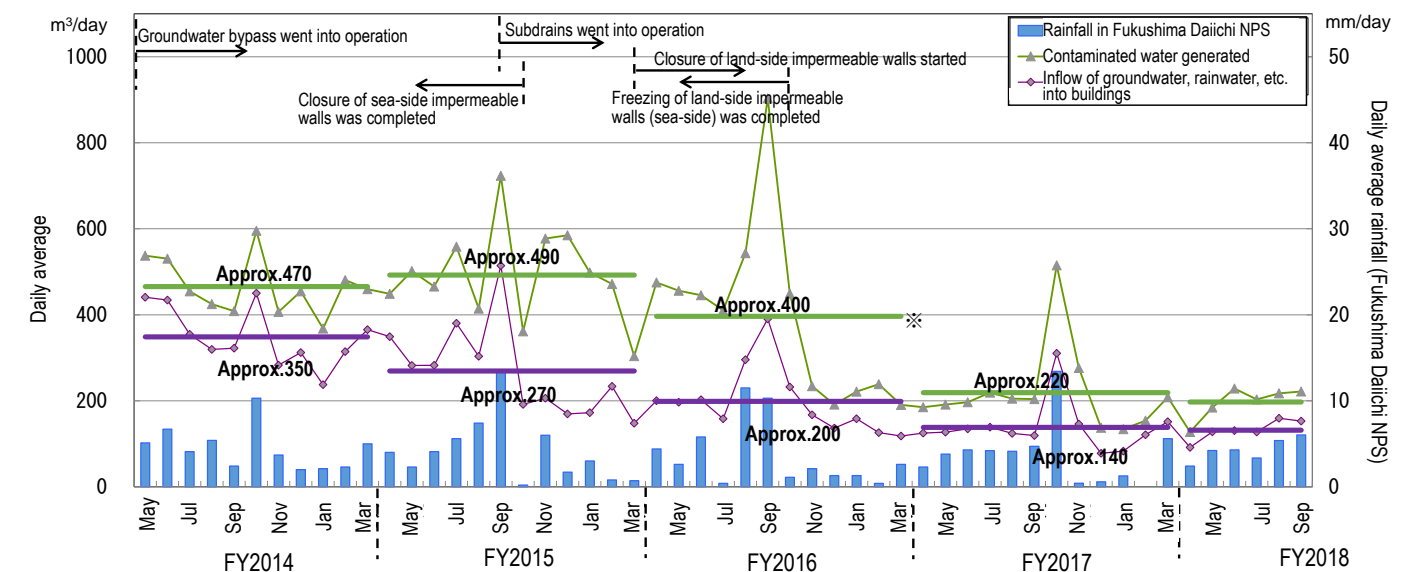
Figure 1: Changes in contaminated water generated and inflow of groundwater, rainwater, etc. into buildings

- Multi-layered measures including pumping up by subdrains and land-side impermeable walls, which have been implemented to control the continued generation of contaminated water, reduced groundwater inflow into buildings.
- As a result of steady implementation of “isolation” measures (groundwater bypass subdrains, frozen walls, etc.), the inflow reduced from approx. 470 m³/day (the FY2014 average) when the measures were first launched to approx. 220 m³/day (the FY2017 average), though the figure varied depending on rainfall, etc.
- Measures will continue to further reduce the volume of contaminated water generated.

※ Values differ from those announced at the 20th Committee on Countermeasures for Contaminated Water Treatment (held on August 25, 2017) because the calculation method of contaminated water volume generated was reviewed on March 1, 2018. Details of the review are described in the materials for the 50th and 51st meetings of the Secretariat of the Team for Countermeasures for Decommissioning and Contaminated Water Treatment.

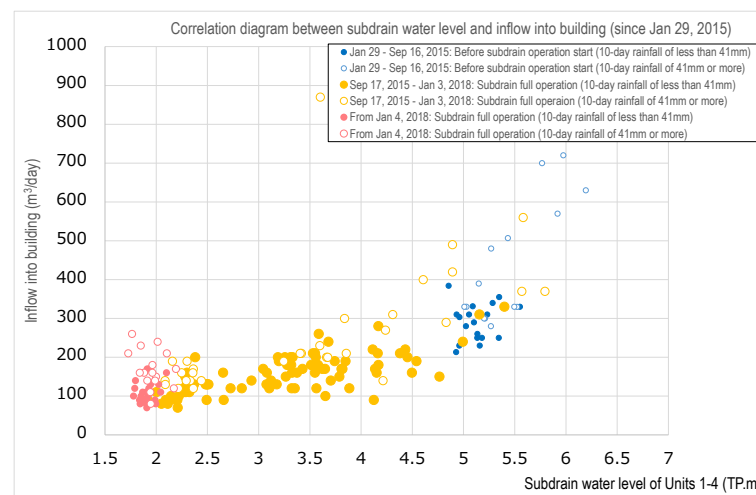
Figure 2: Correlation between inflow such as groundwater and rainwater into buildings and the water level of Unit 1-4 subdrains

- Since the subdrains went into operation, the inflow into buildings tended to decline to under 150 m³/day when the subdrain water level declined below T.P. 3.0 m but increased during rainfall.

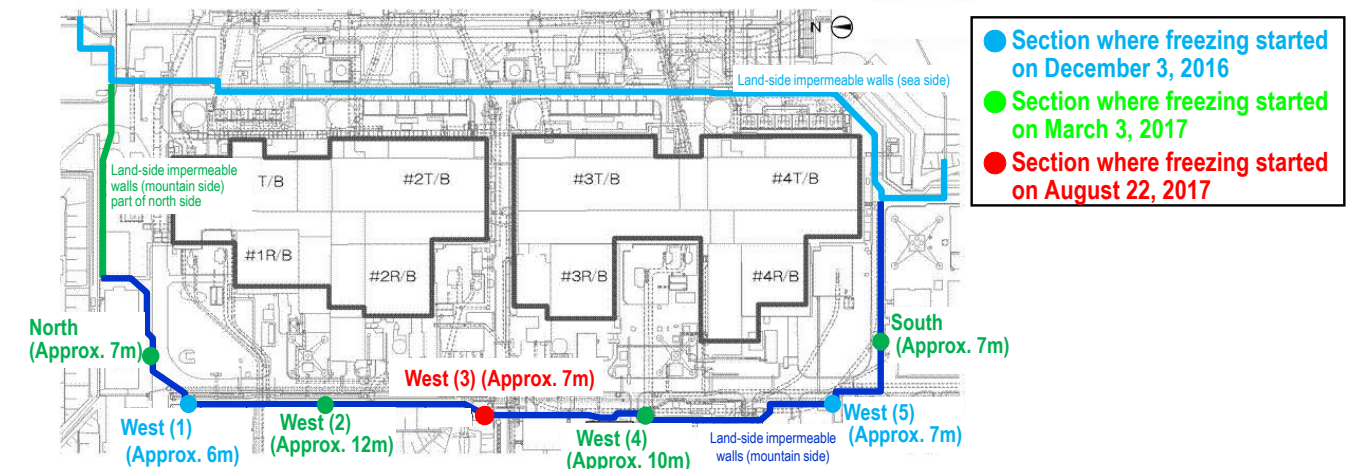
Figure 3: Closure of part of the land-side impermeable walls (on the mountain side)

- In March 2018, the land-side impermeable walls were considered completed except for a portion of the depths, based on a monitoring result showing that the underground temperature had declined below 0°C in almost all areas, while on the mountain side, the difference between the inside and outside increased to approx. 4-5 m. Multi-layered contaminated water management measures, including subdrains and facing, have kept the groundwater level stable.

Consequently, a water-level management system to isolate the buildings from groundwater was considered to have been established. The Committee on Countermeasures for Contaminated Water Treatment, held on March 7, clearly recognized the effect of the land-side impermeable walls in shielding groundwater and evaluated that the land-side impermeable walls had allowed a significant reduction in the amount of contaminated water generated.

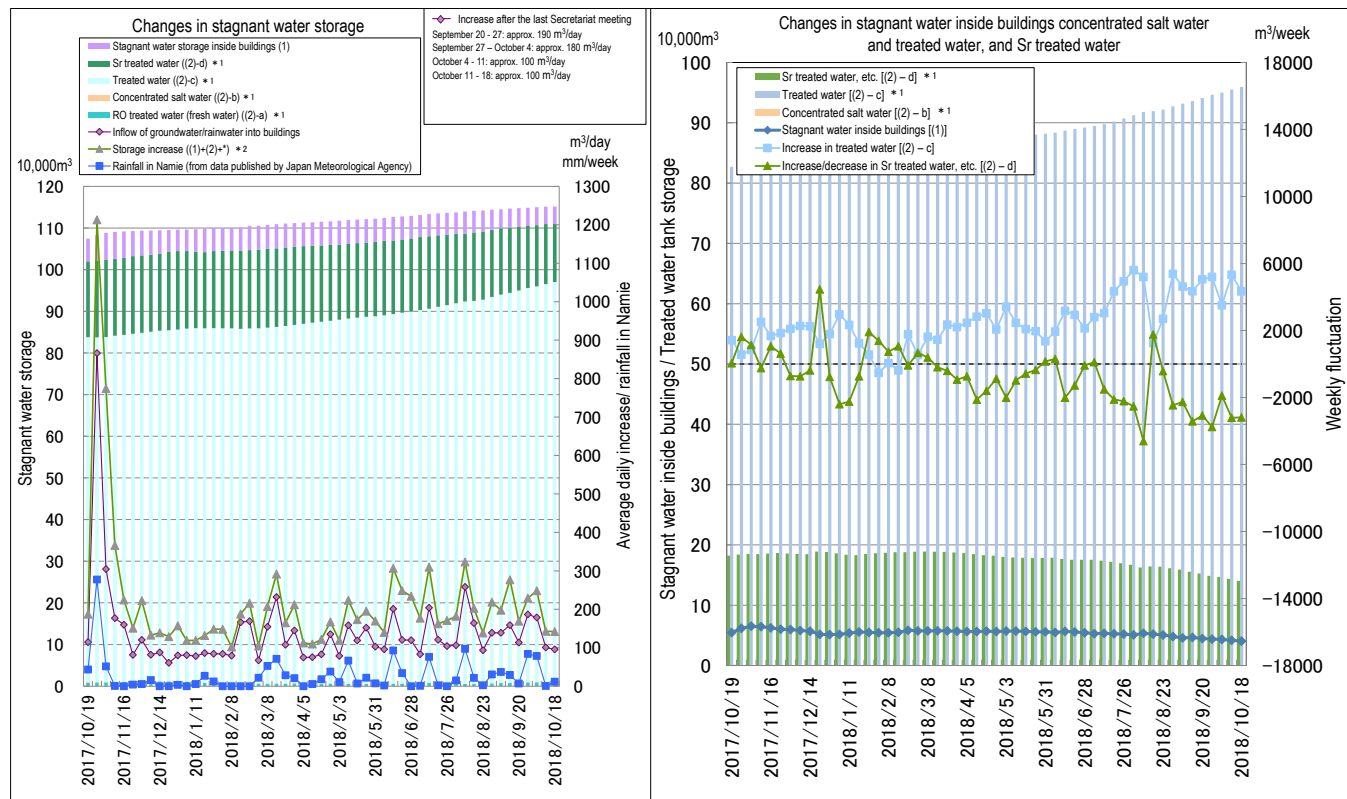
- *1: Water amount for which the water-level gauge indicates 0% or more
- *2: To detect storage increases more accurately, the calculation method was reviewed as follows from February 9, 2017: (The revised method was applied from March 1, 2018) [(Inflow of groundwater/rainwater into buildings) + (other transfer) + (chemical injection into ALPS)]

- *3: Reevaluated by adding groundwater and rainwater inflow into the residual water areas (January 18 and 25, 2018).
- *4: Reviewed because SARRY reverse cleaning water was added to "Storage increase." (January 25, 2018)

- *9: Inflow into buildings increased due to the effect of repair work on the K drainage channel.
- *10: The storage increase rate rose due to the effect of water transfer to buildings in association with construction, etc. (the transferred water comprised (1) rainwater from the 3uT/B roof: approx. 60m³/day, and (2) condensed rainwater from the desalination equipment RO: approx. 10m³/day).

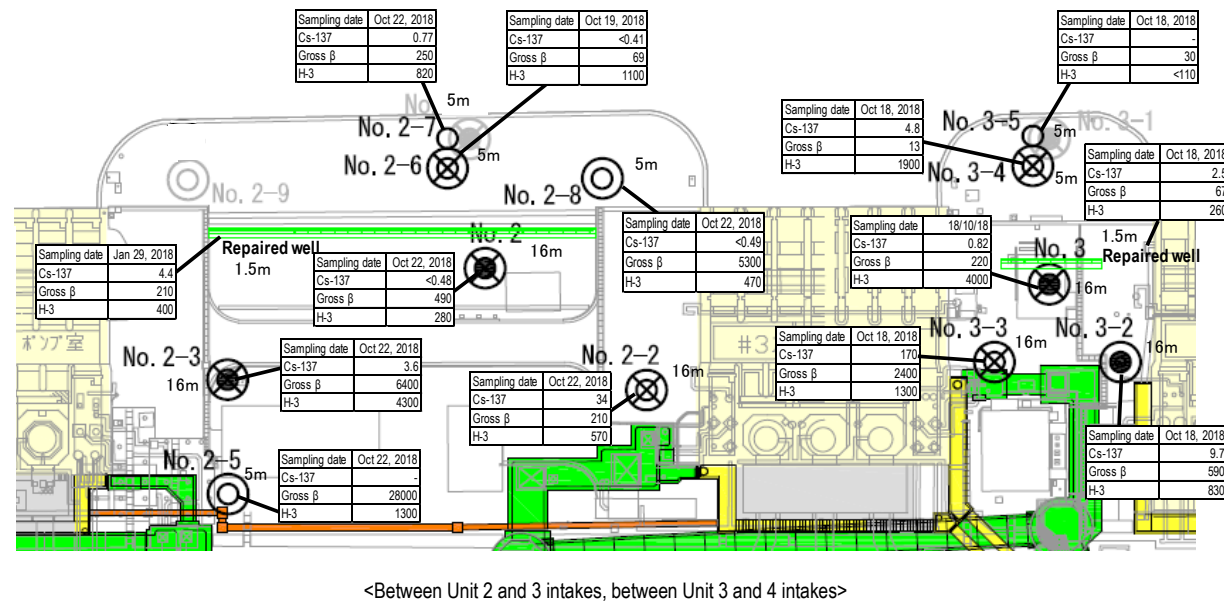
Figure 5: Groundwater density on the Turbine Building east side

- The H-3 density at No. 1-14 remained constant at around 3,000 Bq/L, then declining since September 2018 and currently stands at around 1,500 Bq/L.
- The density of gross β radioactive materials at No. 1-16 had been declining from around 43,000 Bq/L since April 2018 and currently stands at around 18,000 Bq/L. Since August 15, 2013, pumping of groundwater continued (at the well point between the Unit 1 and 2 intakes: August 15, 2013 – October 13, 2015 and from October 24; at the repaired well: October 14 - 23, 2015).

- The density of gross β radioactive materials at No. 2-5 had been increasing from around 30,000 Bq/L since March 2018 to around 70,000 Bq/L, then declining and currently stands at around 27,000 Bq/L. Since December 18, 2013, pumping of groundwater continued (at the well point between the Unit 2 and 3 intakes: December 18, 2013 - October 13, 2015; at the repaired well: from October 14, 2015).

- The H-3 density at No. 3-4 had been declining from around 2,000 Bq/L since January 2018 to around 900 Bq/L, then increasing and currently stands at around 2,000 Bq/L. Since April 1, 2015, pumping of groundwater continued (at the well point between the Unit 3 and 4 intakes: April 1 – September 16, 2015; at the repaired well: from September 17, 2015).

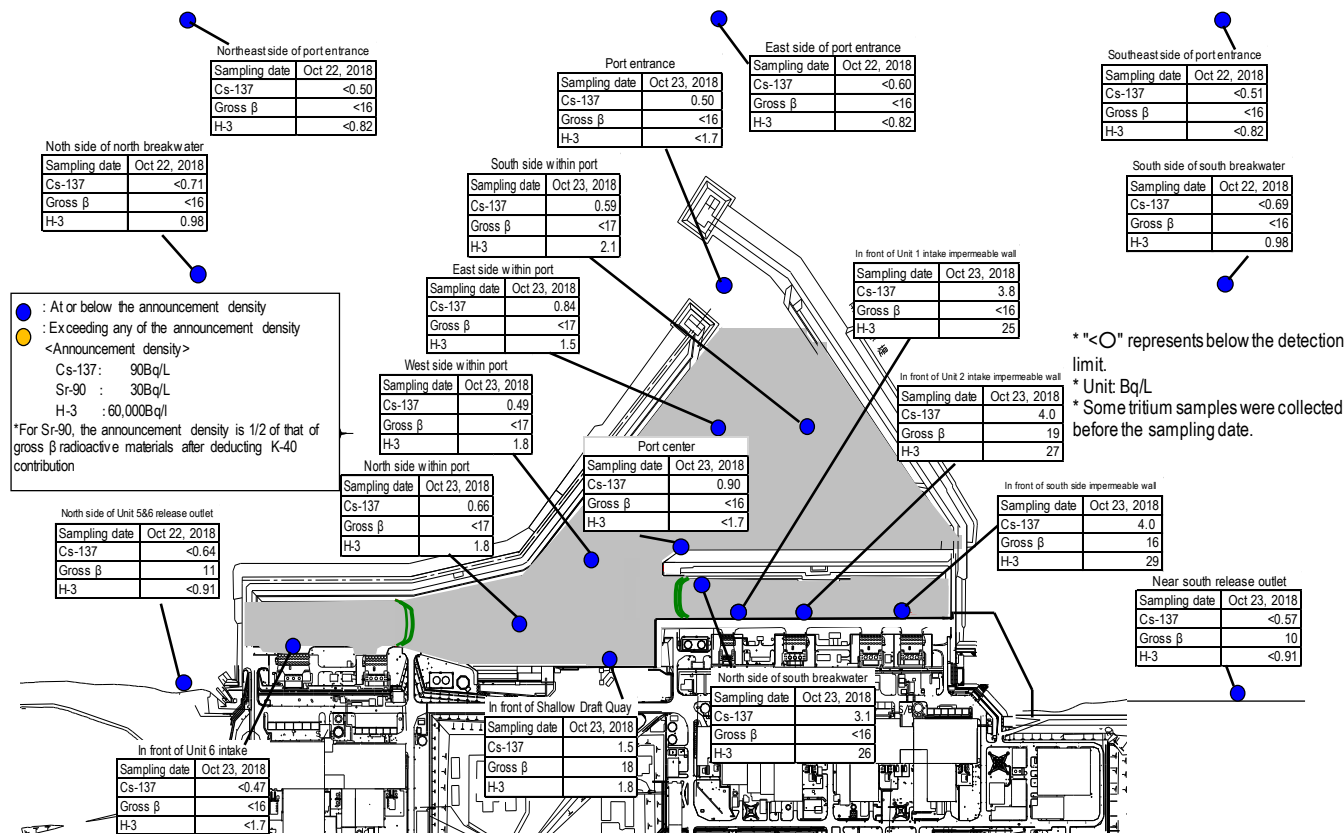
Figure 6: Seawater density around the port

- Regarding the radioactive materials in seawater in the area within the port, densities have remained below the legal discharge limit except for the increase in cesium 137 and strontium 90 during heavy rain but have been declining following the completed installation and the connection of steel pipe sheet piles for the sea-side impermeable walls.

- Regarding the radioactive materials in seawater in the area outside the port, densities of cesium 137 and strontium 90 have been declining, but remained unchanged and below the legal discharge limit following the completed installation and the connection of steel pipe sheet piles for the sea-side impermeable walls.

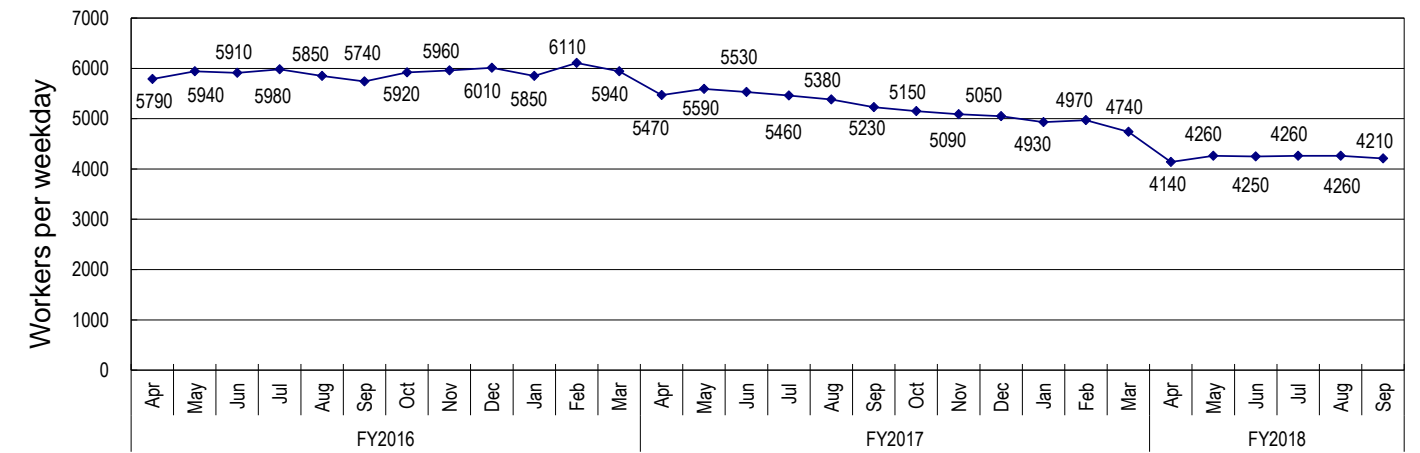
Figure 7: Changes in the average number of workers per weekday for each month since FY2016 (actual values)

- It was confirmed with the prime contractors that the estimated manpower necessary for the work in November 2018 (approx. 4,270 per day: TEPCO and partner company workers) would be secured at present. The average numbers of workers per day per month (actual values) were maintained, with approx. 4,100 to 6,200 since FY2016 (see Figure 7).

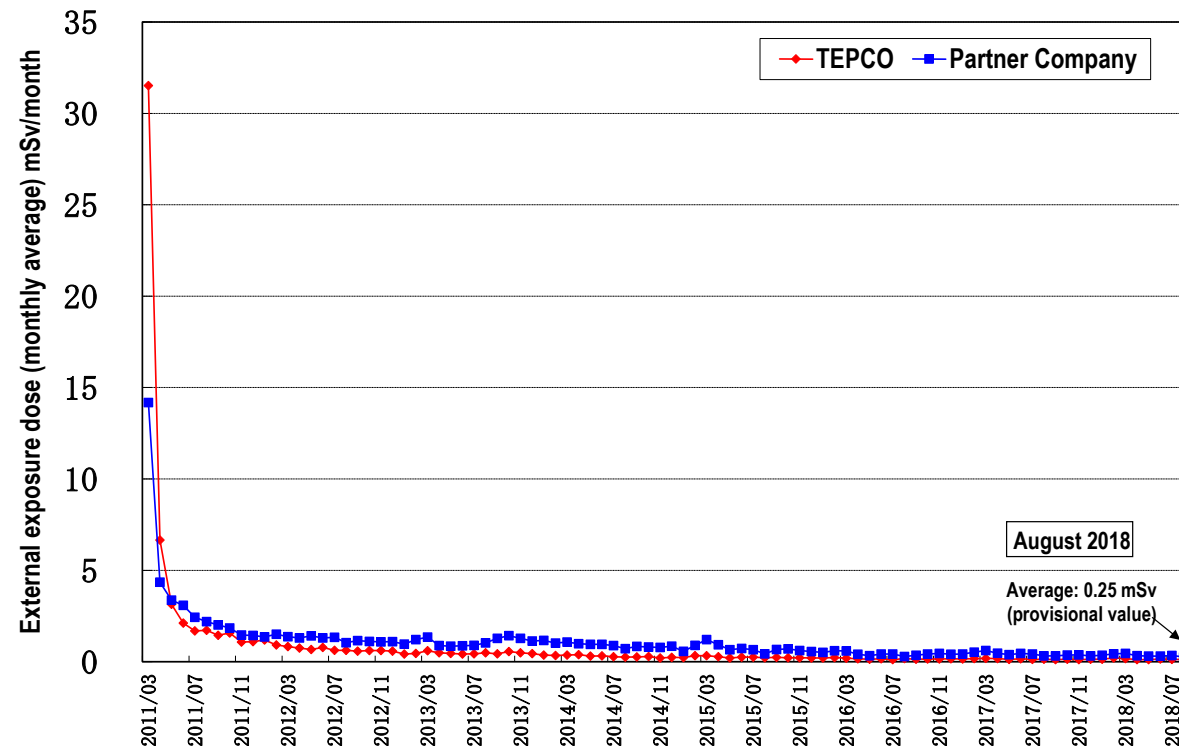
Figure 8: Changes in monthly individual worker exposure dose (monthly average exposure dose since March 2011)

- The monthly average exposure dose of workers remained at approx. 0.59 mSv/month during FY2015, approx. 0.39 mSv/month during FY2016 and approx. 0.36 mSv/month during FY2017. (Reference: Annual average exposure dose 20 mSv/year \doteq 1.7 mSv/month)

- For most workers, the exposure dose was sufficiently within the limit and allowed them to continue engaging in radiation work.

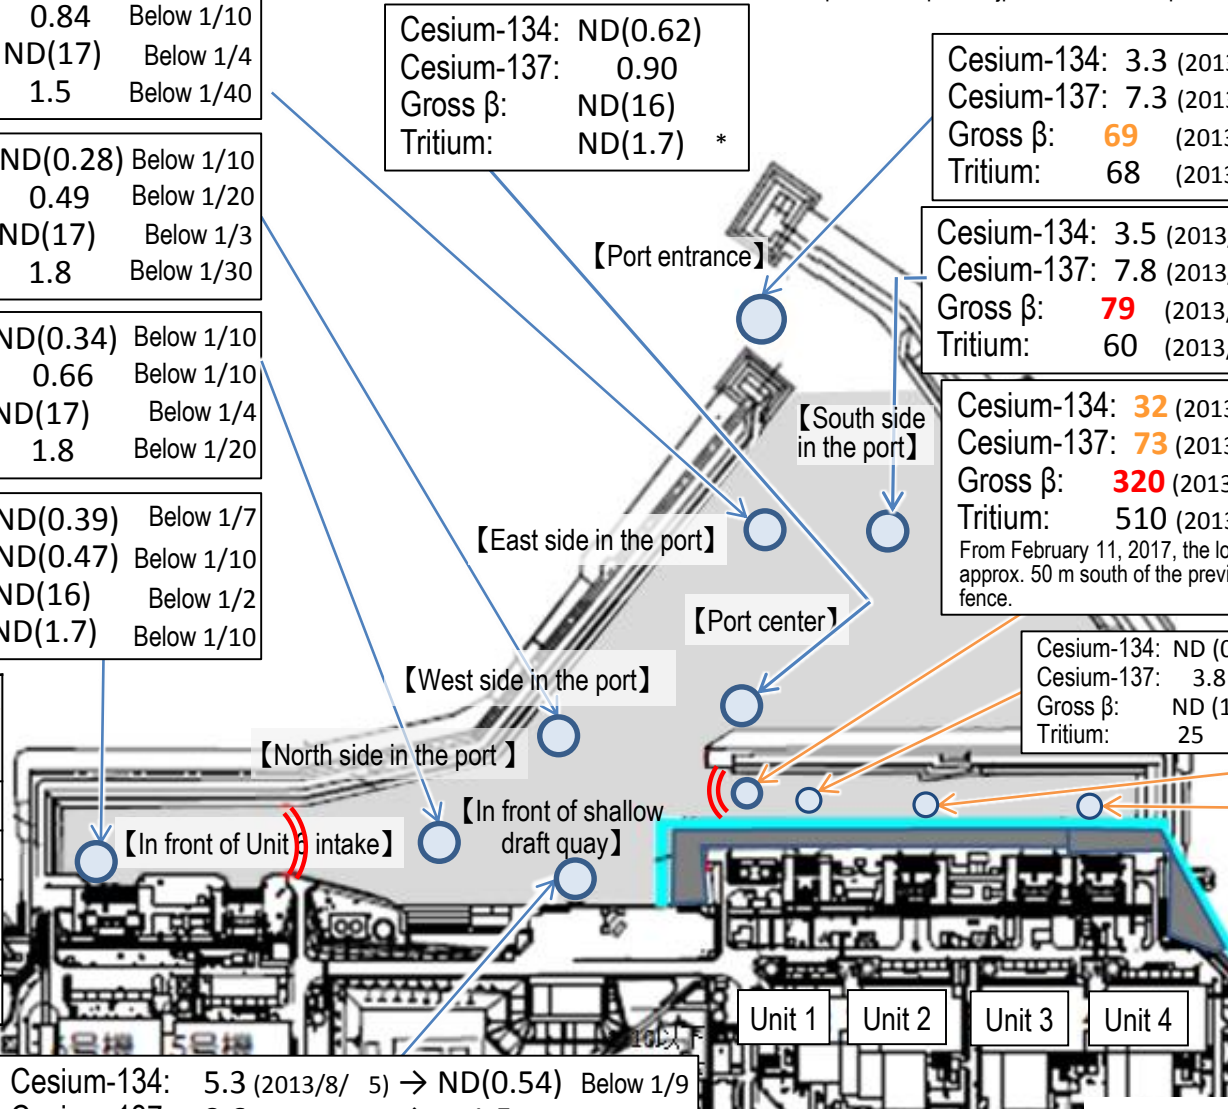
Cesium-134: 5.3 (2013/8/ 5) → ND(0.54) Below 1/9
Cesium-137: 8.6 (2013/8/ 5) → 1.5 Below 1/5
Gross β: **40** (2013/7/ 3) → 18 Below 1/2
Tritium: 340 (2013/6/26) → 1.8 Below 1/100

Note: The gross β measurement values include natural potassium 40 (approx. 12 Bq/L). They also include the contribution of yttrium 90, which radioactively balance strontium 90.

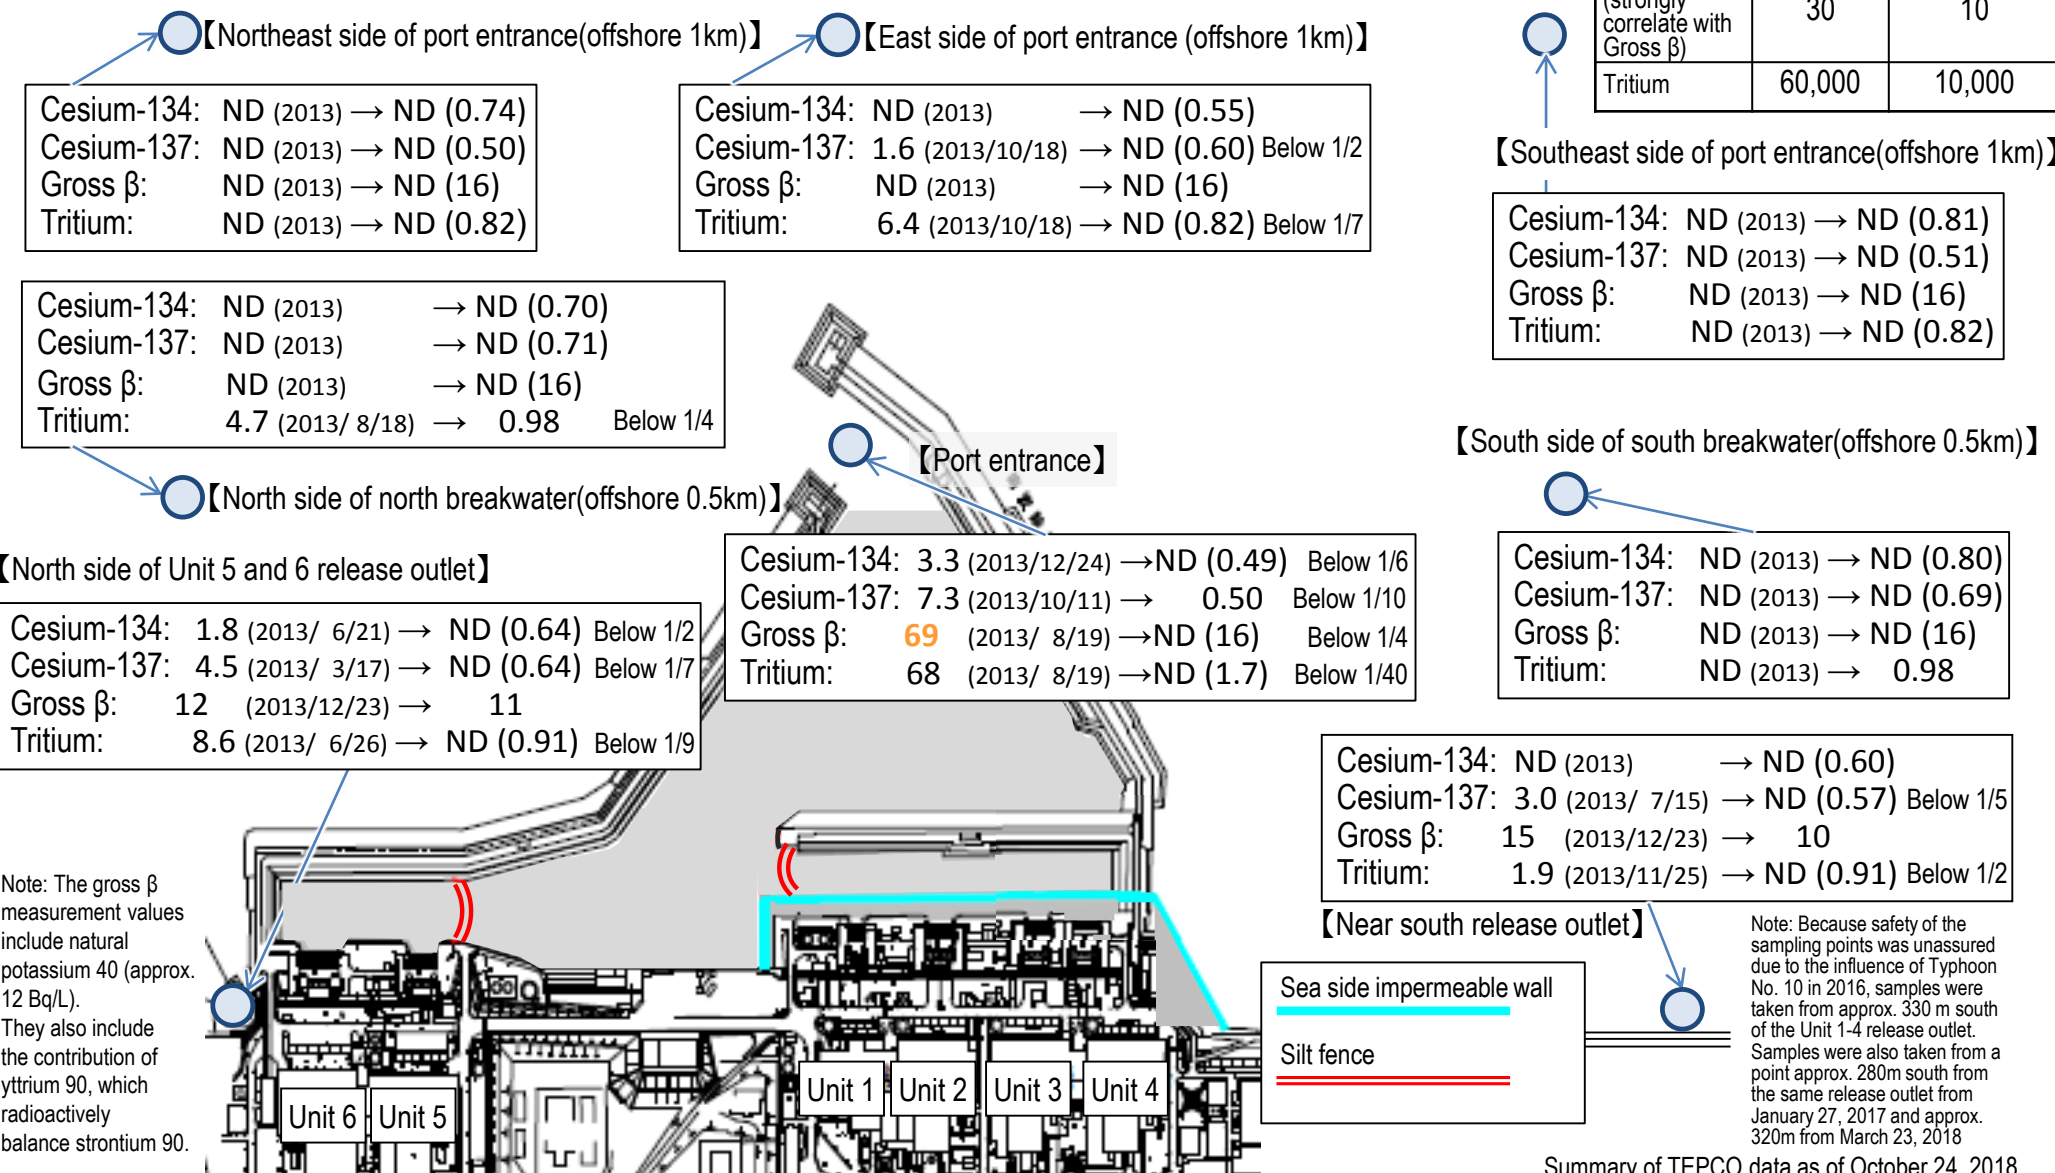
Unit (Bq/L); ND represents a value below the detection limit; values in () represent the detection limit; ND (2013) represents ND throughout 2013

Note: Because safety of the sampling points was unassured due to the influence of Typhoon No. 10 in 2016, samples were taken from approx. 330 m south of the Unit 1-4 release outlet. Samples were also taken from a point approx. 280m south from the same release outlet from January 27, 2017 and approx. 320m from March 23, 2018

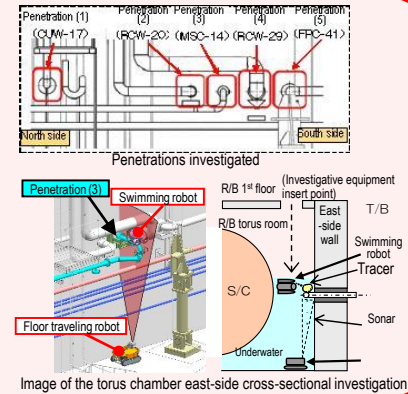
Investigative results on torus chamber walls

- The torus chamber walls were investigated (on the north side of the east-side walls) using equipment specially developed for that purpose (a swimming robot and a floor traveling robot).
- At the east-side wall pipe penetrations (five points), "the status" and "existence of flow" were checked.
- A demonstration using the above two types of underwater wall investigative equipment showed how the equipment could check the status of penetration.
- Regarding Penetrations 1 - 5, the results of checking the sprayed tracer (*) by camera showed no flow around the penetrations. (investigation by the swimming robot)
- Regarding Penetration 3, a sonar check showed no flow around the penetrations. (investigation by the floor traveling robot)

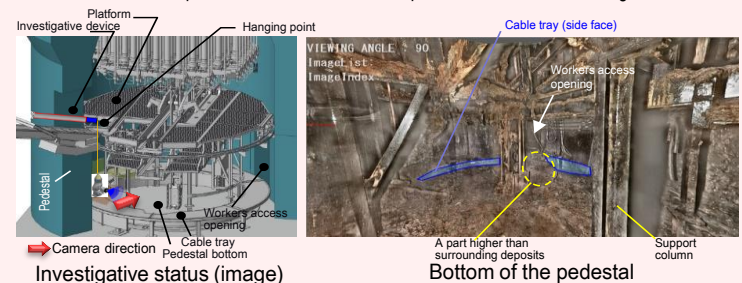
Investigative status (image)

- The results of this series of investigations confirmed fallen and deformed gratings and a quantity of deposit inside the pedestal.
- On January 19, 2018, the status below the platform inside the pedestal was investigated using an investigative device with a hanging mechanism. From the analytical results of images obtained in the investigation, deposits probably including fuel debris were found at the bottom of the pedestal. In addition, multiple parts higher than the surrounding deposits were also detected. We presumed that there were multiple routes of fuel debris falling.

Bottom of the pedestal

- On January 26 and 30, 2017, a camera was inserted from the PCV penetration to inspect the status of the CRD replacement rail on which the robot will travel. On February 9, deposit on the access route of the self-propelled investigative device was removed and on February 16, the inside of the PCV was investigated using the device.

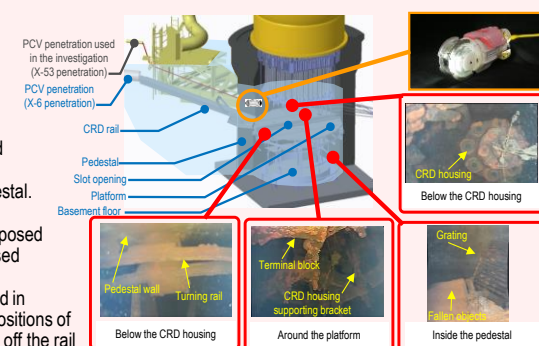
- Analysis of image data obtained in the investigation identified damage to multiple structures and the supposed core internals. Consideration about fuel removal based on the obtained information will continue.

- Videos obtained in the investigation were reproduced in 3D. Based on the reproduced images, the relative positions of the structures, such as the rotating platform slipping off the rail with a portion buried in deposits, were visually understood.

- For the purpose of confirming the status inside the PCV, an investigation device was inserted into the PCV from X-53 penetration on October 20 and 22, 2015 to obtain images, data of dose and temperature and sample stagnant water. No damage was identified on the structure and walls inside the PCV and the water level was almost identical with the estimated value. In addition, the dose inside the PCV was confirmed to be lower than in other Units.
