Main decommissioning works and steps

All fuel had been removed from Unit 4 SFP by December 22, 2014. Work continues toward fuel removal and debris (Note 1) retrieval from Unit 1-3.

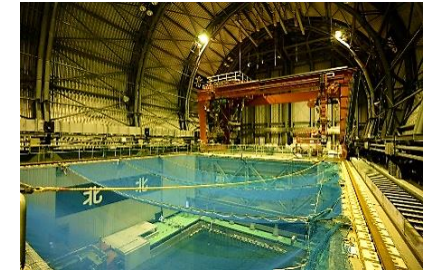
Status inside the cover for fuel removal (March 15, 2018)

As measures to reduce the dose on the Reactor Building operating floor, the decontamination and installation of shields were completed in June and December 2016 respectively. Installation of a fuel removal cover started from January 2017 and installation of all dome roofs was completed in February 2018.

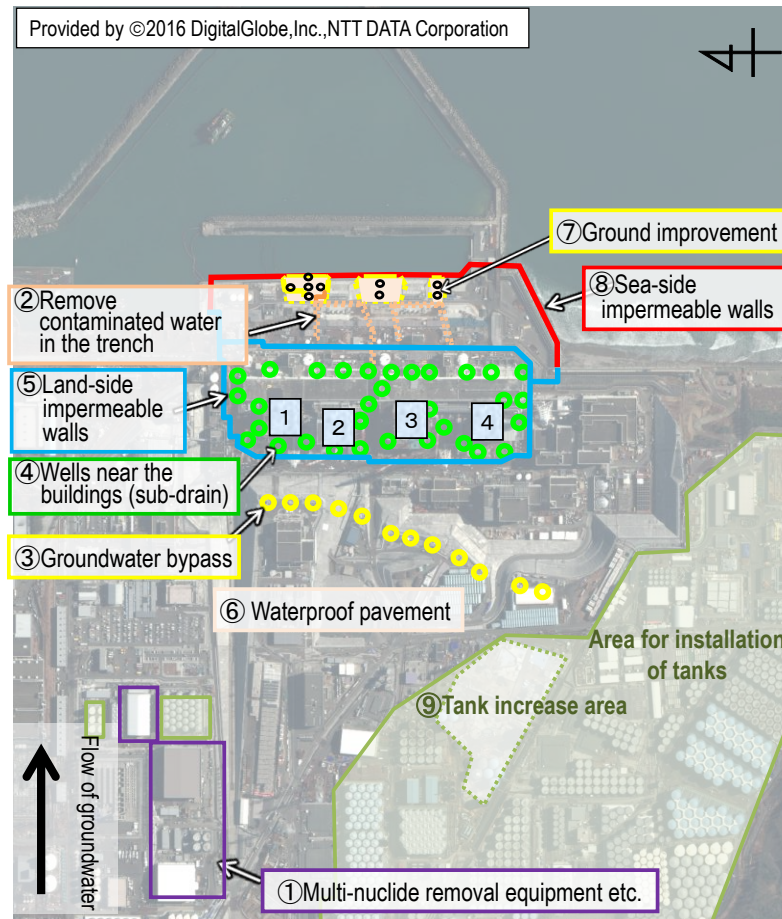
Three principles behind contaminated water countermeasures:

Countermeasures for contaminated water are implemented in accordance with the following three principles:

1. Eliminate contamination sources

- ① Multi-nuclide removal equipment, etc.
- ② Remove contaminated water from the trench (Note 3)
(Note 3) Underground tunnel containing pipes.

2. Isolate water from contamination

- ③ Pump up groundwater for bypassing
- ④ Pump up groundwater near buildings
- ⑤ Land-side impermeable walls
- ⑥ Waterproof pavement

3. Prevent leakage of contaminated water

- ⑦ Enhance soil by adding sodium silicate
- ⑧ Sea-side impermeable walls
- ⑨ Increase the number of (welded-joint) tanks

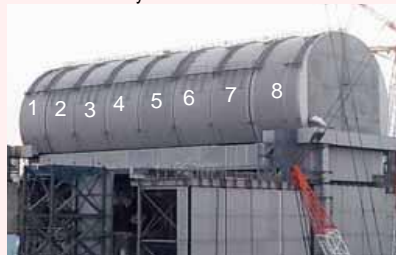
Installation of dome roof (February 21)

Prior to the installation of a cover for fuel removal, removal of large rubble from the spent fuel pool was completed in November 2015. To ensure safe and steady fuel removal, training of remote control was conducted at the factory using the actual fuel-handling machine which will be installed on site (February – December 2015). Measures to reduce dose on the Reactor Building top floor (decontamination, shields) were completed in December 2016. Installation of a cover for fuel removal and a fuel-handling machine is underway from January 2017. Installation of the fuel removal cover was completed on February 23, 2018. Toward fuel removal, after confirming the cause of the failures in the FHM and crane and implementing measures for similar parts, works will continue with safety first.
