## Main decommissioning works and steps

All fuel had been removed from Unit 4 SFP by December 22, 2014. Work continues toward fuel removal and debris (Note 1) retrieval from Unit 1-3.

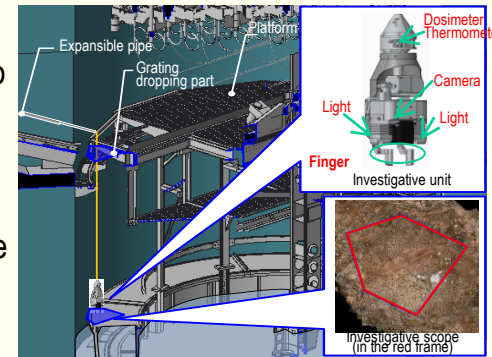
The site and investigative unit for the forthcoming investigation

The investigation inside the Primary Containment Vessel (PCV) in January 2018 detected no significant distortion or damage in the existing facility and found deposits across the bottom of the pedestal. In the forthcoming investigation, to determine the characteristics (hardness and fragility) of deposits, the investigative unit used in the previous investigation will be changed to a finger structure to touch deposits with the finger.

As in the previous investigation, measures to prevent the external leakage of gas in the PCV will be implemented and the dust density monitored throughout the work to prevent any influence on the surrounding environment in the event of leakage.

After operational training, the investigation will start from around February 2019.

- The investigation inside the Primary Containment Vessel (PCV) in January 2018 detected no significant distortion or damage in the existing facility and found deposits across the bottom of the pedestal.
- In the forthcoming investigation, to determine the characteristics (hardness and fragility) of deposits, the investigative unit used in the previous investigation will be changed to a finger structure to touch deposits with the finger.
- As in the previous investigation, measures to prevent the external leakage of gas in the PCV will be implemented and the dust density monitored throughout the work to prevent any influence on the surrounding environment in the event of leakage.
- After providing operational training, the investigation will start from around February 2019.

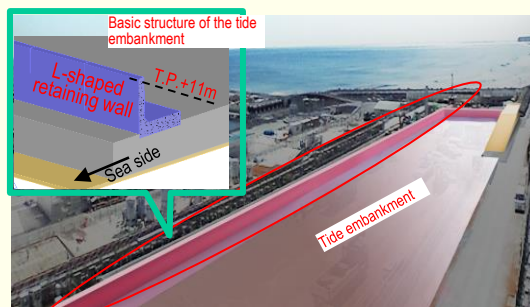
Image of the installed tide embankment

In preparation for the potentially urgent danger of the Chishima trench tsunami, a tide embankment will be installed to prevent any increase in stagnant water in buildings and its outflow due to water ingress into buildings and subsequently reduce the risk of delaying the overall on-site decommissioning work.

The tide embankment will be a reinforced concrete L-shaped retaining wall; T.P. +11.0m in height.

Examination and construction are currently underway while minimizing the influence on the ongoing decommissioning work for an operational launch in the first half of FY2020.

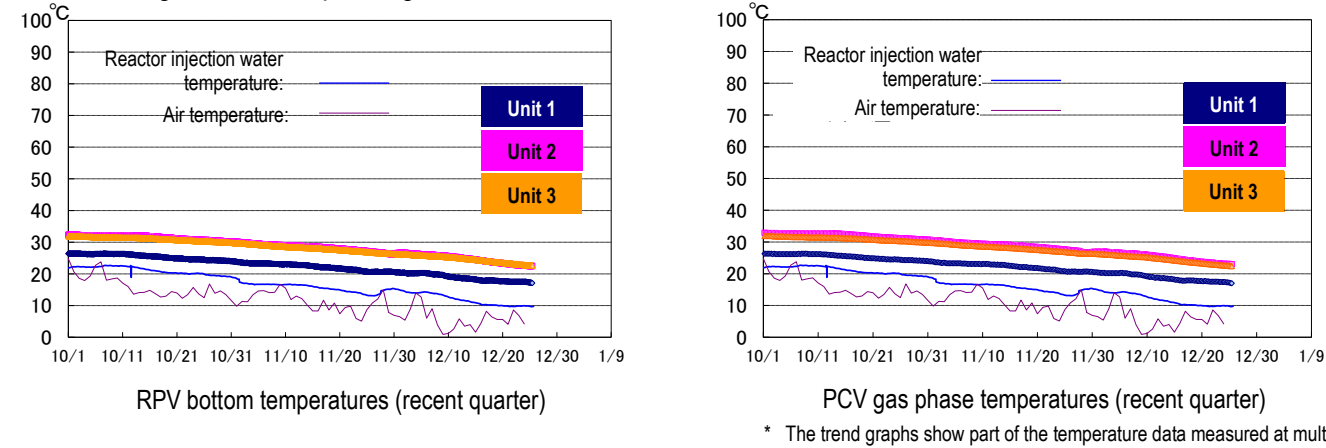
Through continuous reactor cooling by water injection, the temperatures of the Reactor Pressure Vessel (RPV) bottom and the Primary Containment Vessel (PCV) gas phase were maintained within the range of approx. 15 to 30°C for the past month, though it varied depending on the unit and location of the thermometer.

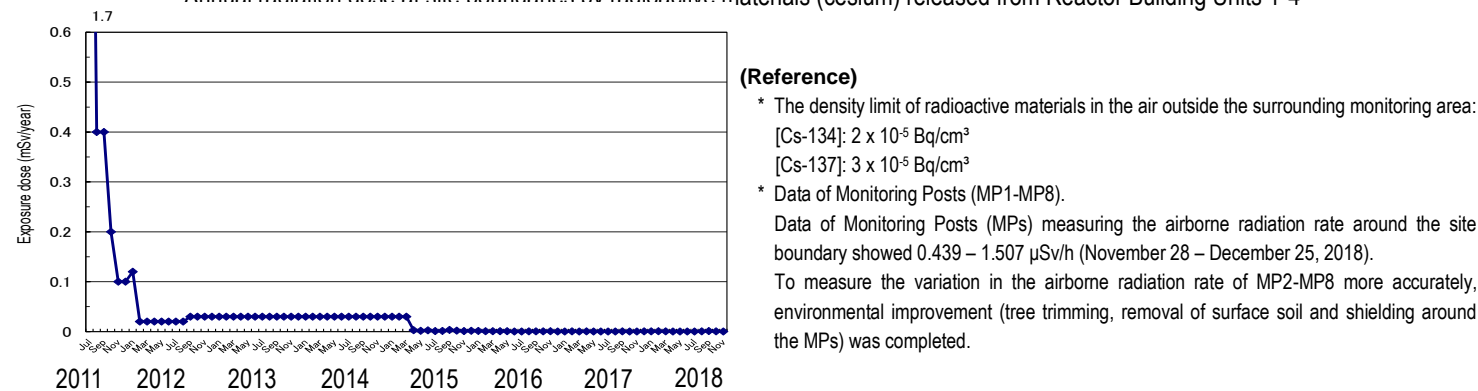
Annual radiation dose at site boundaries by radioactive materials (cesium) released from Reactor Building Units 1-4

As of November 2018, the density of radioactive materials newly released from Reactor Building Units 1-4 in the air and measured at the site boundary was evaluated at approx.  $1.8 \times 10^{-12}$  Bq/cm<sup>3</sup> for Cs-134 and  $3.1 \times 10^{-12}$  Bq/cm<sup>3</sup> for Cs-137, while the radiation exposure dose due to the release of radioactive materials there was less than 0.00022 mSv/year.

Note: Different formulas and coefficients were used to evaluate the radiation dose in the facility operation plan and monthly report. The evaluation methods were integrated in September 2012. As the fuel removal from the spent fuel pool (SFP) commenced for Unit 4, the radiation exposure dose from Unit 4 was added to the items subject to evaluation since November 2013. The evaluation has been changed to a method considering the values of continuous dust monitors since FY2015, with data to be evaluated monthly and announced the following month.

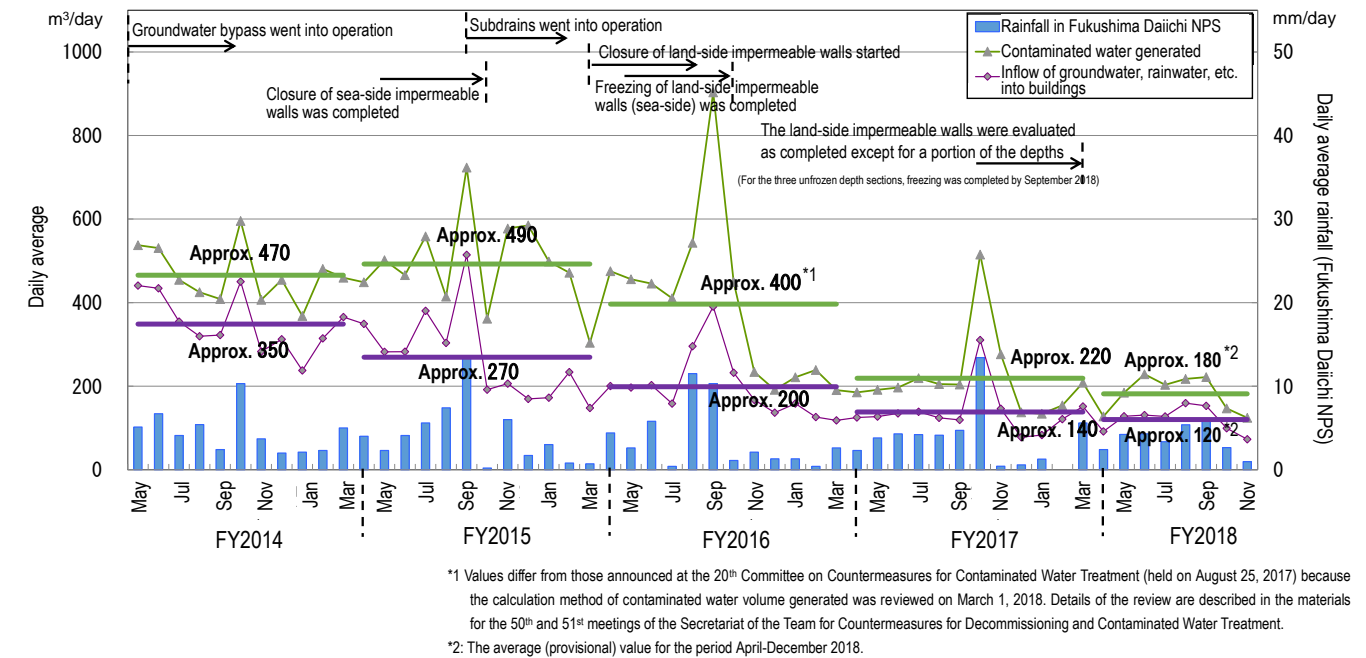
Figure 1: Changes in contaminated water generated and inflow of groundwater, rainwater, etc. into buildings

- Multi-layered measures, including pumping up by subdrains and land-side impermeable walls, which were implemented to control the continued generation of contaminated water, reduced the groundwater inflow into buildings.

- Following the steady implementation of “isolation” measures (groundwater bypass subdrains, frozen walls, etc.), the inflow reduced from approx. 470 m<sup>3</sup>/day (the FY2014 average) when the measures were first launched to approx. 220 m<sup>3</sup>/day (the FY2017 average), though the figure varied depending on rainfall, etc.
- Measures will continue to further reduce the volume of contaminated water generated.

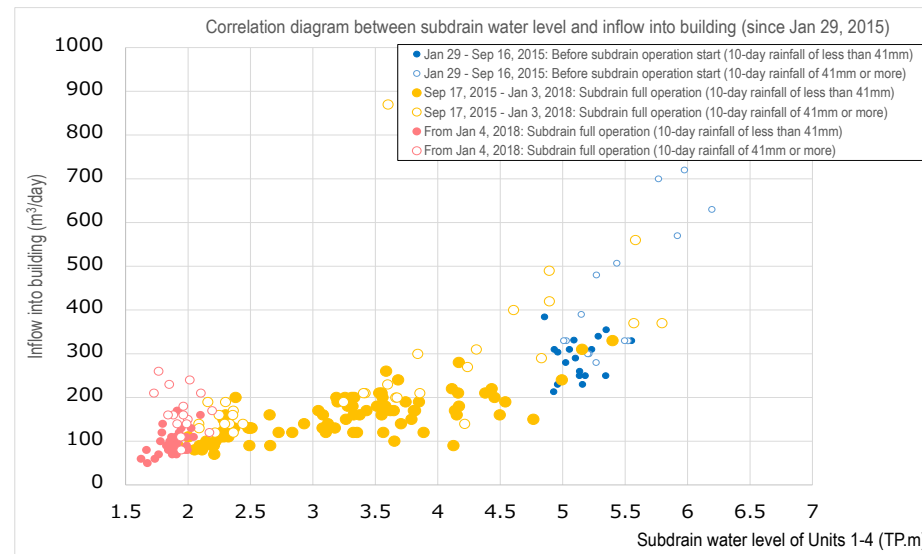
Figure 2: Correlation between inflow such as groundwater and rainwater into buildings and the water level of Unit 1-4 subdrains

- Since the subdrains went into operation, the inflow into buildings tended to decline to under 150 m<sup>3</sup>/day when the subdrain water level declined below T.P. 3.0 m but increased during rainfall.

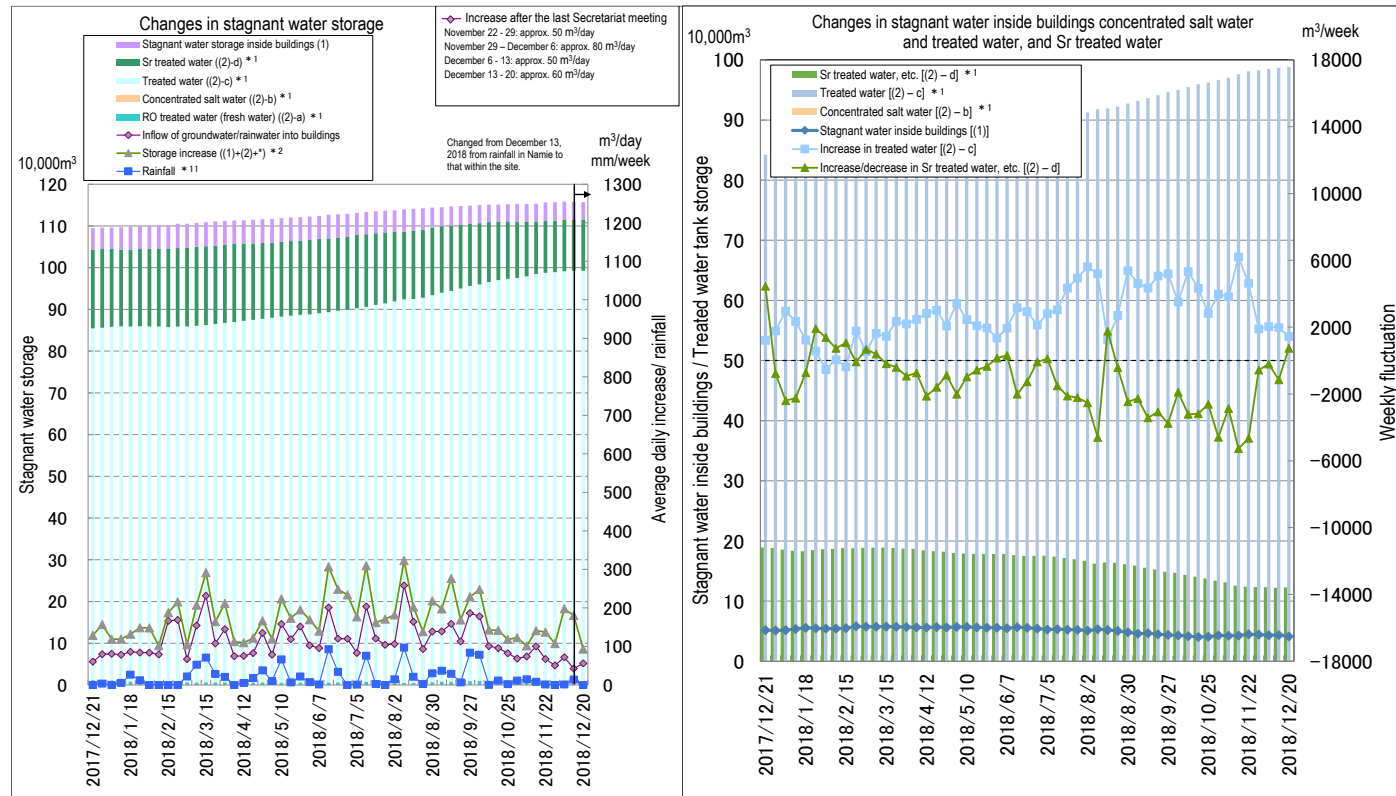
- \*1: Water amount for which the water-level gauge indicates 0% or more
- \*2: To detect storage increases more accurately, the calculation method was reviewed as follows from February 9, 2017: (The revised method was applied from March 1, 2018)  $[(\text{Inflow of groundwater/rainwater into buildings}) + (\text{other transfer}) + (\text{chemical injection into ALPS})]$

- \*3: Reevaluated by adding groundwater and rainwater inflow into the residual water areas (January 18 and 25, 2018).
- \*4: Reviewed because SARRY reverse cleaning water was added to "Storage increase." (January 25, 2018)

- \*9: Inflow into buildings increased due to the effect of repair work on the K drainage channel.
- \*10: The storage amount increased due to transfer to buildings in association with the decommissioning work. (The transferred amount comprised an ALPS chemical injection amount of approx. 12 m<sup>3</sup>/day, transfer from wells and groundwater drains: approx. 14m<sup>3</sup>/day and transfer from On-site Bunker: approx. 100m<sup>3</sup>/day, etc.)

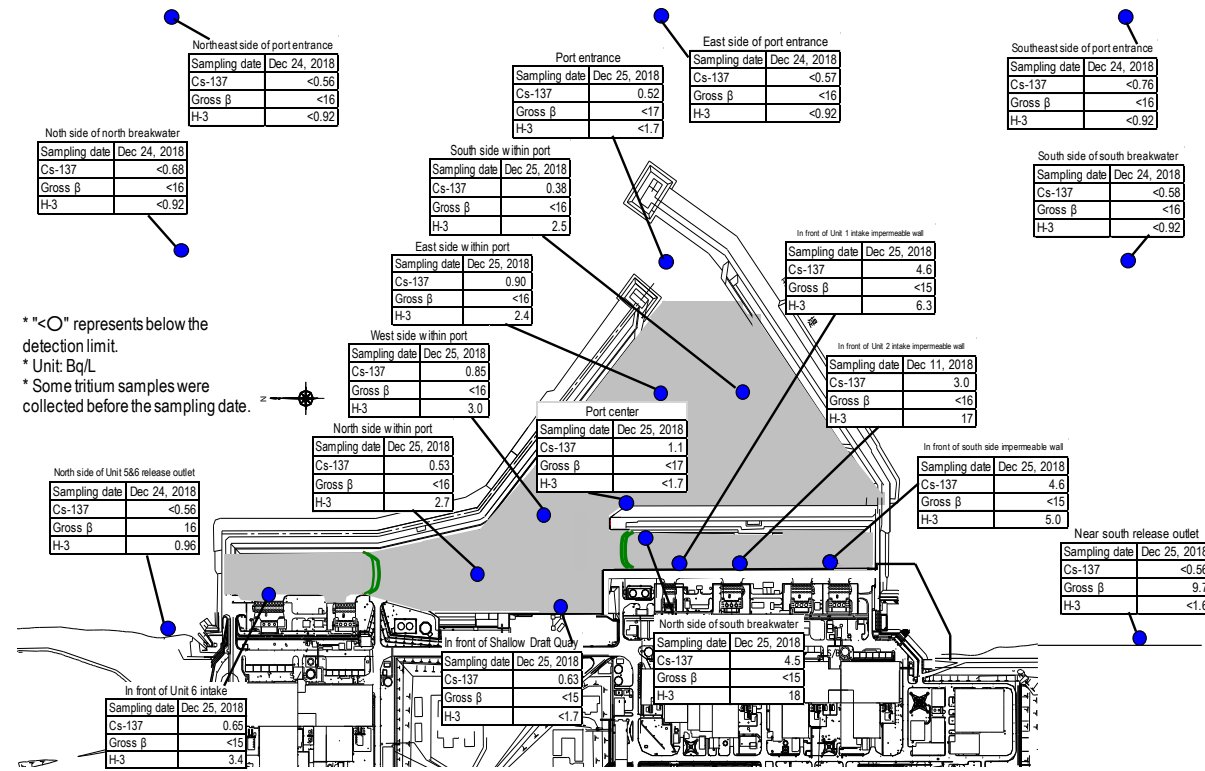
Figure 6: Seawater density around the port

- Regarding the radioactive materials in seawater in the area within the port, densities have remained below the legal discharge limit except for the increase in cesium 137 and strontium 90 during rain. They have been below the level of those in the Unit 1-4 intake open channel area and have been declining following the completed installation and the connection of steel pipe sheet piles for the sea-side impermeable walls.

- Regarding the radioactive materials in seawater in the area outside the port, densities of cesium 137 and strontium 90 have been declining, but remained unchanged following the completed installation and the connection of steel pipe sheet piles for the sea-side impermeable walls.

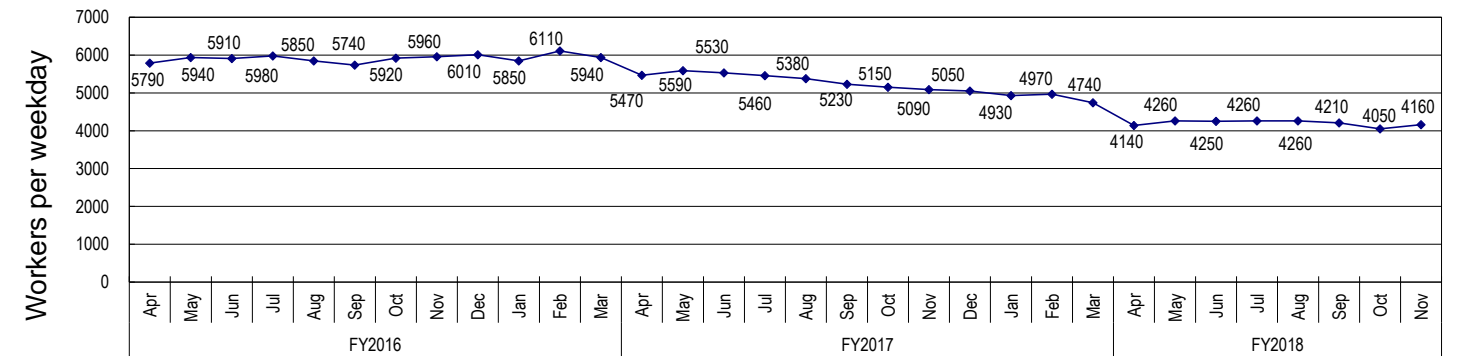
Figure 7: Changes in the average number of workers per weekday for each month since FY2016 (actual values)

- It was confirmed with the prime contractors that the estimated manpower necessary for the work in January 2019 (approx. 4,290 per day: TEPCO and partner company workers) would be secured at present. The average numbers of workers per day per month (actual values) were maintained, with approx. 4,000 to 6,200 since FY2016 (see Figure 7).

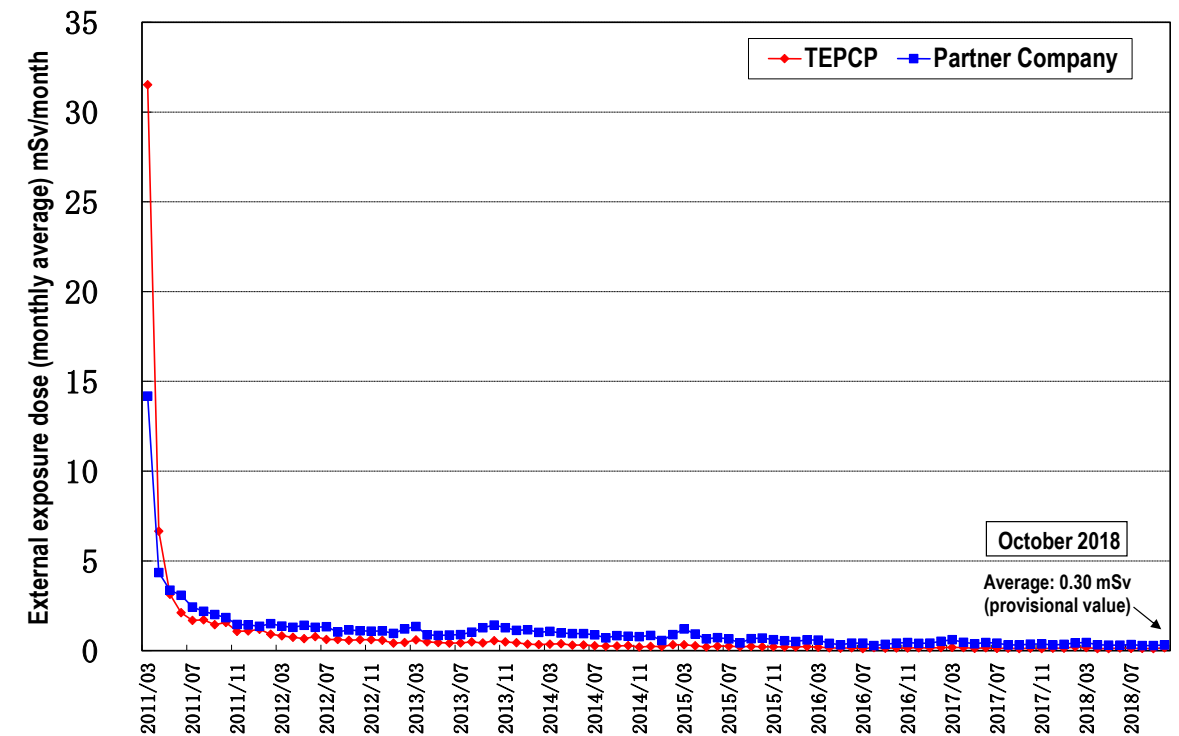
Figure 8: Changes in monthly individual worker exposure dose (monthly average exposure dose since March 2011)

- The monthly average exposure dose of workers remained at approx. 0.59 mSv/month during FY2015, approx. 0.39 mSv/month during FY2016 and approx. 0.36 mSv/month during FY2017. (Reference: Annual average exposure dose 20 mSv/year  $\div$  1.7 mSv/month)

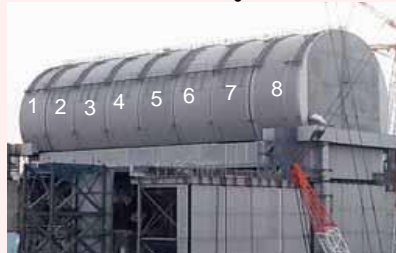
Installation of dome roof (February 21)

Prior to the installation of a cover for fuel removal, removal of large rubble from the spent fuel pool was completed in November 2015. To ensure safe and steady fuel removal, training of remote control was conducted at the factory using the actual fuel-handling machine which will be installed on site (February – December 2015). Measures to reduce dose on the Reactor Building top floor (decontamination, shields) were completed in December 2016. Installation of a cover for fuel removal and a fuel-handling machine is underway from January 2017. Installation of the fuel removal cover was completed on February 23, 2018. Regarding fuel removal, after confirming the cause of the defects in the FHM and crane and implementing measures for similar parts, works will continue toward removal starting from the end of March 2019 putting safety first.

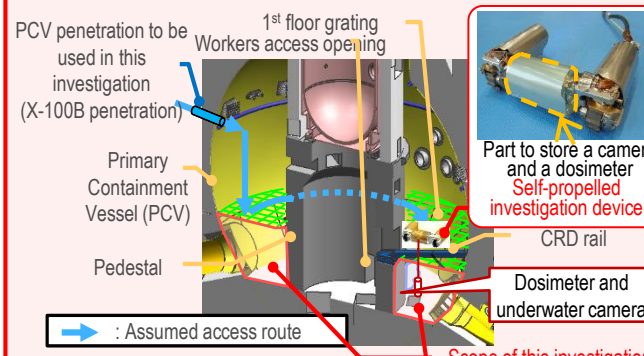
<Image of investigation inside the PCV>

- In April 2015, a device, which entered the inside of the PCV through a narrow access opening (bore:  $\phi$  100 mm), collected information such as images and airborne dose inside the PCV 1st floor.
- In March 2017, the investigation using a self-propelled investigation device, conducted to inspect the spreading of debris to the basement floor outside the pedestal, took images of the PCV bottom status for the first time. The status inside the PCV will continue to be examined based on the collected image and dose data.

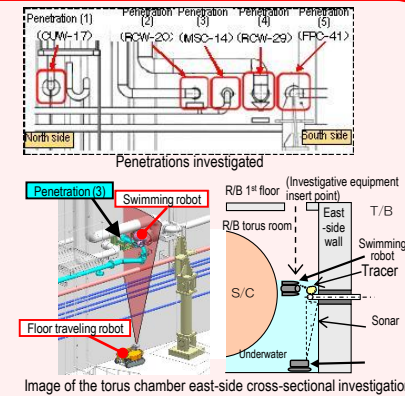
## Investigative results on torus chamber walls

- The torus chamber walls were investigated (on the north side of the east-side walls) using equipment specially developed for that purpose (a swimming robot and a floor traveling robot).
- At the east-side wall pipe penetrations (five points), "the status" and "existence of flow" were checked.
- A demonstration using the above two types of underwater wall investigative equipment showed how the equipment could check the status of penetration.
- Regarding Penetrations 1 - 5, the results of checking the sprayed tracer<sup>(5)</sup> by camera showed no flow around the penetrations. (investigation by the swimming robot)
- Regarding Penetration 3, a sonar check showed no flow around the penetrations. (investigation by the floor traveling robot)

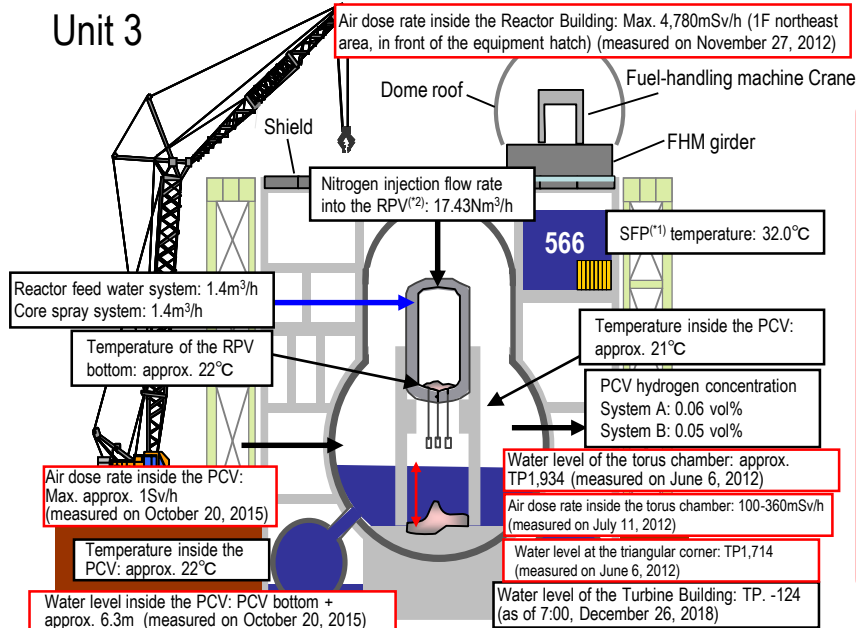
### Unit 3

\* Indices related to plant are values as of 11:00, December 26, 2018

Investigations inside PCV	1st (Oct – Dec 2015)	- Acquiring images - Measuring air temperature and dose rate - Measuring water level and temperature - Sampling stagnant water - Installing permanent monitoring instrumentation (December 2015)
	2nd (Jul 2017)	- Acquiring images - Installing permanent monitoring instrumentation (August 2017)
Leakage points from PCV	- Main steam pipe bellows (identified in May 2014)

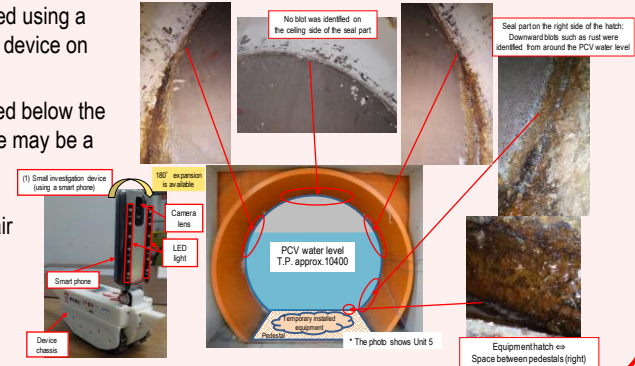
- Given blots such as rust identified below the water level inside the PCV, there may be a leakage from the seal to the extent of bleeding.

Methods to investigate and repair the parts, including other PCV penetrations with a similar structure, will be considered.

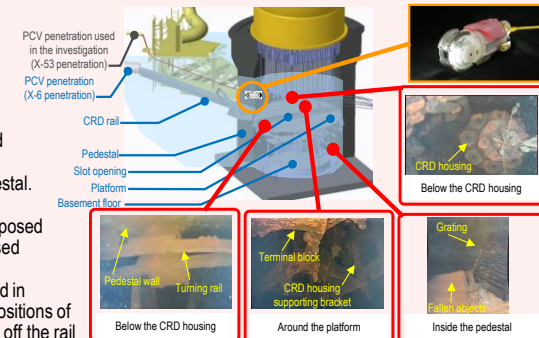
Status inside the pedestal

- Analysis of image data obtained in the investigation identified damage to multiple structures and the supposed core internals. Consideration about fuel removal based on the obtained information will continue.

- Videos obtained in the investigation were reproduced in 3D. Based on the reproduced images, the relative positions of the structures, such as the rotating platform slipping off the rail with a portion buried in deposits, were visually understood.

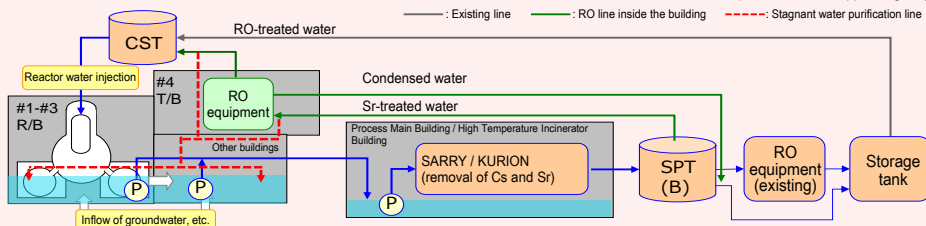
- To reduce the risk of contaminated-water leakage, the circulation loop was shortened by installing a reverse osmosis (RO) device in the Unit 4 Turbine Building within the circulation loop, comprising the transfer of contaminated water, water treatment and injection into the reactors. Operation of the installed RO device started from October 7 and 24-hour operation started from October 20. Installation of the new RO device inside the building shortened the circulation loop from approx. 3 to 0.8 km.

- The risks of stagnant water inside the buildings will continue to be reduced in addition to reduction of its storage.

\* The entire length of contaminated water transfer pipes is approx. 2.1km, including the transfer line of surplus water to the upper heights (approx. 1.3km).

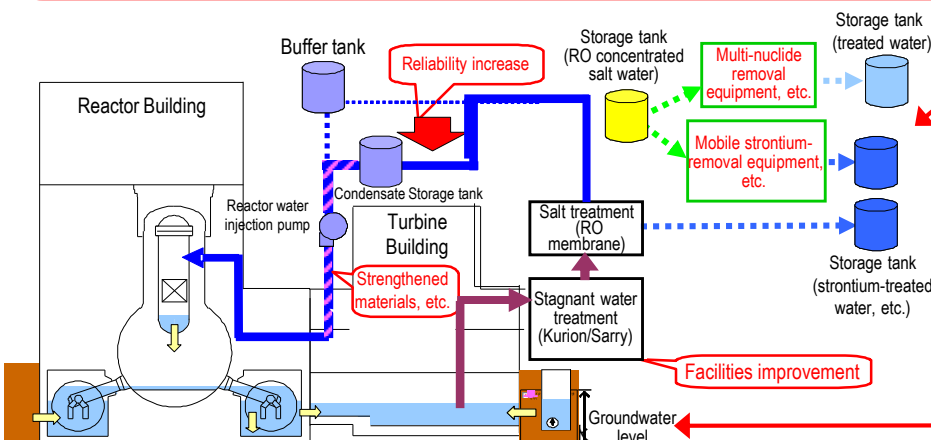
Contaminated water (RO concentrated salt water) is being treated using seven types of equipment including the multi-nuclide removal equipment (ALPS). Treatment of the RO concentrated salt water was completed on May 27, 2015, with the exception of the remaining water at the tank bottom. The remaining water will be treated sequentially toward dismantling the tanks.

The strontium-treated water from other facilities than the multi-nuclide removal equipment will be re-purified in the multi-nuclide removal equipment to further reduce risks.

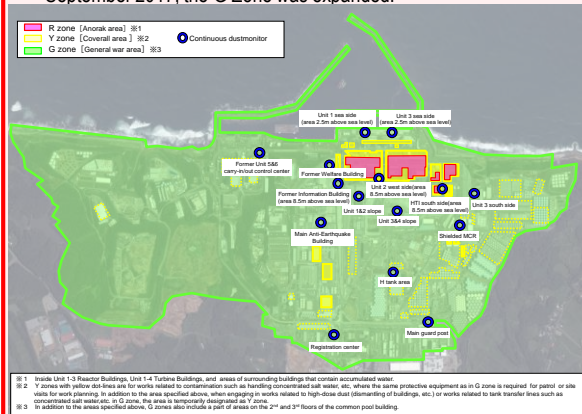
Based on the progress of measures to reduce environmental dosage on site, the site is categorized into two zones: highly contaminated area around Unit 1-4 buildings, etc. and other areas to optimize protective equipment according to each category aiming at improving safety and productivity by reducing load during work.

From March 2016, limited operation started. From March and September 2017, the G zone was expanded.

① Inside Unit 1-3 Reactor Buildings, Unit 1-4 Turbine Buildings, and areas of surrounding buildings that contain accumulated water.  
 ② Y zones with yellow dot areas are for works related to contamination such as handling concentrated salt water, etc. when the same protective equipment as in G zone is required for patrol or site visits for work planning. In addition to the area specified above, when engaging in works related to high-dose dust (dismantling of buildings, etc.) or works related to tank transfer lines such as concentrated salt water tanks in G zone, the area is temporarily designated as Y zone.  
 ③ In addition to the areas specified above, G zones also include a part of areas on the 2nd and 3rd floors of the common pool building.

R zone (Anorak area)	Y zone (Coverall area)	G zone (General wear)
Full-face mask 	Full-face or half-face masks 	Disposable disposable mask 
Anorak on coverall Or double coveralls 	Coverall 	General*3 Dedicated on-site wear

\*1 For works in buildings including water-treatment facilities (multi-nuclide removal equipment, etc.) (excluding site visits), wear a full-face mask.  
 \*2 For works in tank areas containing concentrated salt water or Sr-treated water (excluding works not handling concentrated salt water, etc., patrol, on-site investigation for work planning, and site visits) and works related to tank transfer lines, wear a full-face mask.  
 \*3 Specified light works (patrol, monitoring, delivery of goods brought from outside, etc.)

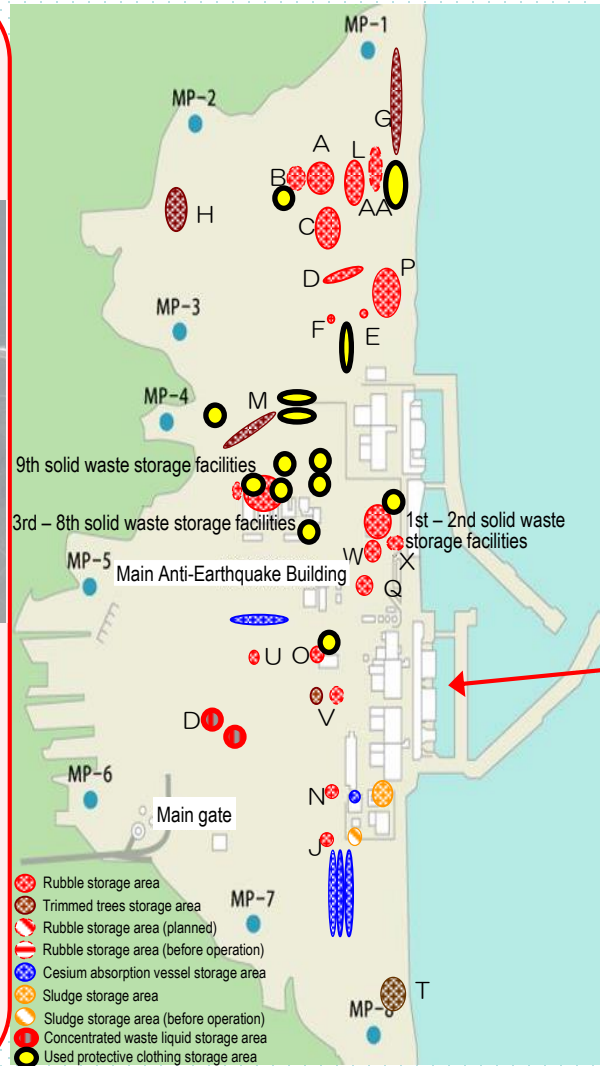
- Rubble storage area
- Trimmed trees storage area
- Rubble storage area (planned)
- Rubble storage area (before operation)
- Cesium absorption vessel storage area
- Sludge storage area
- Sludge storage area (before operation)
- Concentrated waste liquid storage area
- Used protective clothing storage area
