Main decommissioning work and steps

Fuel removal from the Unit 4 SFP was completed on December 22, 2014 and from the Unit 3 SFP is underway from April 15, 2019. Dust density in the surrounding environment is being monitored and work is being implemented with safety first. Work continues sequentially toward the start of fuel removal from Units 1 and 2 and debris (Note 1) retrieval from Units 1-3.

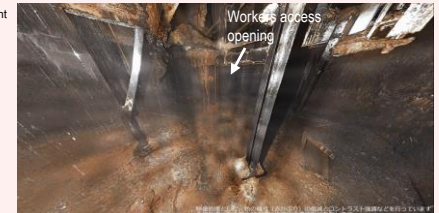
Investigative status (image)

- On February 13, 2019, an investigation touching the deposits at the bottom of the pedestal and on the platform was conducted and confirmed that the pebble-shaped deposits, etc. could be moved and that hard rock-like deposits that could not be gripped may exist.

- In addition, images, etc. would help determine the contour and size of the deposits could be collected by moving the investigative unit closer to the deposits than the previous investigation.

Bottom of the pedestal (after being processed in panoramic image visualization)

- The results of this series of investigations confirmed fallen and deformed gratings and a quantity of deposit inside the pedestal.
- On January 19, 2018, the status below the platform inside the pedestal was investigated using an investigative device with a hanging mechanism. From the analytical results of images obtained in the investigation, deposits probably including fuel debris were found at the bottom of the pedestal. In addition, multiple parts higher than the surrounding deposits were also detected. We presumed that there were multiple routes of fuel debris falling. Obtained data were processed in panoramic image visualization to acquire clearer images.
