Main decommissioning work and steps

Fuel removal from the Unit 4 SFP was completed on December 22, 2014 and removal from the Unit 3 SFP has been underway since April 15, 2019. Dust density in the surrounding environment is being monitored and work is being implemented with safety first. Work continues sequentially toward the start of fuel removal from Units 1 and 2 and debris (Note 1) retrieval from Units 1-3.

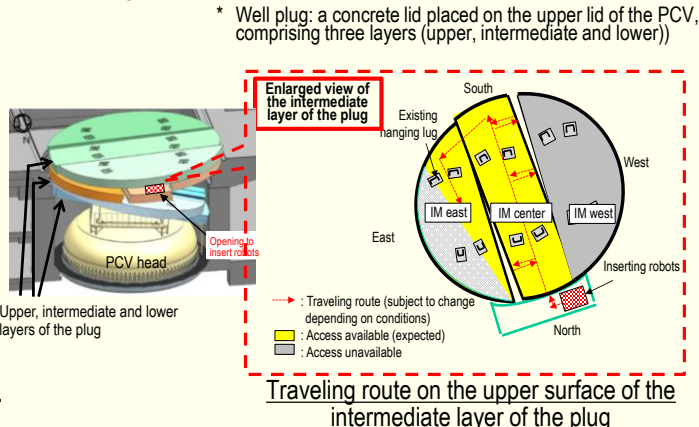
Start of investigation into the Unit 1 well plug from July

The well plug (plug)* was misaligned from the normal position due to the influence of the hydrogen explosion at the time of the accident. Toward fuel removal from the spent fuel pool, the plug will be investigated prior to examining how to handle it.

In the investigation, two robots (for investigation and monitoring) will be inserted through the space between the upper and the intermediate layers to take photos by a camera, measure the airborne radiation dose, etc. within the range that the robots can travel. A mockup test, etc. are currently underway. After removing small rubble around the opening, the investigation will start from mid-July.

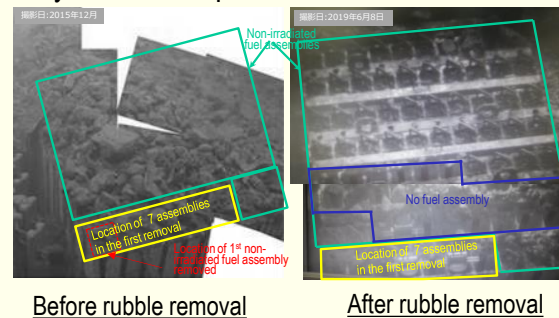
Start of second fuel removal using transport container at Unit 3 from July

At Unit 3, the first fuel removal was completed on April 25 and this removal is being reviewed (improving procedures and facilities). Work has begun to collect the removed rubble and training on removal is being provided toward the second removal using the transport container from July and subsequent removal work.

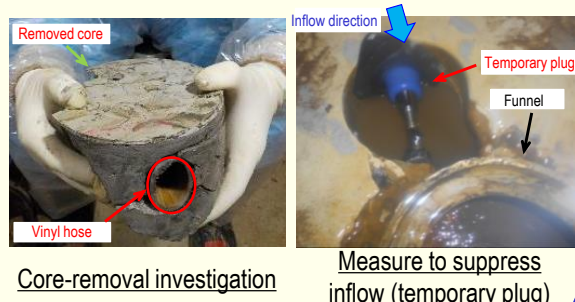
Regarding the inflow of groundwater, etc. to the Onsite Bunker Building, the core was removed near the funnel and the inflow condition of the core section was investigated by June 20 to identify the cause. The investigation detected a vinyl hose laid there, which was supposed to continue to near the outer walls of the building.

Currently a temporary plug has been installed until completion of the water shutoff work to suppress inflow. Toward examining permanent water shutoff measures, an investigation on the upstream side, including the wall side, will be examined and implemented to check the inside of the hose and identify the cause of the inflow.

- Regarding the inflow of groundwater, etc. into the Onsite Bunker Building, the core was removed near the funnel and the inflow condition of the core section was investigated by June 20, 2019 to identify the cause. The investigation detected a vinyl hose laid there, which was supposed to continue to near the outer walls of the building.

- Currently a temporary plug has been installed until completion of the water shutoff work to suppress inflow.
 - Toward examining permanent water shutoff measures, an investigation on the upstream side, including the wall side, will be examined and implemented to check the inside of the hose and identify the cause of the inflow.

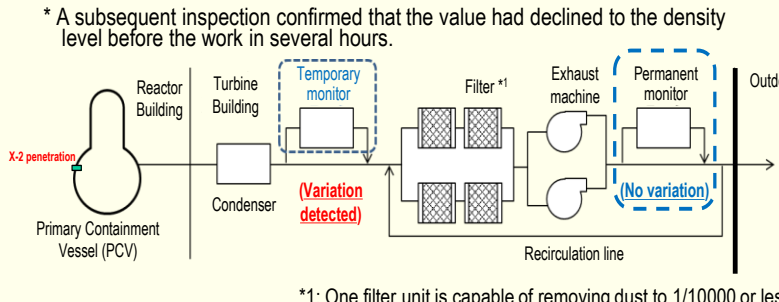
Resume of work to create an access route at Unit 1 from July

Toward the investigation inside the PCV, work to create an access route is underway. The inner door of the X-2 penetration was drilled (for about five minutes) on June 4. Monitoring data during the work showed that the dust density of the temporary monitor, which was installed in front of the filter to reduce the radioactive materials density, exceeded the criteria value* set for work management. Work was suspended and data was checked and evaluated.

During the work on this occasion, the values of the permanent dust monitor, which was installed downstream of the filter, did not vary significantly, nor those around site boundaries, etc., and there was no influence on the environment. Work procedures will be examined, etc. to resume work by around the end of July 2019 and implement work with safety first.

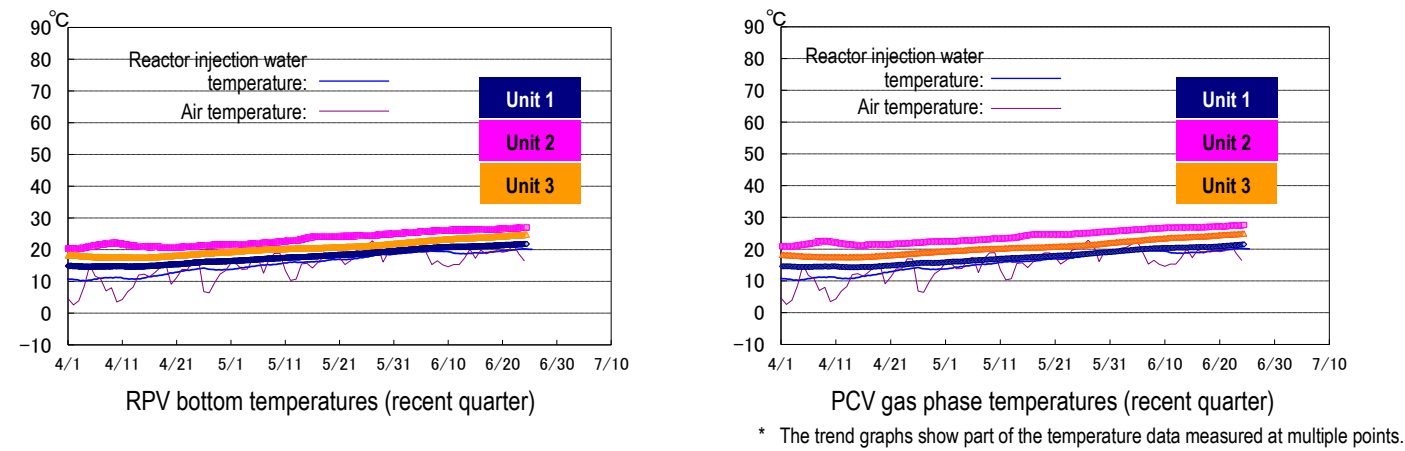
1. Temperatures inside the reactors

Through continuous reactor cooling by water injection, the temperatures of the Reactor Pressure Vessel (RPV) bottom and the Primary Containment Vessel (PCV) gas phase were maintained within the range of approx. 20 to 30°C for the past month, though they varied depending on the unit and location of the thermometer.

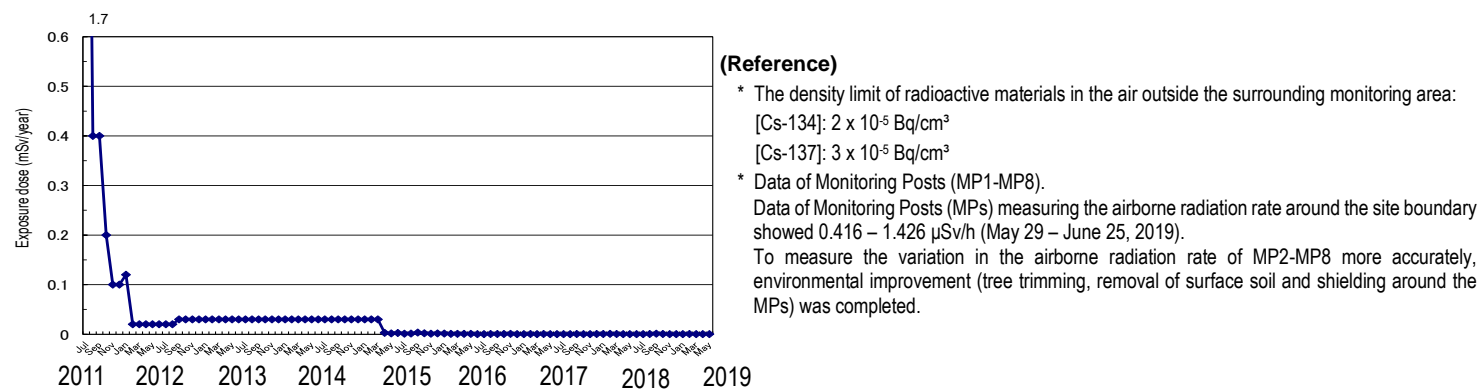
Annual radiation dose at site boundaries by radioactive materials (cesium) released from Reactor Building Units 1-4

As of May 2019, the density of radioactive materials newly released from Reactor Building Units 1-4 into the air and measured at the site boundary was evaluated at approx. 2.6×10^{-12} and 2.9×10^{-12} Bq/cm³ for Cs-134 and -137 respectively, while the radiation exposure dose due to the release of radioactive materials there was less than 0.00023 mSv/year.

Note: Different formulas and coefficients were used to evaluate the radiation dose in the facility operation plan and monthly report. The evaluation methods were integrated in September 2012. As the fuel removal from the spent fuel pool (SFP) commenced for Unit 4, the radiation exposure dose from Unit 4 was added to the items subject to evaluation since November 2013. The evaluation has been changed to a method considering the values of continuous dust monitors since FY2015, with data to be evaluated monthly and announced the following month.

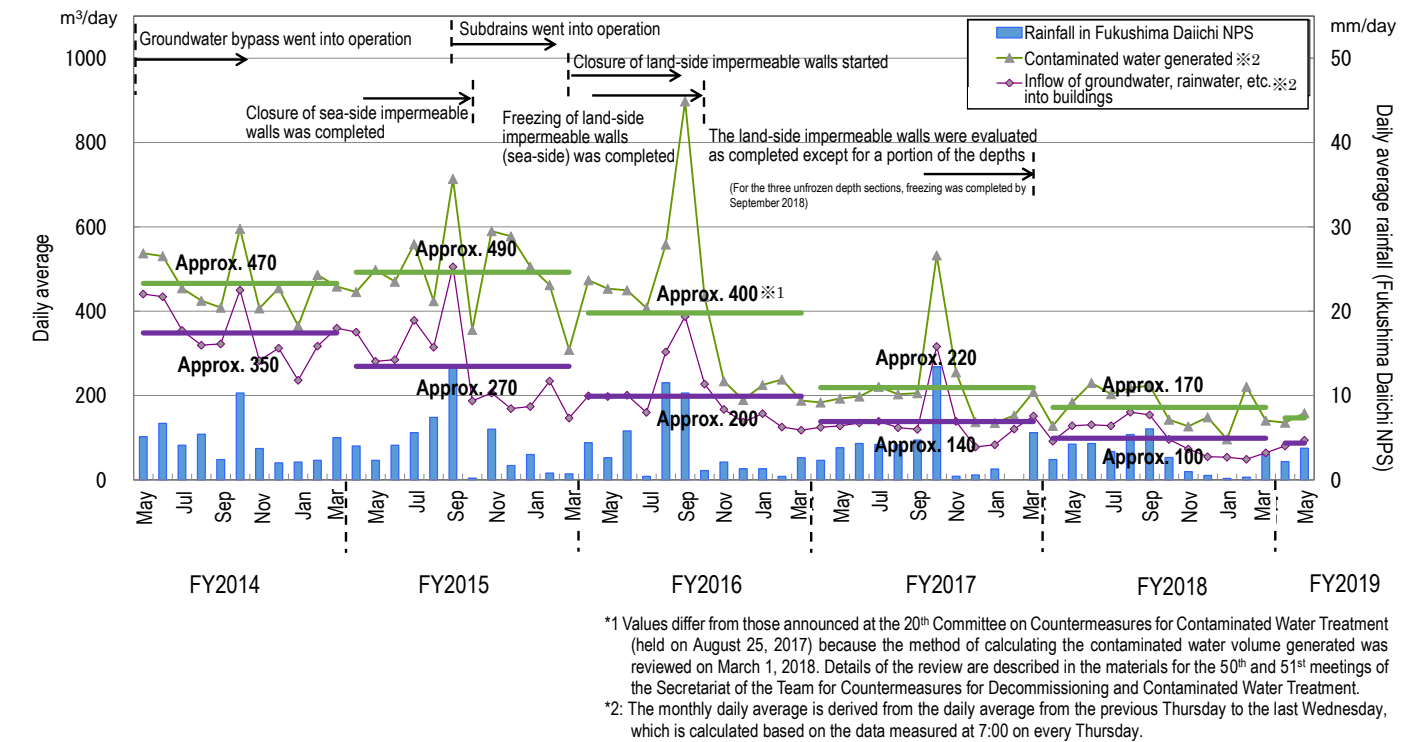
Figure 1: Changes in contaminated water generated and inflow of groundwater, rainwater, etc. into buildings

to approx. 170 m³/day (the FY2018 average), though it varied depending on rainfall, etc.

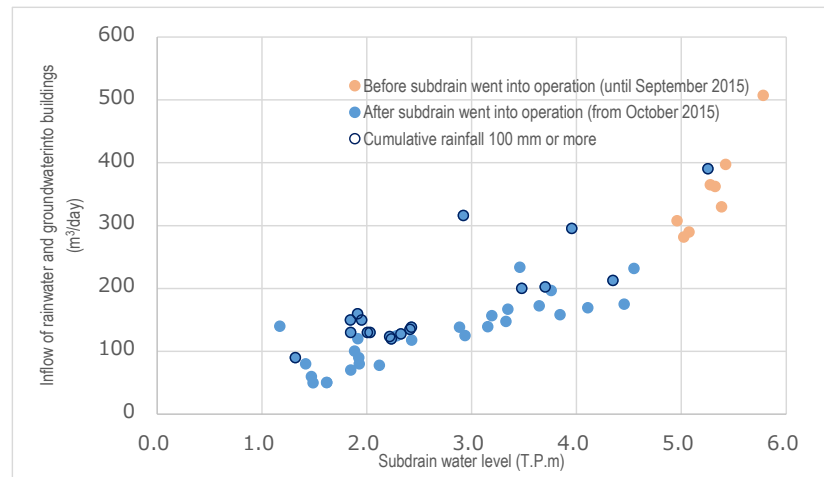
Figure 2: Correlation between inflow such as groundwater and rainwater into buildings and the water level of Unit 1-4 subdrains

- Since the subdrains went into operation, the inflow into buildings tended to decline to under 150 m³/day when the subdrain water level declined below T.P. 3.0 m but increased during rainfall.

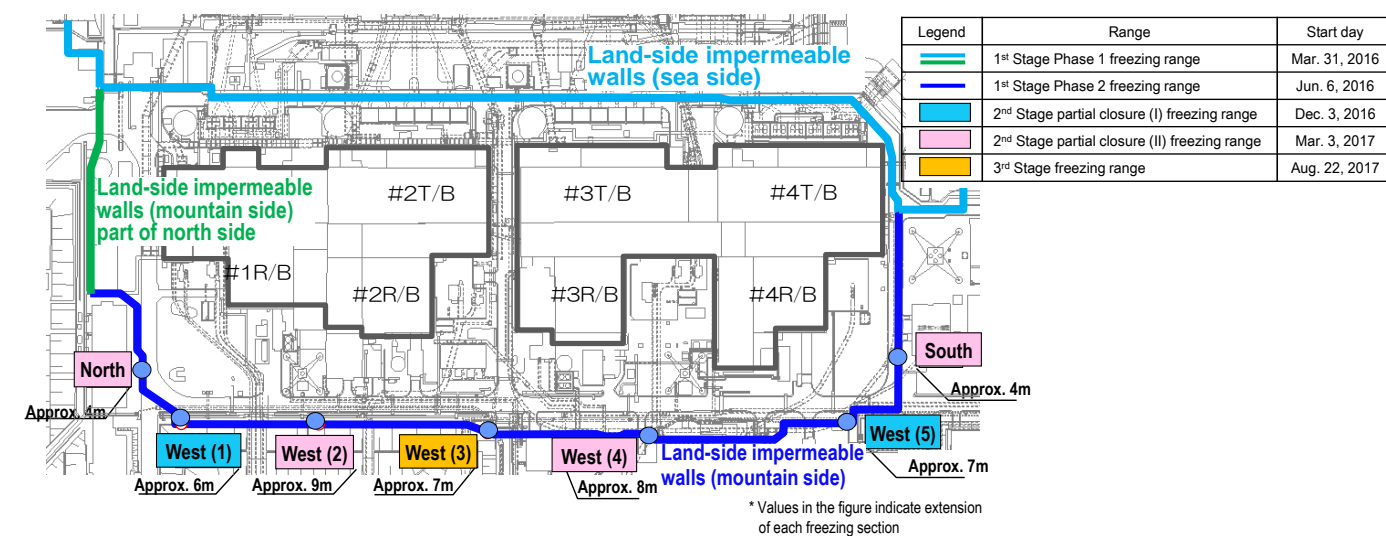
Figure 3: Closure of part of the land-side impermeable walls (on the mountain side)

- A supplementary method was implemented for the unfrozen depth and it was confirmed that the temperature of this portion had declined below 0°C by September 2018. From February 2019, maintenance operation started at all sections.

- The groundwater level in the area inside the land-side impermeable walls has been declining every year. On the mountain side, the difference between the inside and outside increased to approx. 4-5 m. The water level in the bank area has remained low (T.P. 1.6-1.7 m) compared to the ground surface (T.P. 2.5 m).

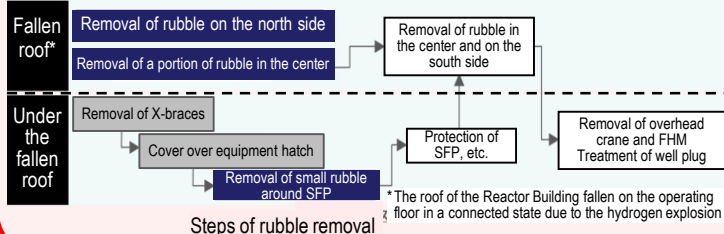
<Status of the operating floor>

From March 18, 2019, removal of small rubble in the east-side area around the SFP started as an initial step using pliers and suction equipment. From April 2, 2019, rubble removal in the same area started using remote-controlled heavy machine.

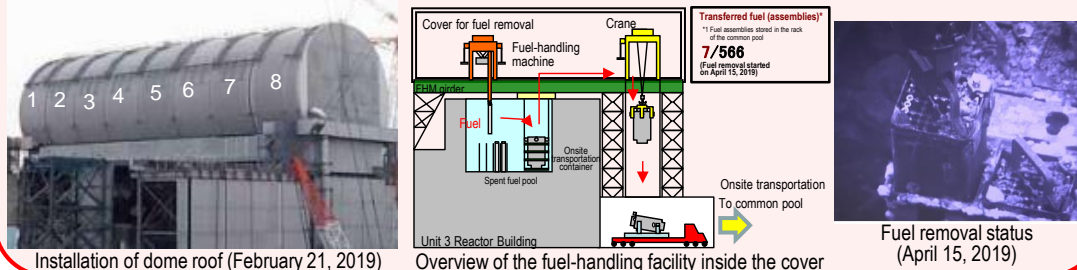
Prior to the installation of a cover for fuel removal, removal of large rubble from the spent fuel pool was completed in November 2015. To ensure safe and steady fuel removal, training of remote control was conducted at the factory using the actual fuel-handling machine which will be installed on site (February – December 2015). Measures to reduce dose on the Reactor Building top floor (decontamination, shields) were completed in December 2016. Installation of a cover for fuel removal and a fuel-handling machine is underway from January 2017. Installation of the fuel removal cover was completed on February 23, 2018.

Toward fuel removal, the rubble retrieval training inside the pool, which was scheduled in conjunction with fuel removal training, started from March 15, 2019, and started fuel removal from April 15, 2019.

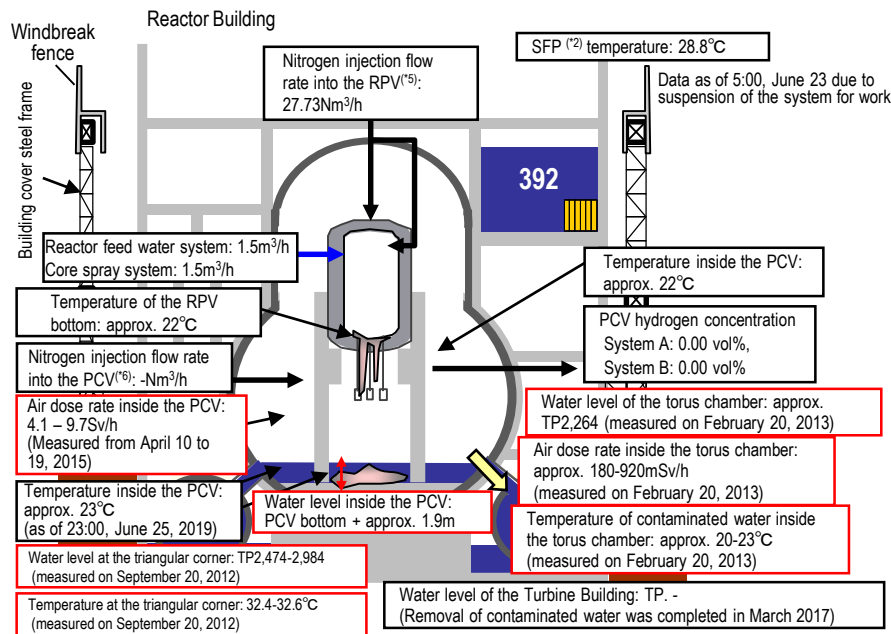
Unit 1

Air dose rate inside the Reactor Building:
Max. 5,150mSv/h (1F southeast area) (measured on July 4, 2012)

* Indices related to the plant are values as of 11:00, June 26, 2019

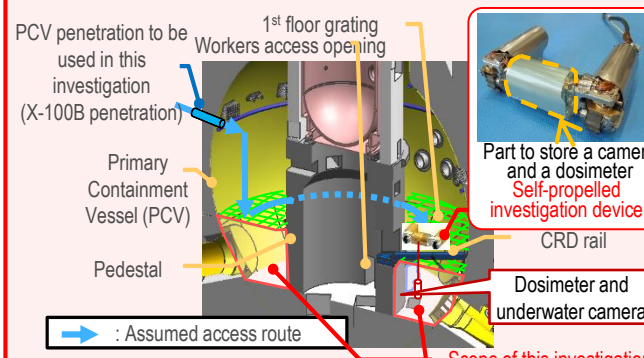
<Image of investigation inside the PCV>

[Investigative outline]

- In April 2015, a device, which entered the inside of the PCV through a narrow access opening (bore: ϕ 100 mm), collected information such as images and airborne dose inside the PCV 1st floor.
- In March 2017, the investigation using a self-propelled investigation device, conducted to inspect the spreading of debris to the basement floor outside the pedestal, took images of the PCV bottom status for the first time. The status inside the PCV will continue to be examined based on the collected image and dose data.

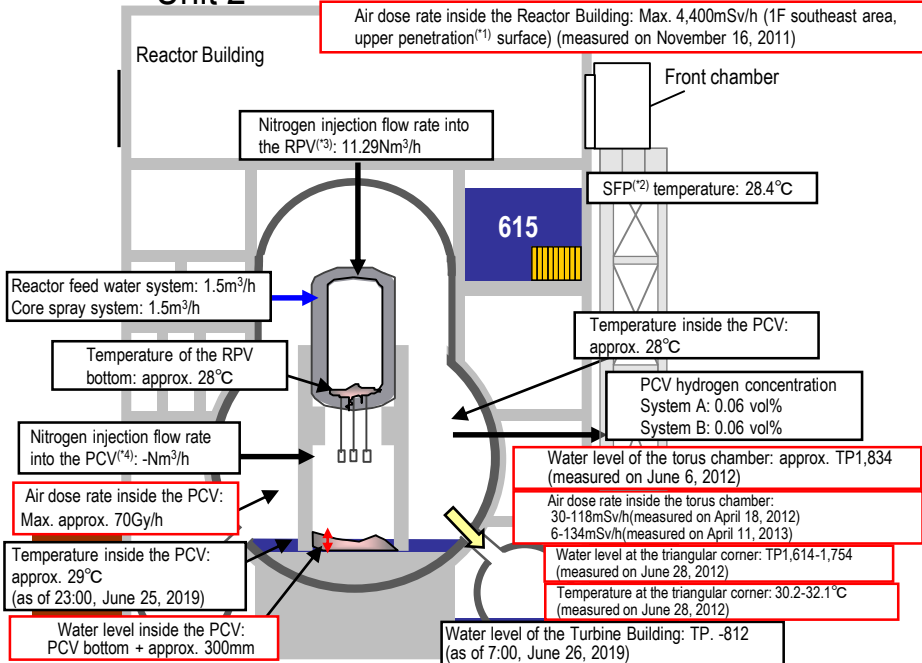
Unit 2

* Indices related to plant are values as of 11:00, June 26, 2019

Investigations inside PCV	Period	Activities
Investigations inside PCV	1st (Jan 2012)	- Acquiring images - Measuring air temperature
	2nd (Mar 2012)	- Confirming water surface - Measuring water temperature - Measuring dose rate
	3rd (Feb 2013 - Jun 2014)	- Acquiring images - Sampling contaminated water - Measuring water level - Installing permanent monitoring instrumentation
	4th (Jan - Feb 2017)	- Acquiring images - Measuring dose rate - Measuring air temperature
Leakage points from PCV		- No leakage from torus chamber rooftop - No leakage from all inside/outside surfaces of S/C

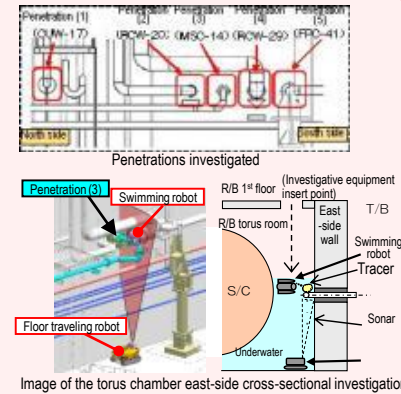
Investigative results on torus chamber walls

- The torus chamber walls were investigated (on the north side of the east-side walls) using equipment specially developed for that purpose (a swimming robot and a floor traveling robot).
- At the east-side wall pipe penetrations (five points), "the status" and "existence of flow" were checked.
- A demonstration using the above two types of underwater wall investigative equipment showed how the equipment could check the status of penetration.
- Regarding Penetrations 1 - 5, the results of checking the sprayed tracer⁽⁵⁾ by camera showed no flow around the penetrations. (investigation by the swimming robot)
- Regarding Penetration 3, a sonar check showed no flow around the penetrations. (investigation by the floor traveling robot)

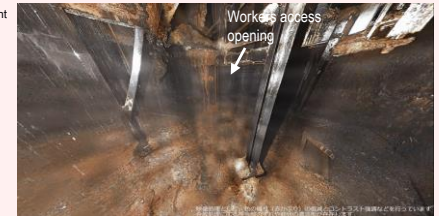
- On January 26 and 30, 2017, a camera was inserted from the PCV penetration to inspect the status of the CRD replacement rail on which the robot will travel. On February 9, deposit on the access route of the self-propelled investigative device was removed and on February 16, the inside of the PCV was investigated using the device.

- The results of this series of investigations confirmed fallen and deformed gratings and a quantity of deposit inside the pedestal.
- On January 19, 2018, the status below the platform inside the pedestal was investigated using an investigative device with a hanging mechanism. From the analytical results of images obtained in the investigation, deposits probably including fuel debris were found at the bottom of the pedestal. In addition, multiple parts higher than the surrounding deposits were also detected. We presumed that there were multiple routes of fuel debris falling. Obtained data were processed in panoramic image visualization to acquire clearer images.

- On February 13, 2019, an investigation touching the deposits at the bottom of the pedestal and on the platform was conducted and confirmed that the pebble-shaped deposits, etc. could be moved and that hard rock-like deposits that could not be gripped may exist.

- In addition, images, etc. would help determine the contour and size of the deposits could be collected by moving the investigative unit closer to the deposits than the previous investigation.

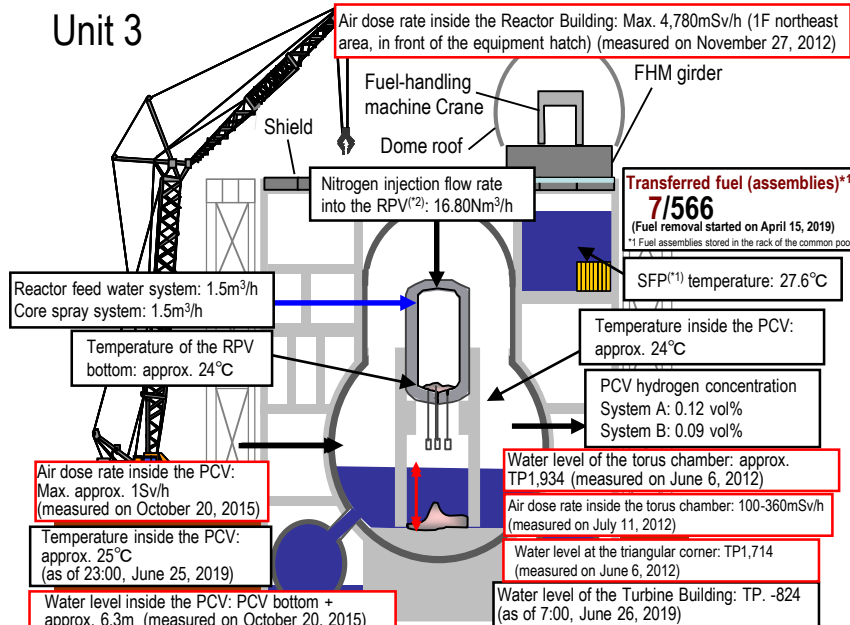
Unit 3

* Indices related to plant are values as of 11:00, June 26, 2019

Investigations inside PCV	1st (Oct – Dec 2015)	- Acquiring images - Measuring air temperature and dose rate - Measuring water level and temperature - Installing permanent monitoring instrumentation (December 2015)
	2nd (Jul 2017)	- Acquiring images - Installing permanent monitoring instrumentation (August 2017)
Leakage points from PCV	- Main steam pipe bellows (identified in May 2014)

From April 23, 2014, image data has been acquired by camera and the radiation dose measured via pipes for measurement instrumentation, which connect the air-conditioning room on the Reactor Building 2nd floor with the Main Steam Isolation Valve Room on the 1st floor. On May 15, 2014, water flow from the expansion joint of one Main Steam Line was detected.

This is the first leak from PCV detected in the Unit 3. Based on the images collected in this investigation, the leak volume will be estimated and the need for additional investigations will be examined. The investigative results will also be utilized to examine water stoppage and PCV repair methods.

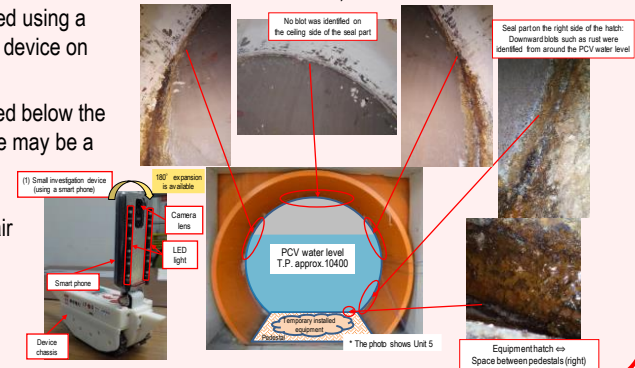
- Given blots such as rust identified below the water level inside the PCV, there may be a leakage from the seal to the extent of bleeding.

Methods to investigate and repair the parts, including other PCV penetrations with a similar structure, will be considered.

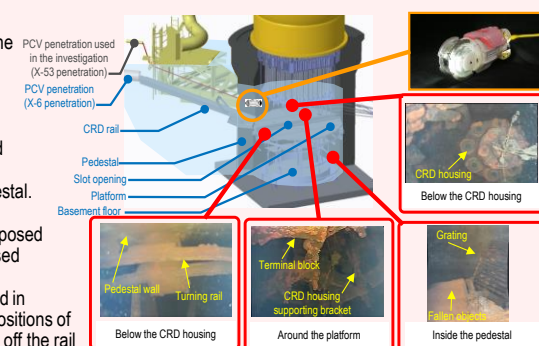
Status inside the pedestal

- Analysis of image data obtained in the investigation identified damage to multiple structures and the supposed core internals. Consideration about fuel removal based on the obtained information will continue.

- Videos obtained in the investigation were reproduced in 3D. Based on the reproduced images, the relative positions of the structures, such as the rotating platform slipping off the rail with a portion buried in deposits, were visually understood.

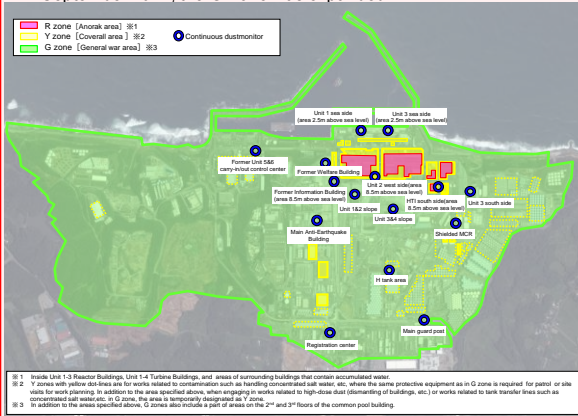
Based on the progress of measures to reduce environmental dosage on site, the site is categorized into two zones: highly contaminated area around Unit 1-4 buildings, etc. and other areas to optimize protective equipment according to each category aiming at improving safety and productivity by reducing load during work.

From March 2016, limited operation started. From March and September 2017, the G Zone was expanded.

※1 Inside Unit 1-3 Reactor Buildings, Unit 1-4 Turbine Buildings, and areas of surrounding buildings that contain accumulated water.
 ※2 Y zones with yellow dot areas are for works related to contamination such as handling concentrated salt water, etc. when the same protective equipment as in G zone is required for patrol or site visits for work planning. In addition to the area specified above, when engaging in works related to high-dose dust (disassembling of buildings, etc.) or works related to tank transfer lines such as concentrated salt water tanks in G zone, the area is temporarily designated as Y zone.
 ※3 In addition to the areas specified above, G zones also include a part of areas on the 2nd and 3rd floors of the common pool building.

R zone (Anorak area)	Y zone (Coverall area)	G zone (General wear)
Full-face mask 	Full-face or half-face masks 	Disposable disposable mask
Anorak on coverall Or double coveralls 	Coverall 	General*3 Dedicated on-site wear
