## Main decommissioning work and steps

Fuel removal from the Unit 4 SFP was completed on December 22, 2014 and removal from the Unit 3 SFP has been underway since April 15, 2019. Dust density in the surrounding environment is being monitored and work is being implemented with safety first. Work continues sequentially toward the start of fuel removal from Units 1 and 2 and debris (Note 1) retrieval from Units 1-3.

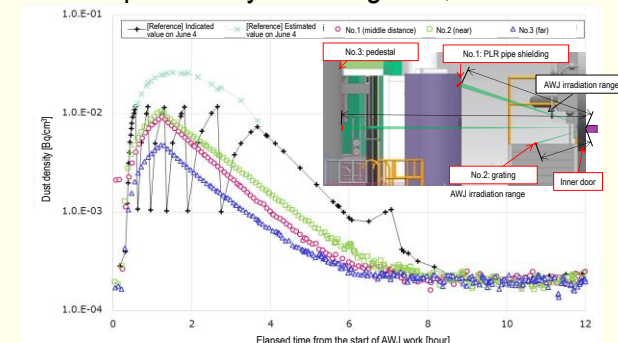
Change in the dust density of the temporary monitor during AWJ work

The results showed that the max. dust density of the temporary monitor was declining with the distance from PCV internals. It was also confirmed that regardless of the distance from PCV internals, the dust density increased approx. 10 minutes after starting the work, peaked approx. one hour later, then reverted to the level within several hours. More data needs to be collected for short-time work.

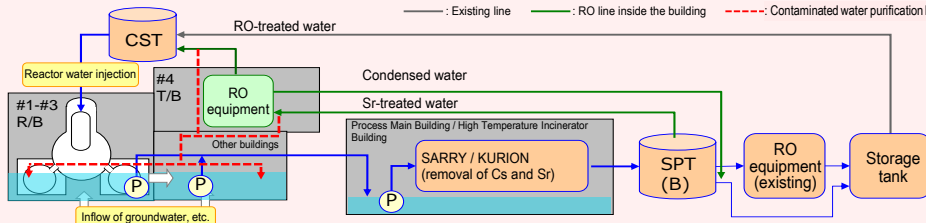
- To reduce the risk of contaminated-water leakage, the circulation loop was shortened by installing a reverse osmosis (RO) device in the Unit 4 Turbine Building within the circulation loop, comprising the transfer of contaminated water, water treatment and injection into the reactors. Operation of the installed RO device started from October 7 and 24-hour operation started from October 20. Installation of the new RO device inside the building shortened the circulation loop from approx. 3 to 0.8 km.

\* The entire length of contaminated water transfer pipes is approx. 2.1km, including the transfer line of surplus water to the upper heights (approx. 1.3km).
