## Main decommissioning work and steps

Fuel removal from the Unit 4 SFP was completed on December 22, 2014 and removal from the Unit 3 SFP has been underway since April 15, 2019. Dust density in the surrounding environment is being monitored and work is being implemented with safety first. Work continues sequentially toward the start of fuel removal from Units 1 and 2 and debris (Note 1) retrieval from Units 1-3.

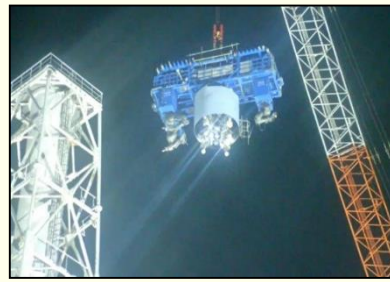
Dismantling of the 3rd block of the Unit 1/2 exhaust stack started from October 7 and was completed on October 22. The cutting work was implemented almost as planned using a procedure in which insights obtained during the 2nd block work was reflected. Following the verification of the 3rd block work, dismantling of the 4th block started from October 27. In this work, the support tower will also be cut in addition to the stack. We proceed with the goal of completing the cutting of the 4th block by early November.

Hanging down of the 3rd block

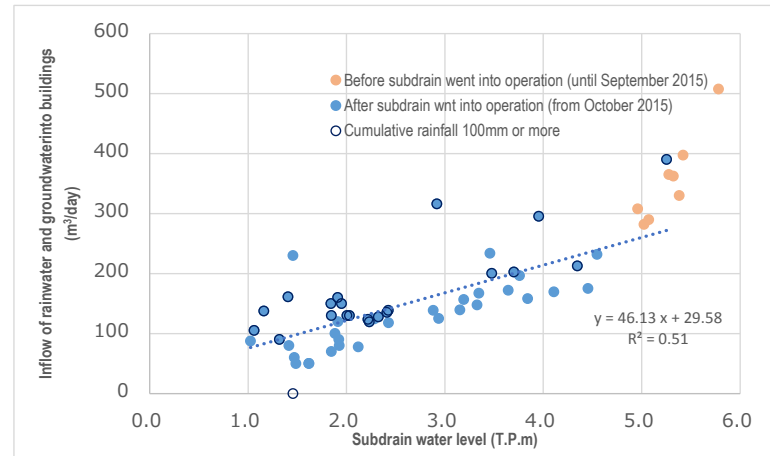
- To maintain the level of groundwater pumped up from the subdrains, work to install additional subdrain pits and recover those already in place is underway. The additional pits are scheduled to begin operation sequentially from a pit for which work was completed (12 of 14 pits went into operation). For recovered pits, work for all three pits scheduled was completed, all of which went into operation from December 26, 2018. Work to recover another pit will start within FY2019 (No. 49 pit).
- To eliminate the need to suspend water pumping while cleaning the subdrain transfer pipe, the pipe will be duplicated. Installation of the pipe and ancillary facilities was completed.
- Since the subdrains went into operation, the inflow into buildings tended to decline to under 150 m<sup>3</sup>/day when the subdrain water level declined below T.P. 3.0 m but increased during rainfall.

Figure 2: Correlation between inflow such as groundwater and rainwater into buildings and the water level of Unit 1-4 subdrains

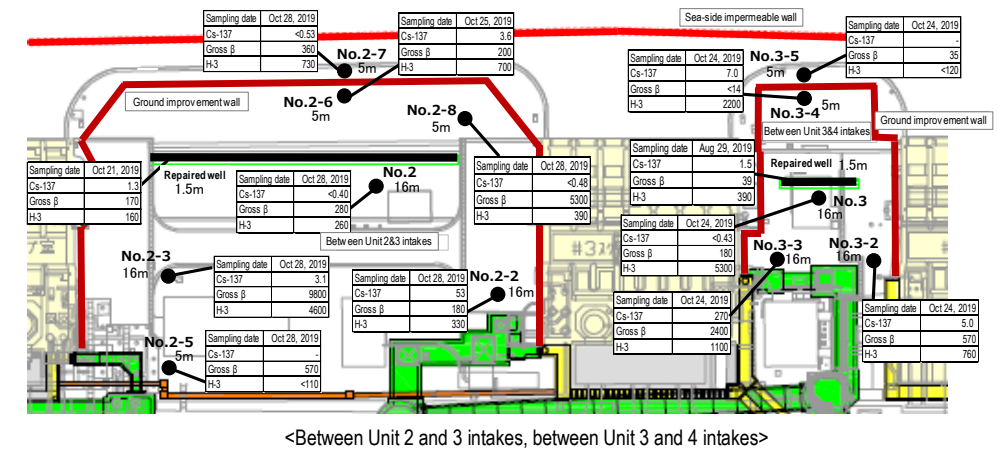
Figure 5: Groundwater density on the Turbine Building east side

- At No. 1-14, the H-3 density has been repeatedly increasing and declining from around 1,300 Bq/L since July 2019 and currently stands at around 3,000 Bq/L. Since August 15, 2013, pumping of groundwater continued (at the well point between the Unit 1 and 2 intakes: August 15, 2013 – October 13, 2015 and from October 24; at the repaired well: October 14-23, 2015).

- At No. 2-6, the density of gross  $\beta$  radioactive materials had been increasing from around 100 Bq/L since May 2019 and currently stands at around 200 Bq/L. Since December 18, 2013, pumping of groundwater continued (at the well point between the Unit 2 and 3 intakes: December 18, 2013 - October 13, 2015; at the repaired well: from October 14, 2015).

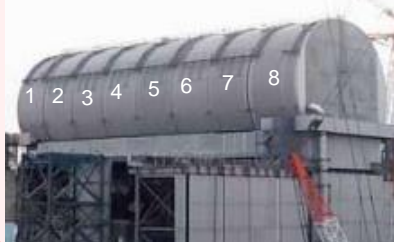
Installation of dome roof (February 21, 2019)

Prior to the installation of a cover for fuel removal, removal of large rubble from the spent fuel pool was completed in November 2015. To ensure safe and steady fuel removal, training of remote control was conducted at the factory using the actual fuel-handling machine which will be installed on site (February – December 2015). Measures to reduce dose on the Reactor Building top floor (decontamination, shields) were completed in December 2016. Installation of a cover for fuel removal and a fuel-handling machine is underway from January 2017. Installation of the fuel removal cover was completed on February 23, 2018. Toward fuel removal, the rubble retrieval training inside the pool, which was scheduled in conjunction with fuel removal training, started from March 15, 2019, and started fuel removal from April 15, 2019.
