## Main decommissioning work and steps

Fuel removal from the Unit 4 SFP was completed on December 22, 2014 and removal from the Unit 3 SFP has been underway since April 15, 2019. Dust density in the surrounding environment is being monitored and work is being implemented with safety first. Work continues sequentially toward the start of fuel removal from Units 1 and 2 and debris (Note 1) retrieval from Units 1-3.

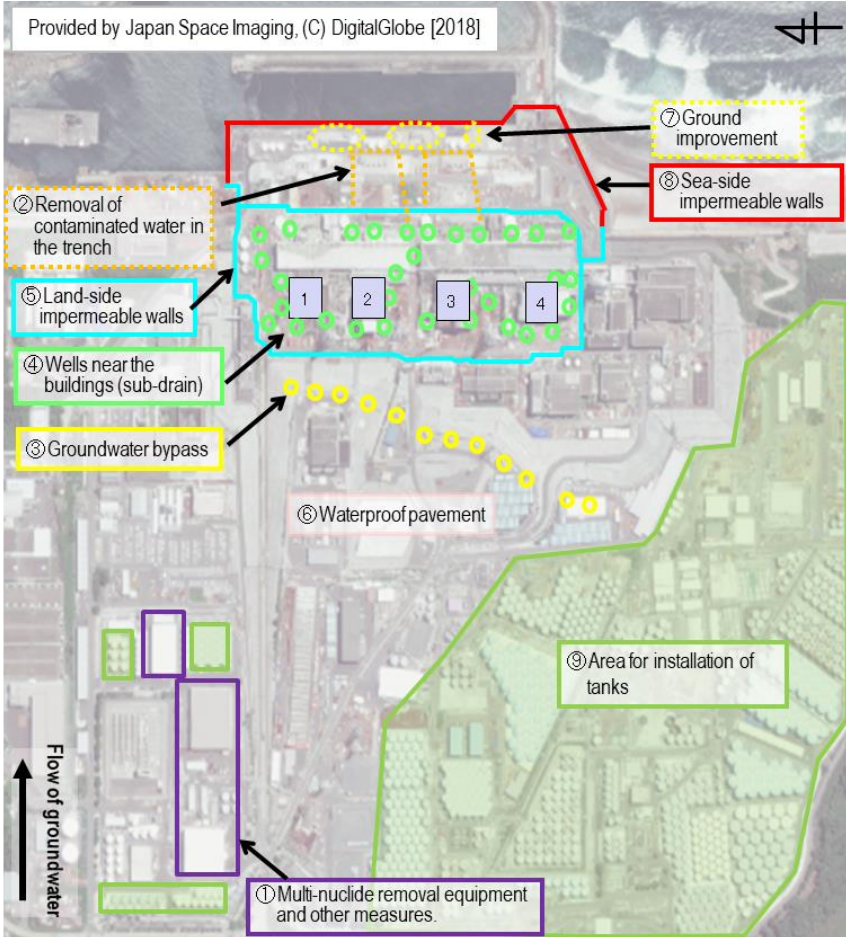
Countermeasures for contaminated water are implemented in accordance with the following three principles:

- 1 **Remove** contamination sources
  - ① Purification using Multi-nuclide removal equipment and other measures
  - ② Removal of contaminated water from the trench (Note 3)

(Note 3) Underground tunnel containing pipes.
2. **Redirect groundwater** from contamination sources
  - ③ Pump up groundwater for bypass
  - ④ Pump up groundwater near buildings
  - ⑤ Land-side impermeable walls (frozen-soil walls)
  - ⑥ Waterproof pavement
3. **Prevent leakage** of contaminated water
  - ⑦ Enhance soil by adding sodium silicate
  - ⑧ Sea-side impermeable walls
  - ⑨ Increase the number of (welded-joint) tanks

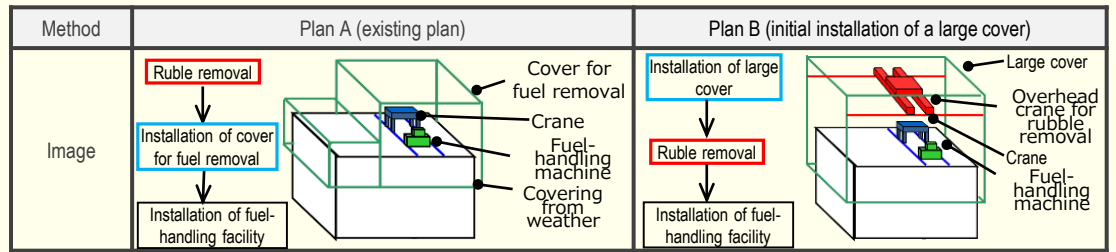
## Examination of the plan to initially install a large cover for fuel removal from Unit 1

Toward fuel removal from Unit 1, the conditions of the fallen roof on the south side and contamination on the reactor well plug were investigated. Based on the results of these investigations, the fallen overhead crane and other items removal is required to more careful work, taking dust scattering into consideration. Thus, in addition to existing plan (Plan A), Plan B which initially install a large cover over the Reactor Building and then remove rubble inside the cover for safer and more secure removal, are being examined.

- Toward fuel removal from Unit 1, the condition of the fallen roof on the south side and contamination on the reactor well plug were investigated.
  - Based on the results of these investigations, the fallen overhead crane and other items removal is required to more careful work, taking dust scattering into consideration. Thus, in addition to existing plan(Plan A), Plan B which initially install a large cover over the Reactor Building and then remove rubble inside the cover for safer and more secure removal, are being examined.

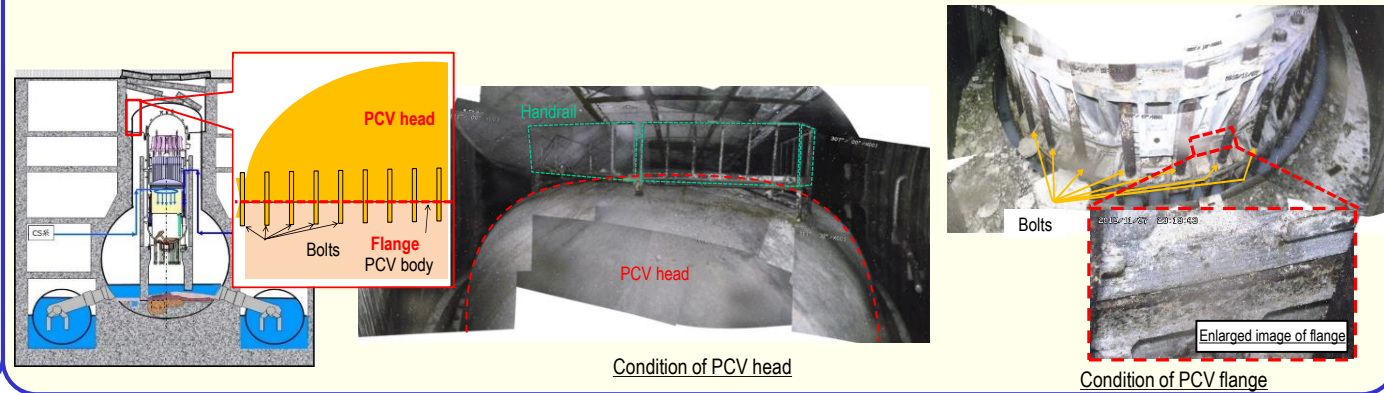
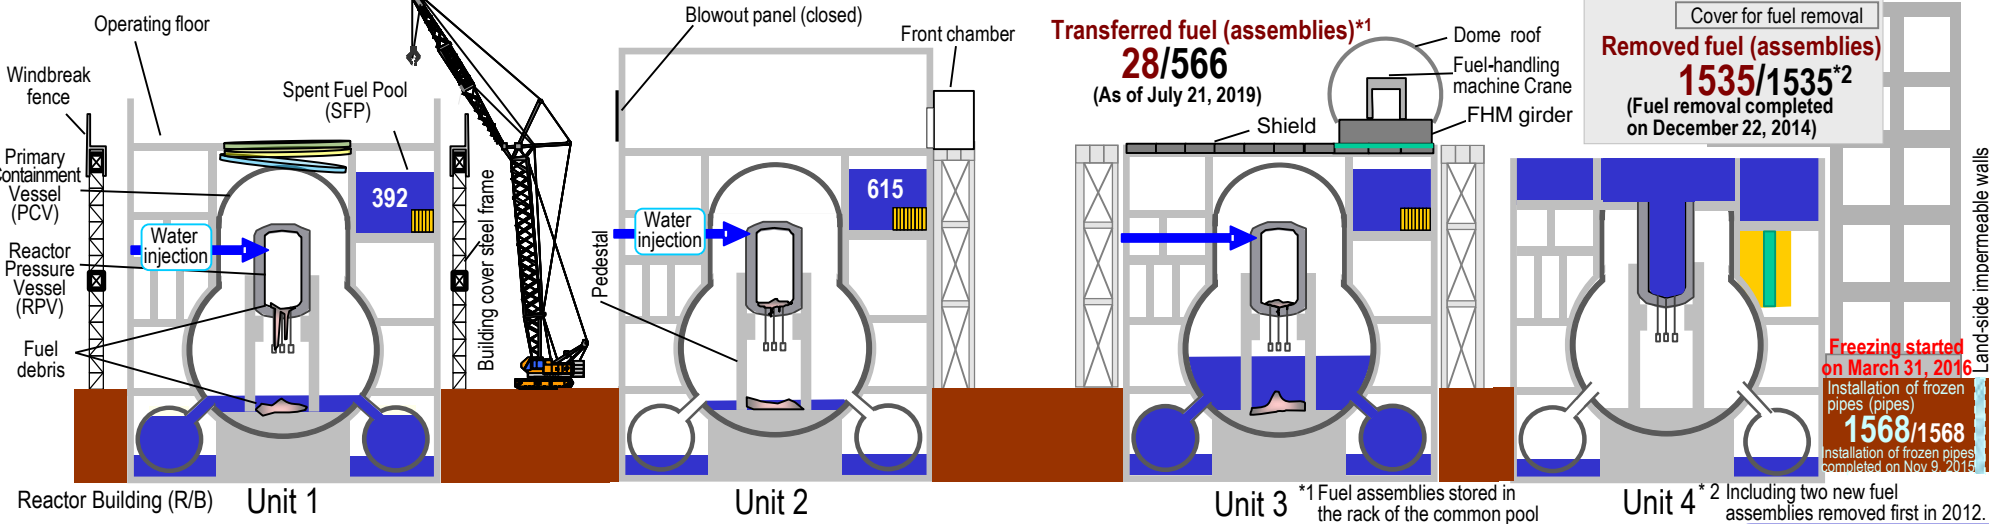
## Check on the condition of the Unit 1 PCV head

To enhance the dust density monitoring during construction of an access route for the internal investigation of the Unit 1 PCV, a dust monitor for the work was installed near the PCV head. During the installation, the condition of the PCV head was checked using a camera. The image obtained showed no significant damage or large deformation detected on the PCV head and its flange.

- **Check of the condition of the Unit 1 PCV head**
  - To enhance the dust-density monitoring during construction of an access route for the internal investigation of the Unit 1 PCV, a dust monitor for the work was installed near the PCV head.

- During the installation, the condition of the PCV head was checked using a camera. The image obtained showed no significant damage or large deformation detected on the PCV head and its flange.

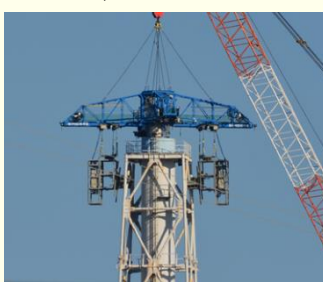
Cutting of diagonal bracing

## Dismantling for the 4th block of the Unit 1/2 exhaust stack

Dismantling of the 4th block started from October 27. Subsequently, the subdrain, which is temporarily suspended due to work interference, will be restored. In parallel with that, the efforts will be made to improve so that safer work can be done with reviewing the work to date.

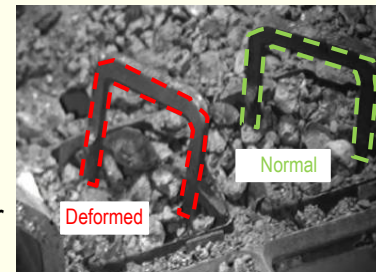
Detected fuel assemblies with deformed handle

## Check on the condition of fuel handles, with the progress of the rubble removal from the Unit 3 SFP

Toward fuel removal from Unit 3, rubble removal from the SFP was resumed from September 2. With the progress of the removal, the condition of fuel handles inside the pool was also checked (286/566). During the check, 12 fuel assemblies with deformed handles were confirmed, including those previously detected. No variation was detected in the water quality of the pool and it was evaluated that there was no influence on the environment. Work to repair defects detected in October will continue toward completion of fuel removal by the end of FY2020.

- From September 2, 2019, rubble removal from the SFP resumed. With the progress of the removal progressed, the condition of fuel handles inside the pool was also checked (286/566).

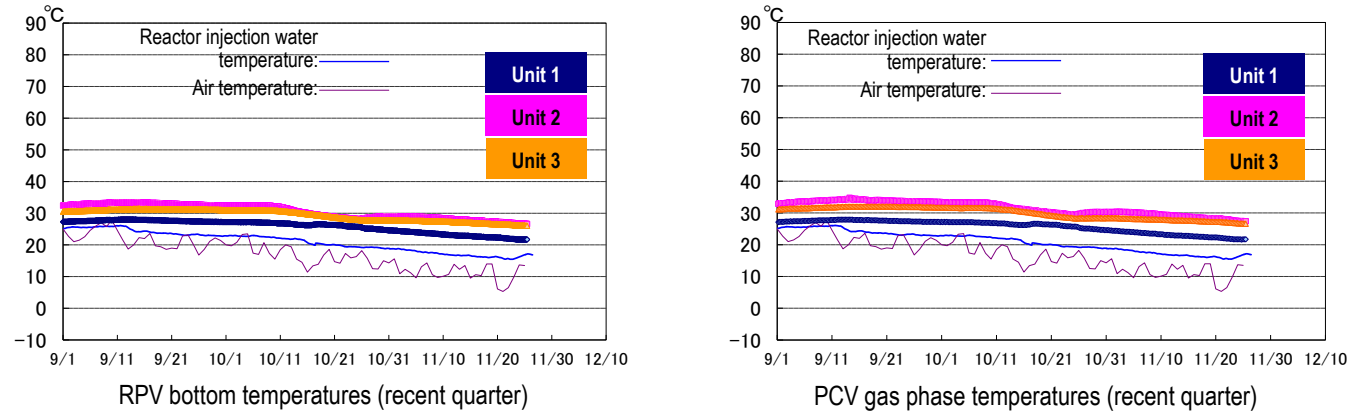
Through continuous reactor cooling by water injection, the temperatures of the Reactor Pressure Vessel (RPV) bottom and the Primary Containment Vessel (PCV) gas phase were maintained within the range of approx. 20 to 30°C for the past month, though they varied depending on the unit and location of the thermometer.

\* The trend graphs show part of the temperature data measured at multiple points.

◆ The temperatures of the Reactor Pressure Vessel (RPV) and Primary Containment Vessel (PCV) of Units 1-3 have been maintained within the range of approx. 20-30°C<sup>\*1</sup> over the past month. There was no significant change in the density of radioactive materials newly released from Reactor Buildings into the air<sup>\*2</sup>. It was concluded that the comprehensive cold shutdown condition had been maintained.

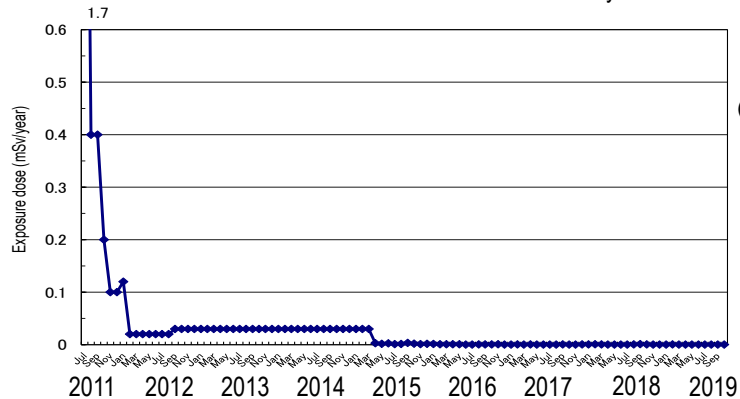
Annual radiation dose at site boundaries by radioactive materials (cesium) released from Reactor Building Units 1-4

As of October 2019, the density of the radioactive materials newly released from Reactor Building Units 1-4 into the air and measured at the site boundary was evaluated at approx.  $2.7 \times 10^{-12}$  Bq/cm<sup>3</sup> and  $7.1 \times 10^{-12}$  Bq/cm<sup>3</sup> for Cs-134 and Cs-137 respectively, while the radiation exposure dose due to the release of radioactive materials there was less than 0.00009 mSv/year.

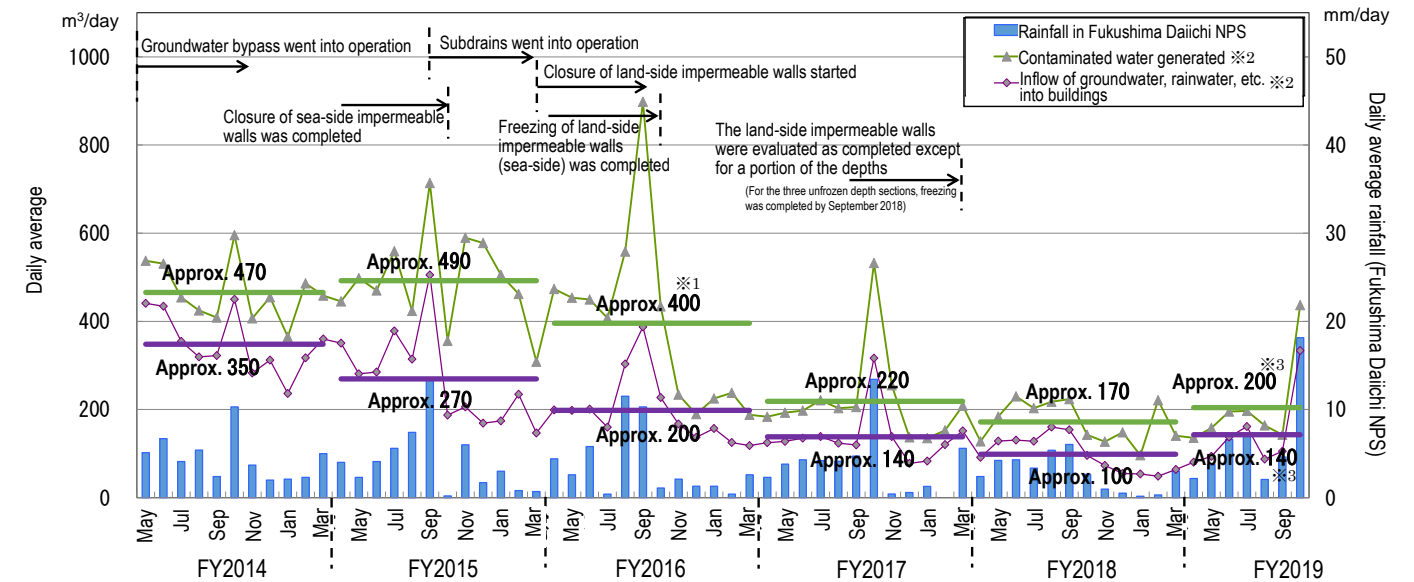
Figure 1: Changes in contaminated water generated and inflow of groundwater, rainwater, into buildings

- Multi-layered measures, including pumping up by subdrains and land-side impermeable walls, which were implemented to control the continued generation of contaminated water, suppress the groundwater inflow into buildings.
- Following the steady implementation of "redirecting" measures (groundwater bypass, subdrains, land-side impermeable walls and other measures), the generation amount reduced from approx. 470 m<sup>3</sup>/day (the FY2014 average) when the measures were first launched to approx. 170 m<sup>3</sup>/day (the FY2018 average).
- Measures will continue to further reduce the volume of contaminated water generated.

- \*1 Values differ from those announced at the 20<sup>th</sup> Committee on Countermeasures for Contaminated Water Treatment (held on August 25, 2017) because the method of calculating the contaminated water volume generated was reviewed on March 1, 2018. Details of the review are described in the materials for the 50<sup>th</sup> and 51<sup>st</sup> meetings of the Secretariat of the Team for Countermeasures for Decommissioning and Contaminated Water Treatment.
- \*2: The monthly daily average is derived from the daily average from the previous Thursday to the last Wednesday, which is calculated based on the data measured at 7:00 on every Thursday.
- \*3: The average (provisional value) for the period April – October 2019.

- Through these measures, the generation of contaminated water was reduced from approx. 470 m<sup>3</sup>/day (in FY2014) to approx. 170 m<sup>3</sup>/day (in FY2018).

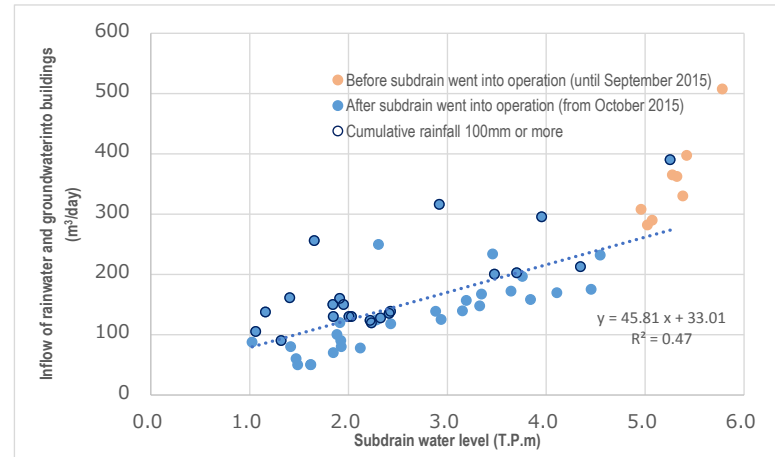
Figure 2: Correlation between inflow such as groundwater and rainwater into buildings and the water level of Unit 1-4 subdrains

- To maintain the level of groundwater pumped up from the subdrains, work to install additional subdrain pits and recover those already in place is underway. The additional pits are scheduled to begin operation sequentially from a pit for which work was completed (12 of 14 pits went into operation). For recovered pits, work for all three pits scheduled was completed, all of which went into operation from December 26, 2018. Work to recover another pit started from November 2019 (No. 49 pit).
- To eliminate the need to suspend water pumping while cleaning the subdrain transfer pipe, the pipe will be duplicated. Installation of the pipe and ancillary facilities was completed.
- Since the subdrains went into operation, the inflow into buildings tended to decline to under 150 m<sup>3</sup>/day when the subdrain water level declined below T.P. 3.0 m but increased during rainfall.

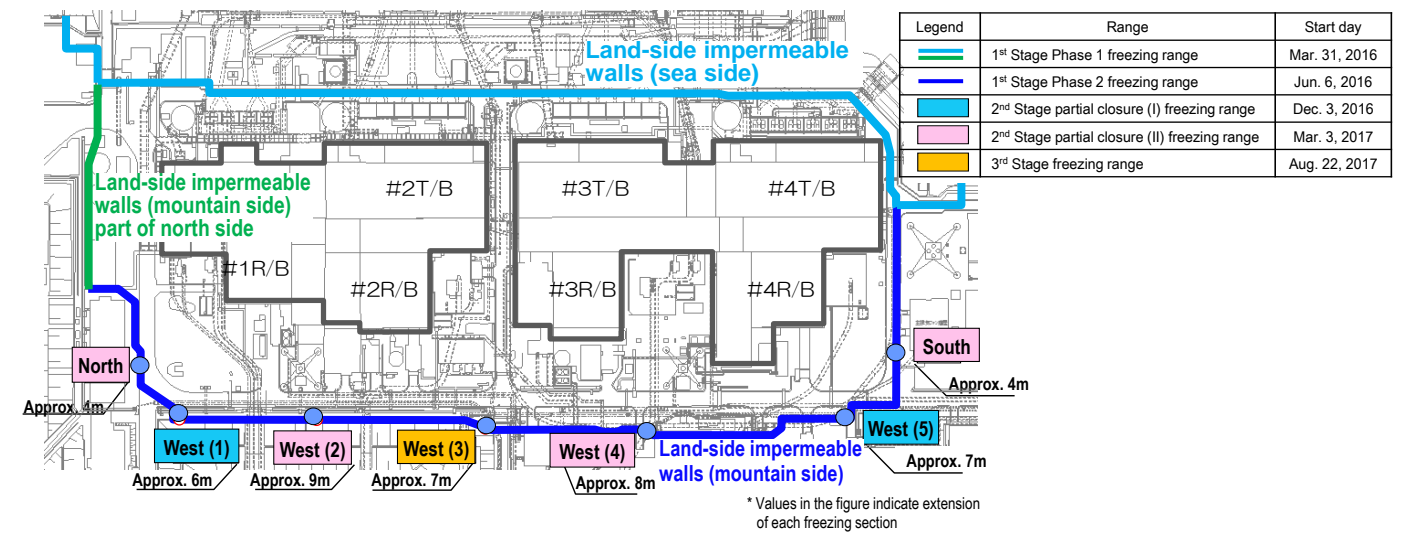
Figure 3: Closure parts of the land-side impermeable walls (on the mountain side)

- A supplementary method was implemented for the unfrozen depth and it was confirmed that the temperature of this portion had declined below 0°C by September 2018. From February 2019, a maintenance operation started throughout all sections.

- The groundwater level in the area inside the land-side impermeable walls has been declining every year. On the mountain side, the difference between the inside and outside increased to approx. 4-5 m. The water level in the bank area has remained low (T.P. 1.6-1.7 m) compared to the ground surface (T.P. 2.5 m).

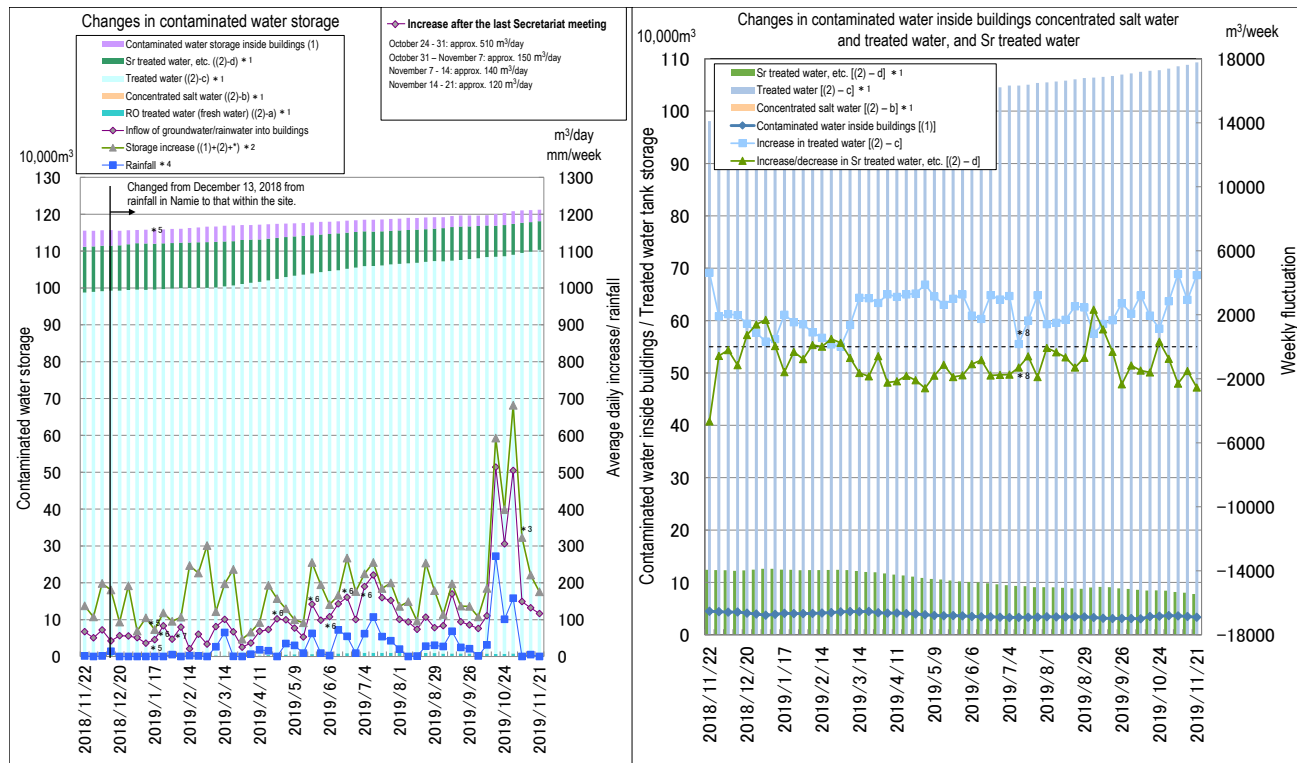
- \*1: Water amount for which the water-level gauge indicates 0% or more
- \*2: To detect storage increases more accurately, the calculation method was reviewed as follows from February 9, 2017: (The revised method was applied from March 1, 2018) [(Inflow of groundwater/rainwater into buildings) + (other transfer) + (chemical injection into ALPS)]

- \*3: The storage amount increased due to transfer to buildings in association with the decommissioning work. (The transferred amount comprised ①Transfer of RO concentrated water from groundwater drains to Turbine Building: approx. 80 m³/day, ②Transfer from wells and groundwater drains: approx.50 m³/day, ③Transfer from Unit 5/6 SPT to Process Main Building: approx. 20 m³/day, others)

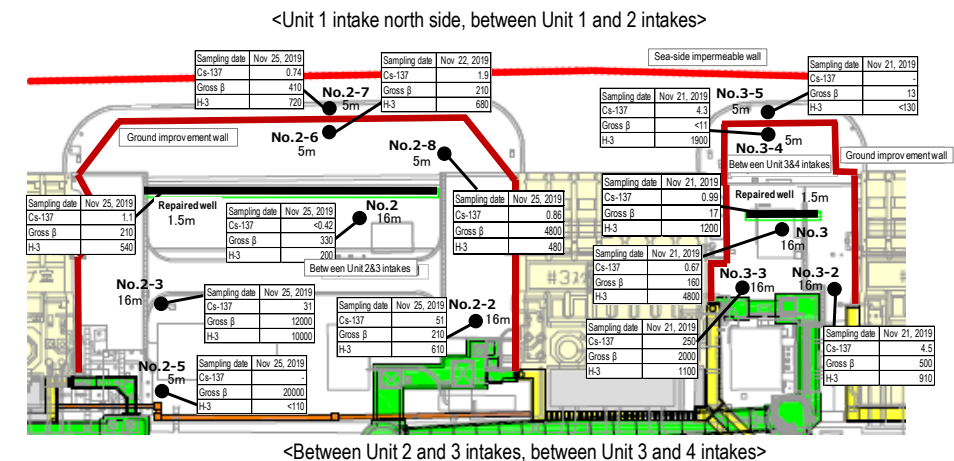
Figure 5: Groundwater density on the Turbine Building east side

- At No. 2-6, the density of gross  $\beta$  radioactive materials had been increasing from around 100 Bq/L since May 2019 and currently stands at around 210 Bq/L. Since December 18, 2013, pumping of groundwater continued (at the well point between the Unit 2 and 3 intakes: December 18, 2013 - October 13, 2015; at the repaired well: from October 14, 2015).

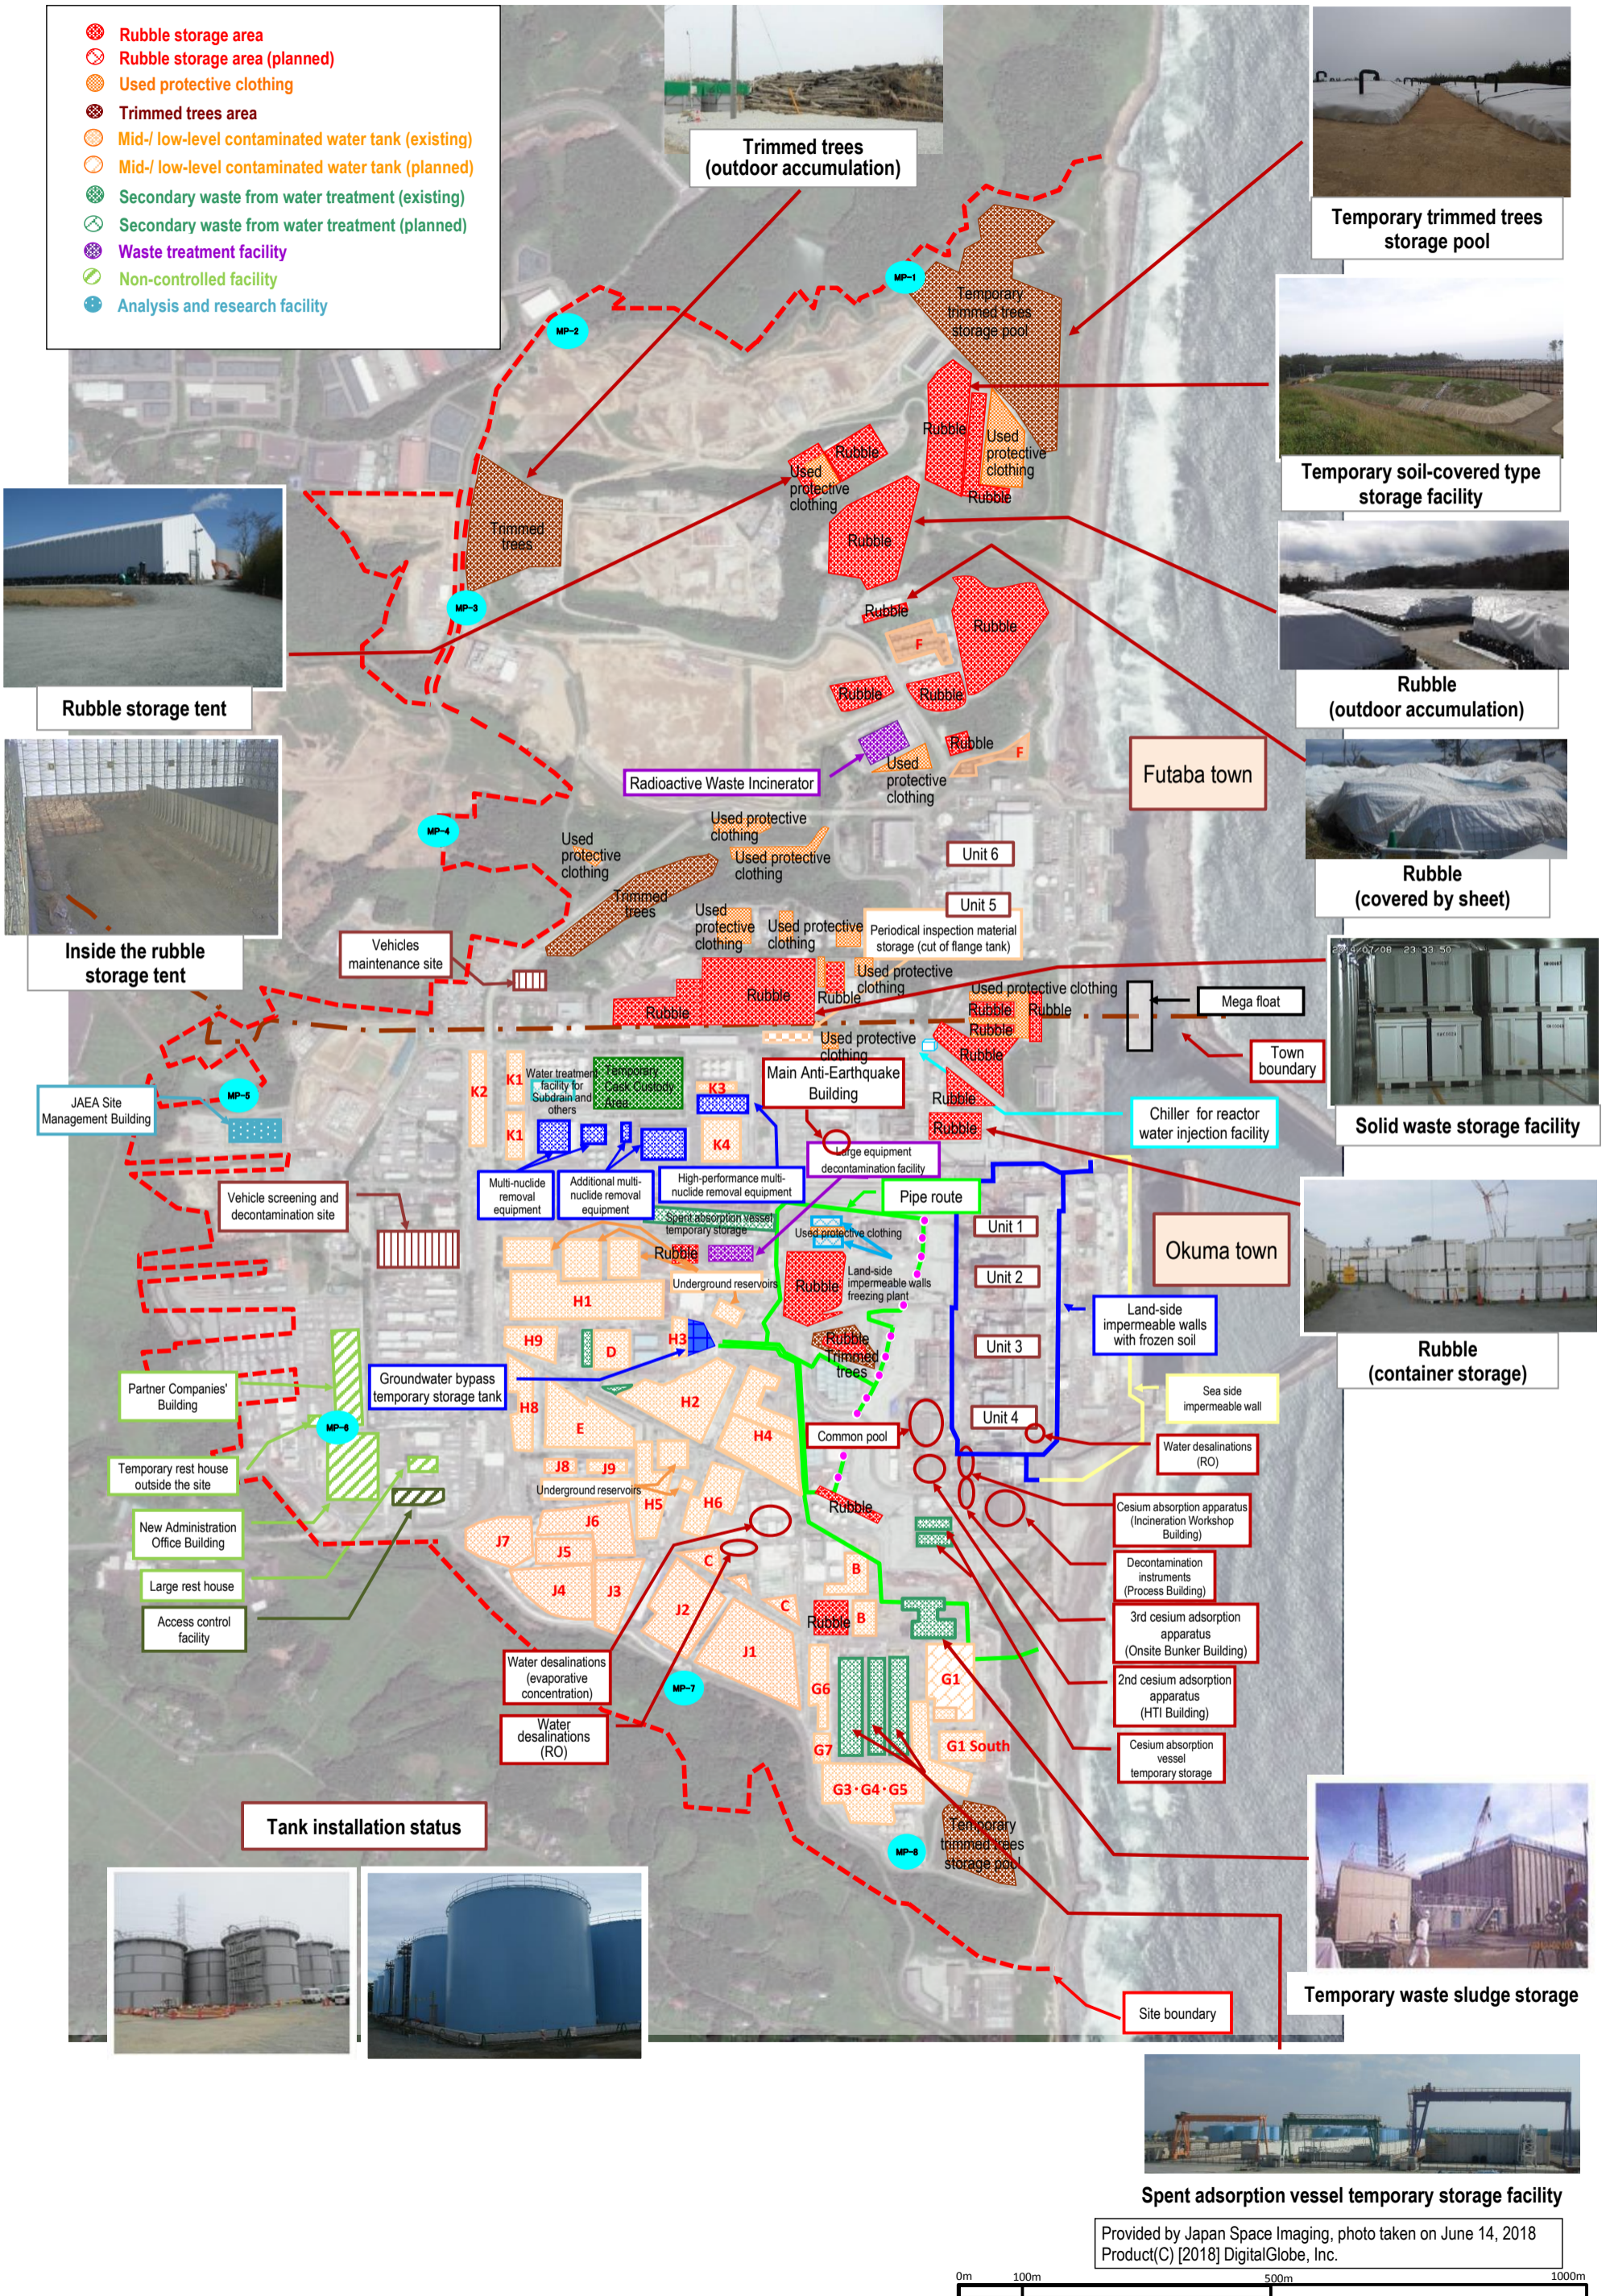
# TEPCO Holdings Fukushima Daiichi Nuclear Power Station Site Layout

- Rubble storage area
- Rubble storage area (planned)
- Used protective clothing
- Trimmed trees area
- Mid-/ low-level contaminated water tank (existing)
- Mid-/ low-level contaminated water tank (planned)
- Secondary waste from water treatment (existing)
- Secondary waste from water treatment (planned)
- Waste treatment facility
- Non-controlled facility
- Analysis and research facility

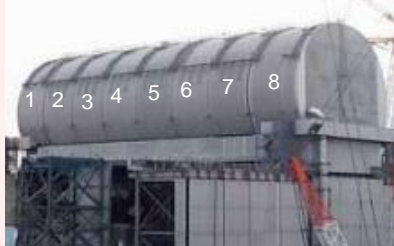
Installation of dome roof (February 21, 2019)

Prior to the installation of a cover for fuel removal, removal of large rubble from the spent fuel pool was completed in November 2015. To ensure safe and steady fuel removal, training of remote control was conducted at the factory using the actual fuel-handling machine which will be installed on site (February – December 2015). Measures to reduce dose on the Reactor Building top floor (decontamination, shields) were completed in December 2016. Installation of a cover for fuel removal and a fuel-handling machine is underway from January 2017. Installation of the fuel removal cover was completed on February 23, 2018.

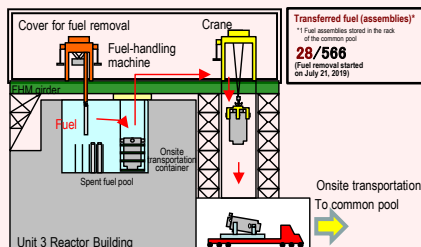
Fuel removal status  
(April 15, 2019)

Toward fuel removal, the rubble retrieval training inside the pool, which was scheduled in conjunction with fuel removal training, started from March 15, 2019, and started fuel removal from April 15, 2019.

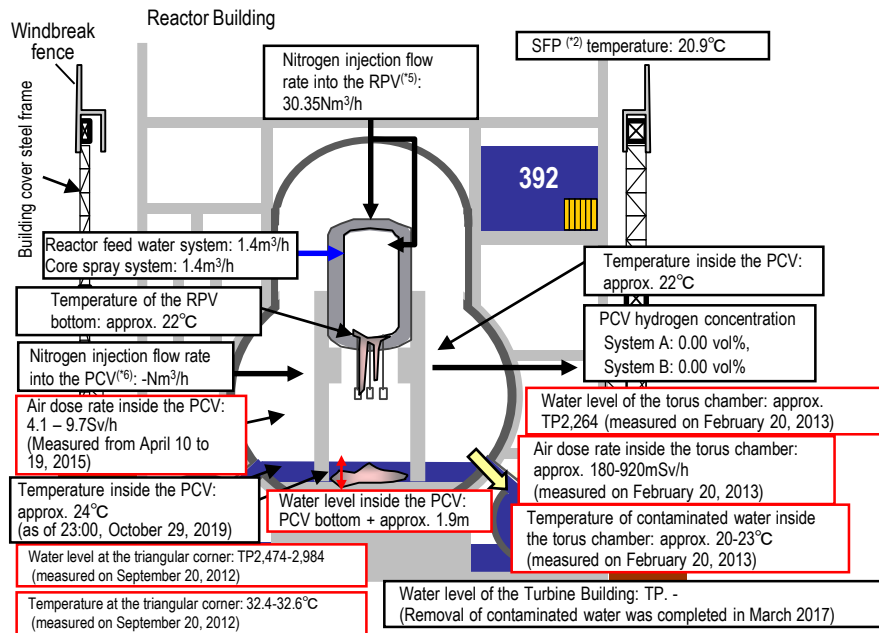
## Unit 1

Air dose rate inside the Reactor Building:  
Max. 5,150mSv/h (1F southeast area) (measured on July 4, 2012)

\* Indices related to the plant are values as of 11:00, November 27, 2019

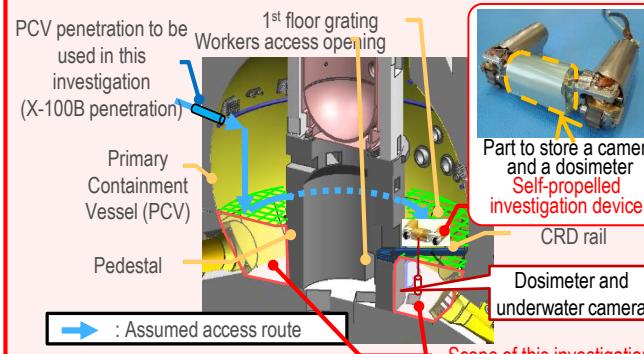
<Image of investigation inside the PCV>

- In April 2015, a device, which entered the inside of the PCV through a narrow access opening (bore:  $\phi$  100 mm), collected information such as images and airborne dose inside the PCV 1st floor.
- In March 2017, the investigation using a self-propelled investigation device, conducted to inspect the spreading of debris to the basement floor outside the pedestal, took images of the PCV bottom status for the first time. The status inside the PCV will continue to be examined based on the collected image and dose data.

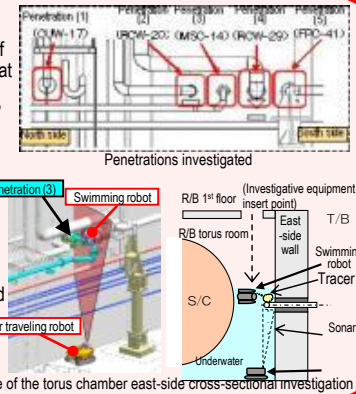
**Investigative results on torus chamber walls**

- The torus chamber walls were investigated (on the north side of the east-side walls) using equipment specially developed for that purpose (a swimming robot and a floor traveling robot).
- At the east-side wall pipe penetrations (five points), "the status" and "existence of flow" were checked.
- A demonstration using the above two types of underwater wall investigative equipment showed how the equipment could check the status of penetration.
- Regarding Penetrations 1 - 5, the results of checking the sprayed tracer (\*) by camera showed no flow around the penetrations. (investigation by the swimming robot)
- Regarding Penetration 3, a sonar check showed no flow around the penetrations. (investigation by the floor traveling robot)

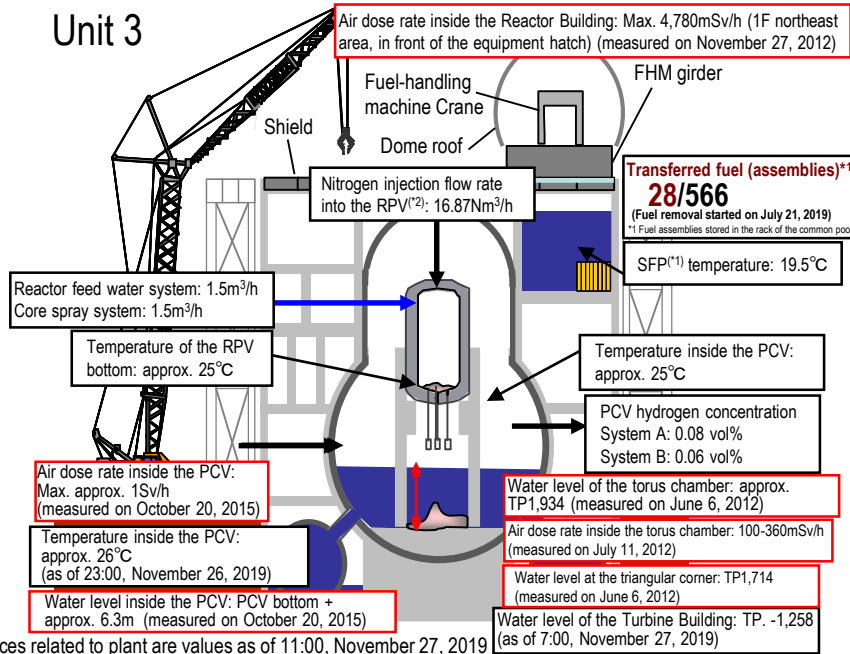
### Unit 3

\* Indices related to plant are values as of 11:00, November 27, 2019

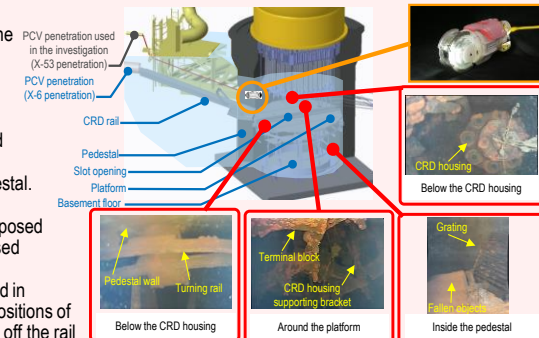
Status inside the pedestal

- Analysis of image data obtained in the investigation identified damage to multiple structures and the supposed core internals. Consideration about fuel removal based on the obtained information will continue.

- Videos obtained in the investigation were reproduced in 3D. Based on the reproduced images, the relative positions of the structures, such as the rotating platform slipping off the rail with a portion buried in deposits, were visually understood.

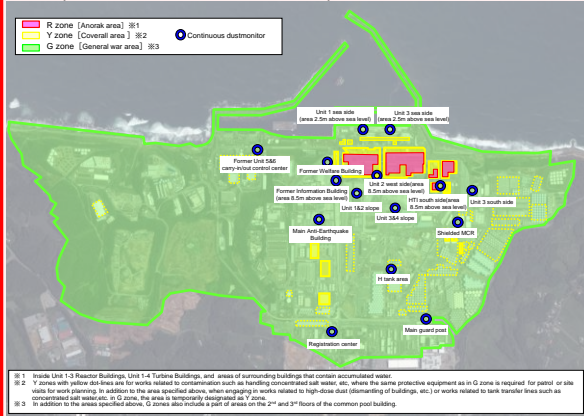
Based on the progress of measures to reduce environmental dosage on site, the site is categorized into two zones: highly contaminated area around Unit 1-4 buildings, etc. and other areas to optimize protective equipment according to each category aiming at improving safety and productivity by reducing load during work.

From March 2016, limited operation started. From March and September 2017, the G Zone was expanded.

※1 Inside Unit 1-3 Reactor Buildings, Unit 1-4 Turbine Buildings, and areas of surrounding buildings that contain accumulated water.  
 ※2 Y zones with yellow dot areas are for works related to contamination such as handling concentrated salt water, etc. when the same protective equipment as in G zone is required for patrol or site visits for work planning. In addition to the area specified above, when engaging in works related to high-dose dust (dismantling of buildings, etc.) or works related to tank transfer lines such as concentrated salt water areas in G zone, the area is temporarily designated as Y zone.  
 ※3 In addition to the areas specified above, G zones also include a part of areas on the 2<sup>nd</sup> and 3<sup>rd</sup> floors of the common pool building.
