## Main decommissioning work and steps

Fuel removal from the Unit 4 SFP was completed on December 22, 2014 and removal from the Unit 3 SFP has been underway since April 15, 2019. Dust density in the surrounding environment is being monitored and work is being implemented with safety first. Work continues sequentially toward the start of fuel removal from Units 1 and 2 and debris (Note 1) retrieval from Units 1-3.

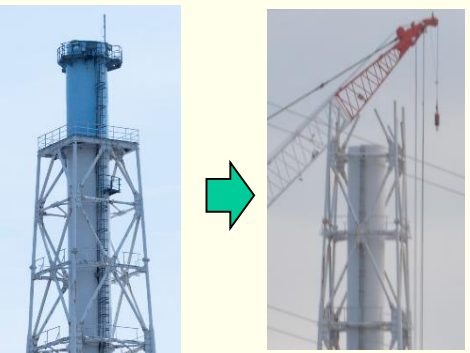
Based on the following review of work to date and refining of the whole process, dismantling is estimated to be completed around early May in 2020\*

Dismantling of the 5th block started from December 16 and was completed on December 19.

Before dismantling / Dismantling of the 5th block was completed / Progress status in dismantling of the exhaust stack

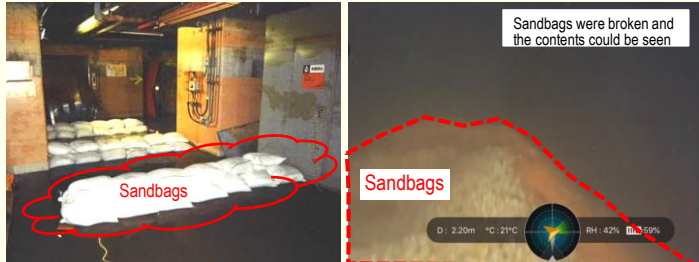
To check the conditions of Zeolite sandbags installed on the basement floor of the High Temperature Incinerator (HTI) Building as a contaminated water treatment measure immediately after the earthquake, a dose investigation using an underwater drone and a visual inspection started from December 3.

The investigation confirmed that sandbags were broken and confirmed that the maximum surface dose of sandbags within the investigative scope was 4,000 mSv/h.

Condition immediately after the earthquake / Current condition of Zeolite sandbags

- To check the conditions of Zeolite sandbags installed on the basement floor of the High Temperature Incinerator Building as a contaminated water treatment measure immediately after the earthquake, a dose investigation using an underwater drone and a visual inspection started from December 3, 2019.
- The investigation confirmed that sandbags were damaged more severely than those in the Process Main Building and detected black particles, which were considered activated carbon, in addition to Zeolite. It was also confirmed that the maximum surface dose of sandbags within the investigative scope was 4,000 mSv/h.
- Based on the investigative results, the dose effect will be assessed.

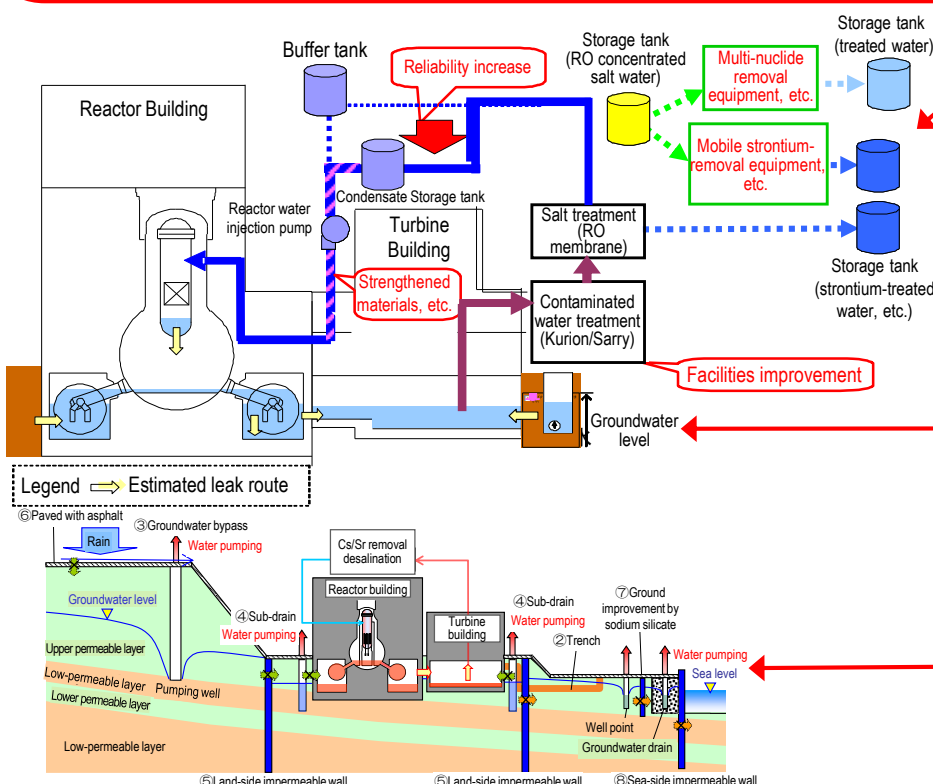
Contaminated water (RO concentrated salt water) is being treated using seven types of equipment including the multi-nuclide removal equipment (ALPS). Treatment of the RO concentrated salt water was completed on May 27, 2015, with the exception of the remaining water at the tank bottom. The remaining water will be treated sequentially toward dismantling the tanks.

The strontium-treated water from other facilities than the multi-nuclide removal equipment will be re-purified in the multi-nuclide removal equipment to further reduce risks.
