Main decommissioning work and steps

Fuel removal from the spent fuel pool was completed on December, 2014 at Unit 4 and started from April 15, 2019 at Unit 3. Dust density in the surrounding environment is being monitored and work is being implemented with safety first. Work continues sequentially toward the start of fuel removal from Units 1 and 2 and debris (Note 1) retrieval from Units 1-3.

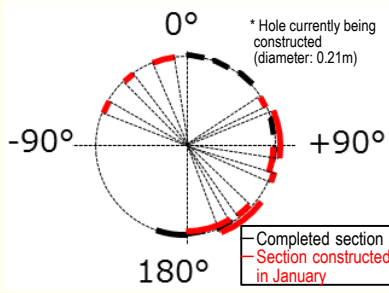
<Image of the cutting range>

After completing the ongoing construction of a hole, PCV internals will be cleaned within March 2020 and the subsequent construction of an access route will start from around April.

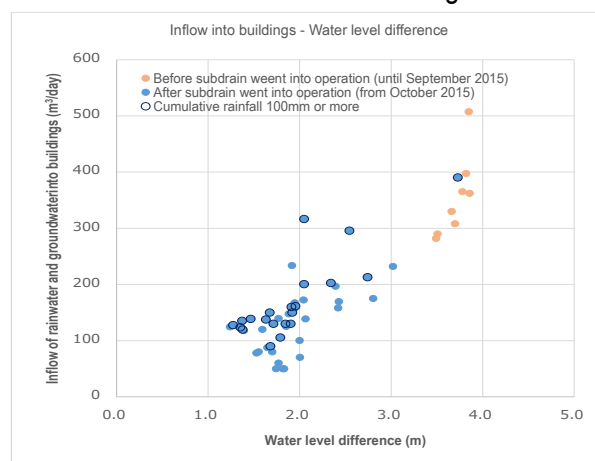
Figure 2: Correlation between inflow such as groundwater and rainwater into buildings and the water level of Units 1-4 subdrains

- To maintain the level of groundwater pumped up from the subdrains, work to install additional subdrain pits and recover those already in place is underway. The additional pits are scheduled to begin operation sequentially from a pit for which work was completed (12 of 14 pits went into operation). For recovered pits, work for all three pits scheduled was completed, all of which went into operation from December 26, 2018. Work to recover another pit started from November 2019 (No. 49 pit).
- To eliminate the need to suspend water pumping while cleaning the subdrain transfer pipe, the pipe will be duplicated. Installation of the pipe and ancillary facilities was completed.
- Since the subdrains went into operation, the inflow to buildings tended to decline to under 150 m³/day when the subdrain water level declined below T.P. 3.0 m but increased during rainfall.

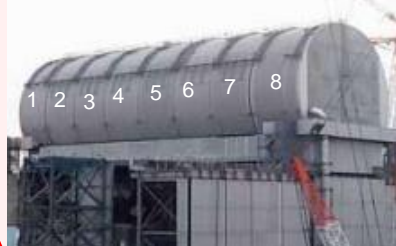
Installation of dome roof (February 21, 2019)

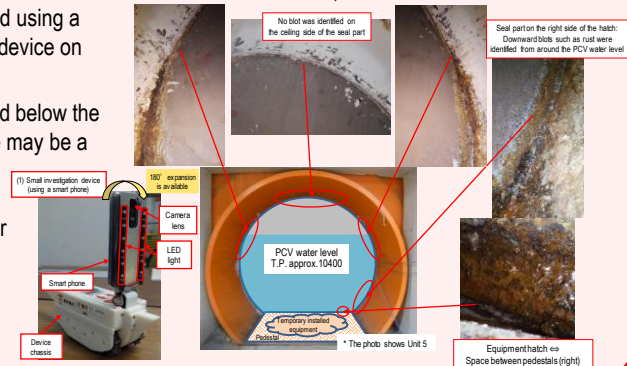
Investigative results into the Unit 3 PCV equipment hatch using a small investigation device

- As part of the investigation into the PCV to facilitate fuel debris retrieval, the status around the Unit 3 PCV equipment hatch was investigated using a small self-traveling investigation device on November 26, 2015.

- Given blots such as rust identified below the water level inside the PCV, there may be a leakage from the seal to the extent of bleeding.
