Main decommissioning work and steps

Fuel removal from the spent fuel pool was completed on December, 2014 at Unit 4 and started from April 15, 2019 at Unit 3. Dust density in the surrounding environment is being monitored and work is being implemented with safety first. Work continues sequentially toward the start of fuel removal from Units 1 and 2 and debris (Note 1) retrieval from Units 1-3.

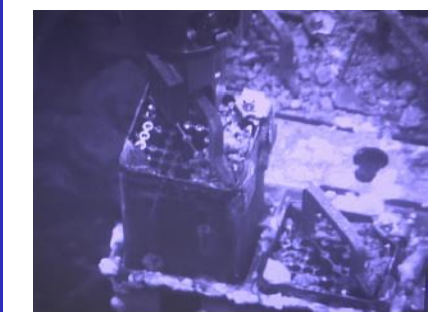
Fuel removal from the spent fuel pool started from April 15, 2019 at Unit 3. Toward completion of fuel removal by the end of FY2020, rubble and fuel are being removed.

Removed fuel (assemblies)
84/566

Fuel removal (April 15, 2019) (As of February 27, 2020)

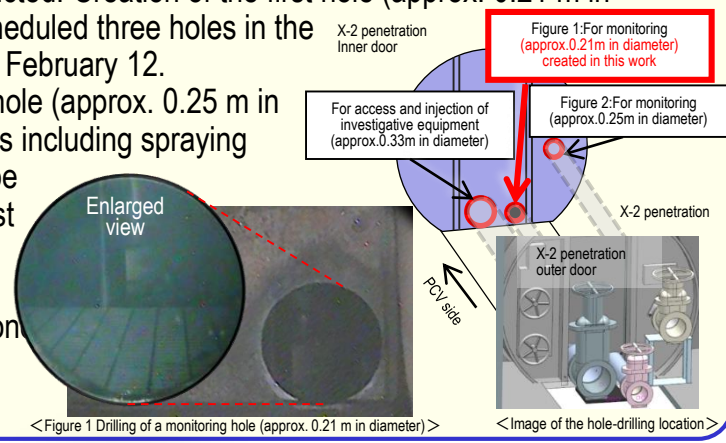
Toward investigating the inside of the Unit 1 primary containment vessel (PCV), an access route is being constructed. Creation of the first hole (approx. 0.21 m in diameter: Figure 1) of the scheduled three holes in the inner door was completed on February 12.

When creating the second hole (approx. 0.25 m in diameter: Figure 2), measures including spraying water from the first hole will be implemented to suppress dust scattering. After training on these measures, drilling of the second hole will start possibly from early March.

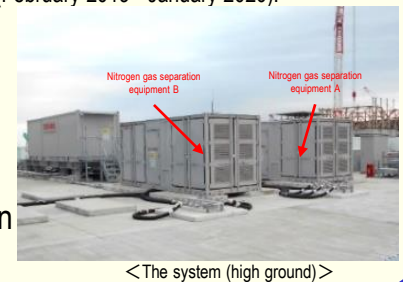
To increase the reliability of the Unit 1-3 nitrogen injection facility, work involving transferring the facility to high ground, installing an additional diesel power generator and duplicating the Unit 1-3 nitrogen injection line was completed (February 2019 - January 2020). Measures to further increase facility reliability will continue including duplicating nitrogen injection points.

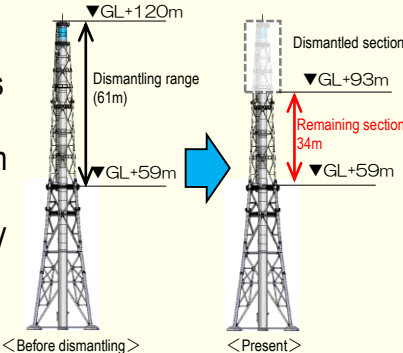
The Unit 1/2 exhaust stack was divided into 23 blocks for dismantling. By February 1, dismantling to the 11th block was completed. The following legal inspection for the crane was completed on February 12 and work was resumed from February 14. Work continues with safety first toward completing the dismantling in early May.

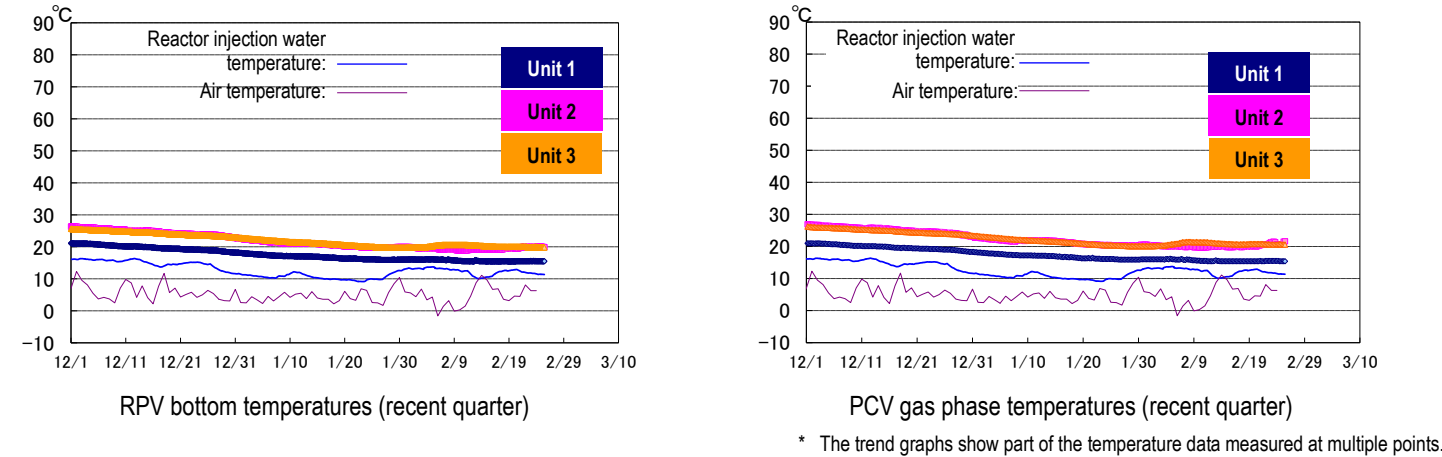
Through continuous reactor cooling by water injection, the temperatures of the Reactor Pressure Vessel (RPV) bottom and the Primary Containment Vessel (PCV) gas phase were maintained within the range of approx. 15 to 25°C for the past month, though they varied depending on the unit and location of the thermometer.

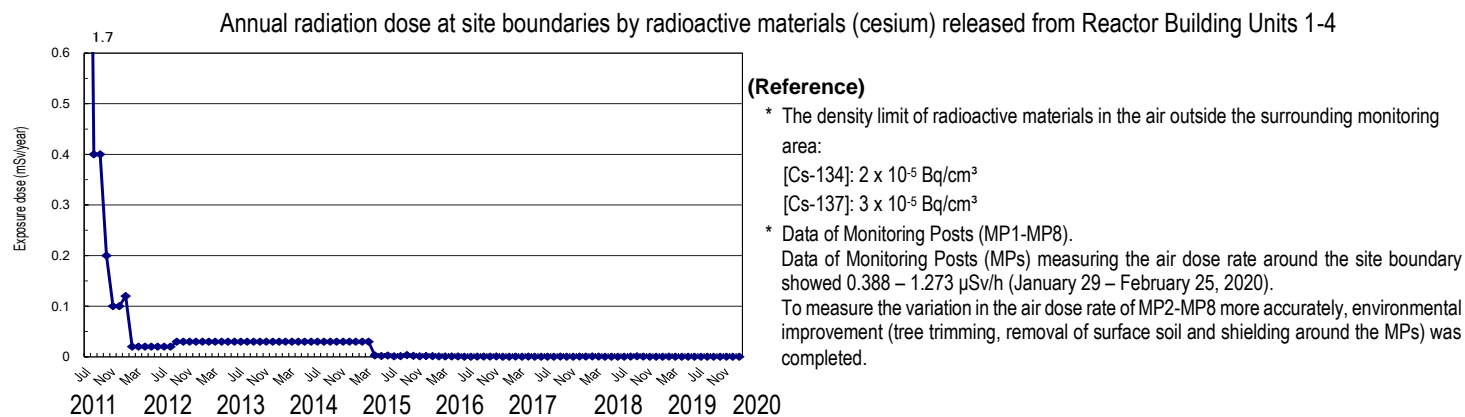
As of January 2020, the density of the radioactive materials newly released from Reactor Building Units 1-4 into the air and measured at the site boundary was evaluated at approx. 3.9×10^{-12} Bq/cm³ and 3.5×10^{-11} Bq/cm³ for Cs-134 and Cs-137 respectively, while the radiation exposure dose due to the release of radioactive materials there was less than 0.00029 mSv/year.

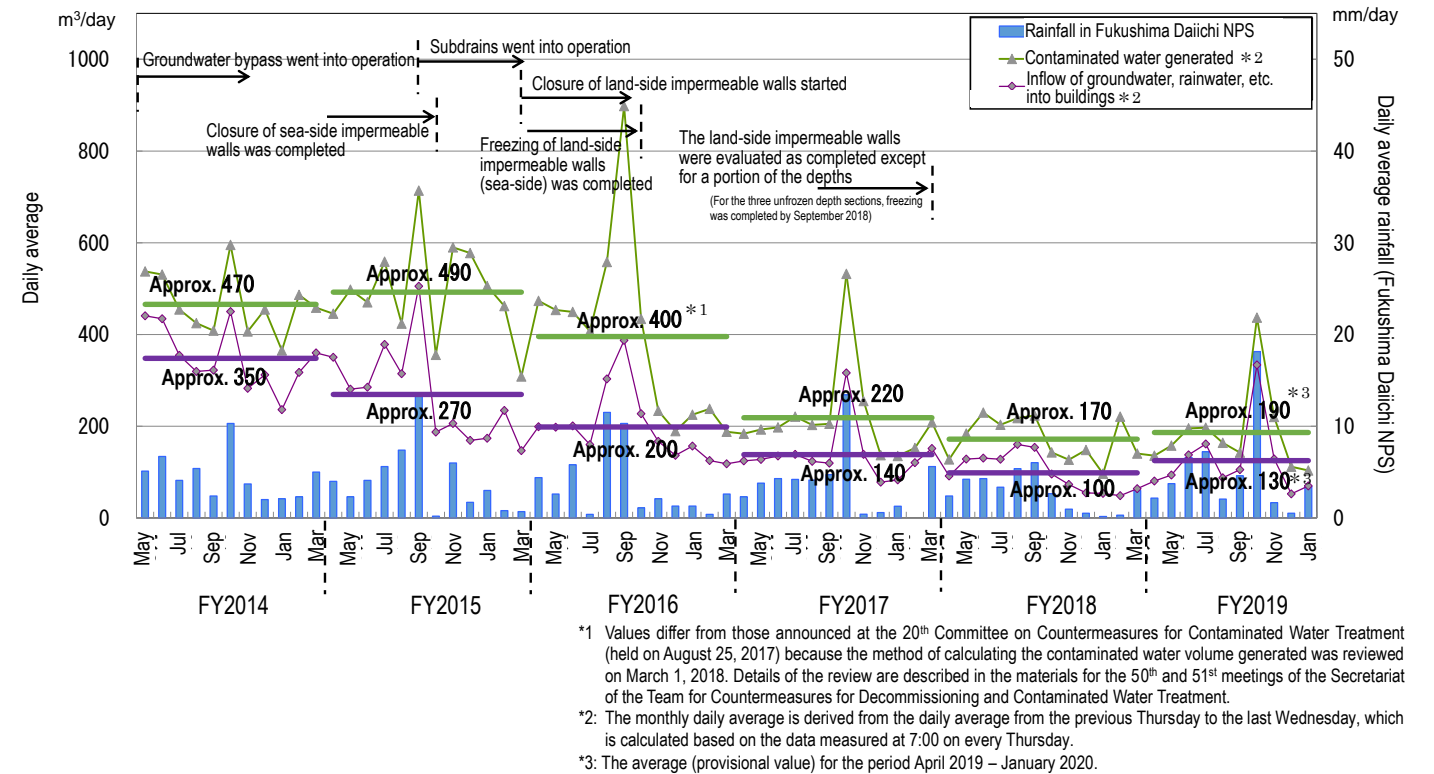
Figure 1: Changes in contaminated water generated and inflow of groundwater, rainwater, into buildings

- Multi-layered measures, including pumping up by subdrains and land-side impermeable walls, which were implemented to control the continued generation of contaminated water, suppressed the groundwater inflow into buildings.
- After "redirecting" measures (groundwater bypass, subdrains, land-side impermeable walls and others) were steadily implemented, the generation amount reduced from approx. 470 m³/day (the FY2014 average) when the measures were first launched to approx. 170 m³/day (the FY2018 average).
- Measures will continue to further reduce the volume of contaminated water generated.

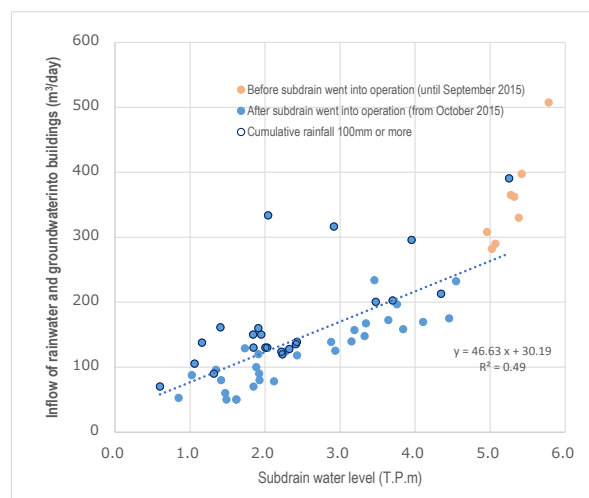
Figure 2: Correlation between inflow such as groundwater and rainwater into buildings and the water level of Units 1-4 subdrains

- To maintain the level of groundwater pumped up from the subdrains, work to install additional subdrain pits and recover those already in place is underway. The additional pits are scheduled to begin operation sequentially from a pit for which work was completed (12 of 14 pits went into operation). For recovered pits, work for all three pits scheduled was completed, all of which went into operation from December 26, 2018. Work to recover another pit started from November 2019 (No. 49 pit).
- To eliminate the need to suspend water pumping while cleaning the subdrain transfer pipe, the pipe will be duplicated. Installation of the pipe and ancillary facilities was completed.
- Since the subdrains went into operation, the inflow to buildings tended to decline to under 150 m³/day when the subdrain water level declined below T.P. 3.0 m but increased during rainfall.

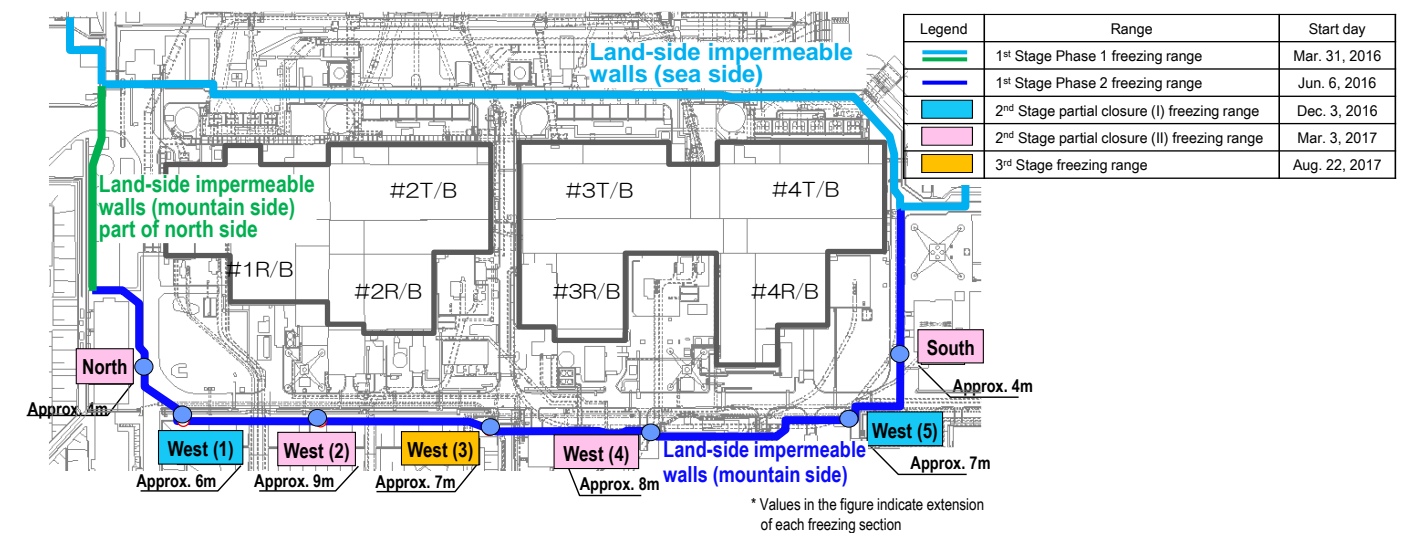
Figure 3: Closure parts of the land-side impermeable walls (on the mountain side)

- The groundwater level in the area inside the land-side impermeable walls has been declining every year. On the mountain side, the difference between the inside and outside increased to approx. 5-6 m. The water level in the bank area has remained low (T.P. 1.6-1.7 m) compared to the ground surface (T.P. 2.5 m).

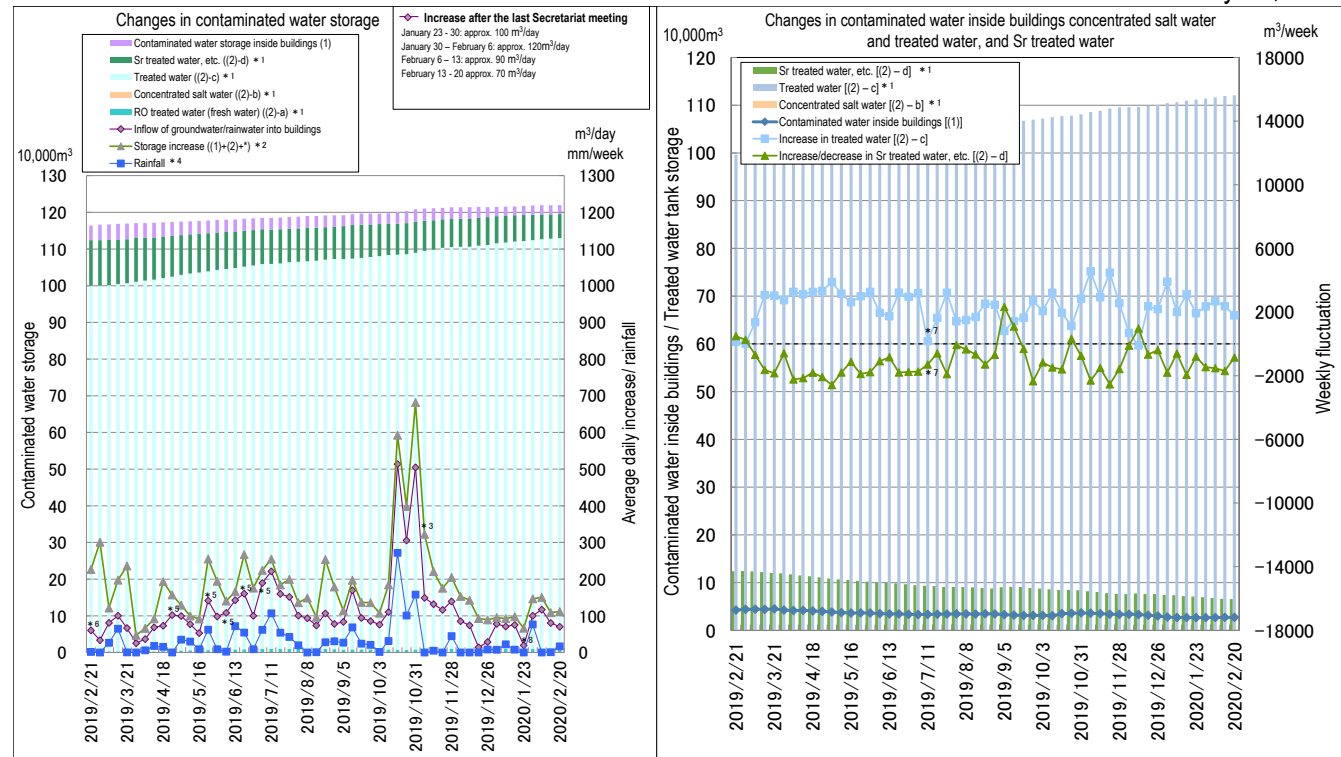
As of February 20, 2020

*1: Water amount for which the water-level gauge indicates 0% or more
 *2: To detect storage increases more accurately, the calculation method was reviewed as follows from February 9, 2017: (The revised method was applied from March 1, 2018) [(Inflow of groundwater/rainwater into buildings) + (other transfer) + (chemical injection into ALPS)]
 *3: The storage amount increased due to transfer to buildings in association with the decommissioning work. (The transferred amount comprised ①Transfer of RO concentrated water from groundwater drains to Turbine Building: approx. 80 m³/day, ②Transfer from wells and groundwater drains: approx. 50 m³/day, ③Transfer from Unit 5/6 SPT to Process Main Building: approx. 20 m³/day, others)
 *4: Changed from December 13, 2018 from rainfall in Namie to that within the site.
 *5: Considered attributable to the increased inflow of groundwater, rainwater and others to buildings due to the decline in the level of contaminated water in buildings. (April 22, May 16 and 30, June 13 and 27, 2019)

*6: Water-level gauges were replaced (February 7 – March 7, 2019)
 *7: Calculation methods for water volume and the capacity of tanks, which had varied in each tank area, were unified in all areas. By this unification, the calculated increase in treated water and variation in Sr-treated water and others changed. However, the actual treated volumes were approx. 2,200 m³/week for treated water and approx. 1,100 m³/week for Sr-treated water and others (July 11, 2019).
 *8: From the period January 16-23, 2019, with the decline of water level in Unit 4 R/B, system water in S/C flowing into R/B contaminated water is reflected in inflow of groundwater and rainwater in addition to transferred amount generated in the decommissioning work.

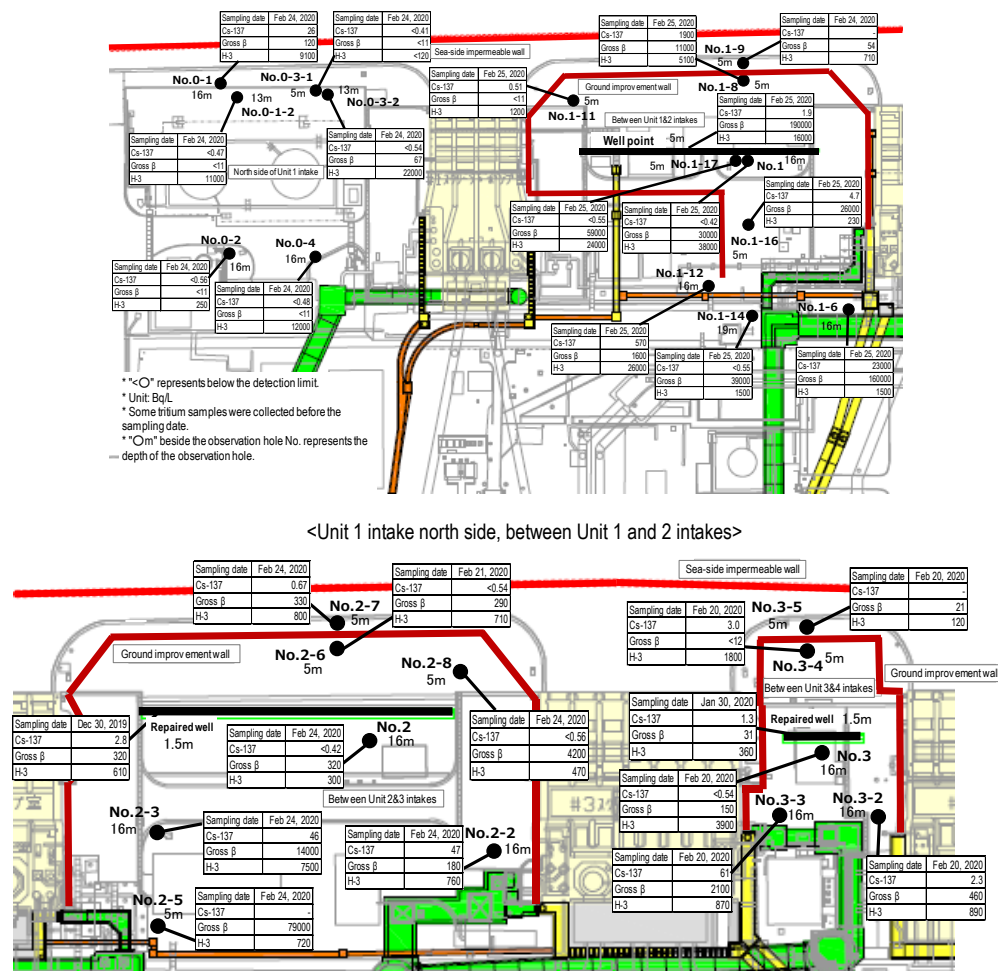
Figure 5: Groundwater density on the Turbine Building east side

- At No. 1-9, the density of gross β radioactive materials has been repeatedly increasing and declining from around 20 Bq/L since April 2019 and currently stands at around 50 Bq/L.
- At No. 1-12, the density of gross β radioactive materials has been increasing from around 500 Bq/L since December 2019 and currently stands at around 1,600 Bq/L. Since August 15, 2013, pumping of groundwater continued (at the well point between the Unit 1 and 2 intakes: August 15, 2013 – October 13, 2015 and from October 24; at the repaired well: October 14-23, 2015).
- At No. 2-3, the H-3 density had been declining from around 6,000 Bq/L since August 2019, then increasing and currently stands at around 7,500 Bq/L. The density of gross β radioactive materials at the same point had been declining from around 14,000 Bq/L to around 5,000 Bq/L since August 2019, then increasing and currently stands at

- At No. 2-6, the density of gross β radioactive materials had been increasing from around 100 Bq/L since May 2019 and currently stands at around 290 Bq/L. Since December 18, 2013, pumping of groundwater continued (at the well point between the Unit 2 and 3 intakes: December 18, 2013 - October 13, 2015; at the repaired well: from October 14, 2015).

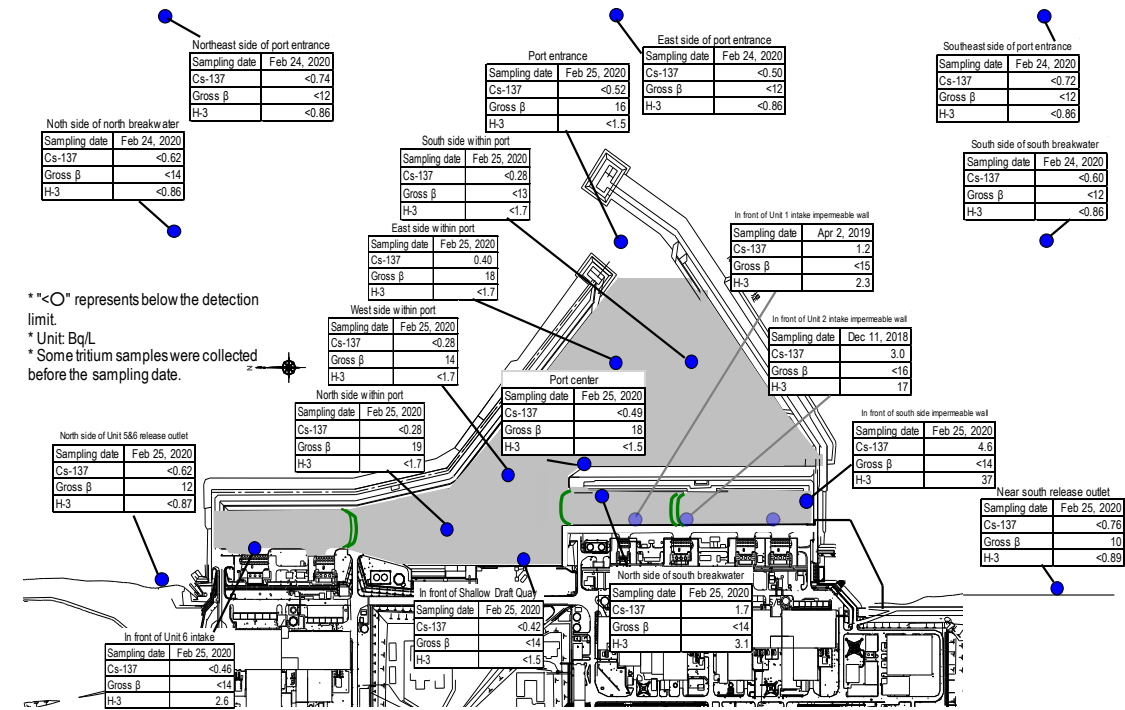
Figure 6: Seawater density around the port

- In the area within the port, densities of radioactive materials in seawater have remained below the legal discharge limit, while increasing in Cs-137 and Sr-90 below the legal discharge limit during rainfall. They have remained below the level of those in the Units 1-4 intake open channel area and been declining following the completed installation and connection of steel pipe sheet piles for the sea-side impermeable walls.

- In the area outside the port, regarding the densities of radioactive materials in seawater, those of Cs-137 and Sr-90 declined and remained low after steel pipe sheet piles for the sea-side impermeable walls were installed and connected.

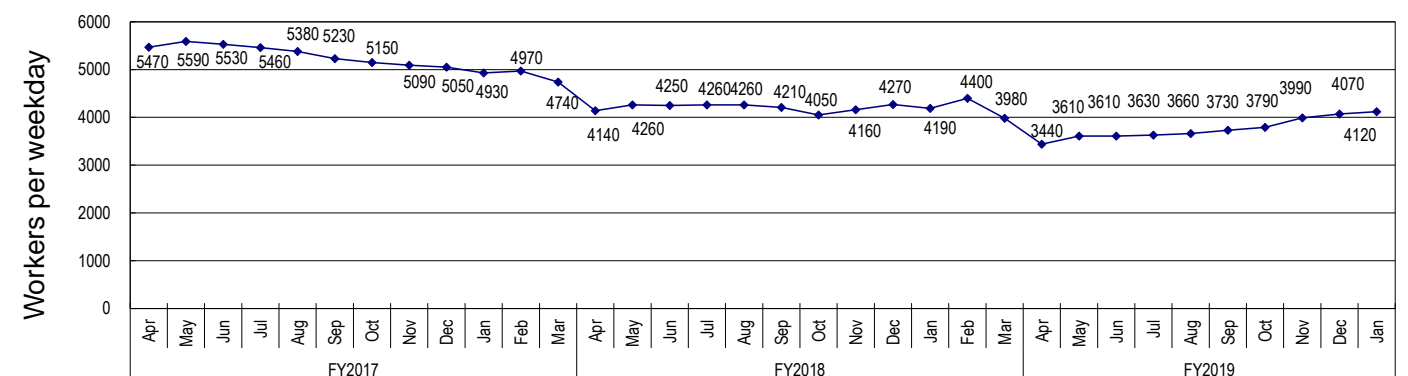
Figure 7: Changes in the average number of workers per weekday for each month since FY2017 (actual values)

- It was confirmed with the prime contractors that the estimated manpower necessary for the work in March 2020 (approx. 4,300 per day: TEPCO and partner company workers) would be secured at present. The average numbers of workers per day per month (actual values) were maintained, with approx. 3,400 to 5,600 since FY2017 (see Figure 7).

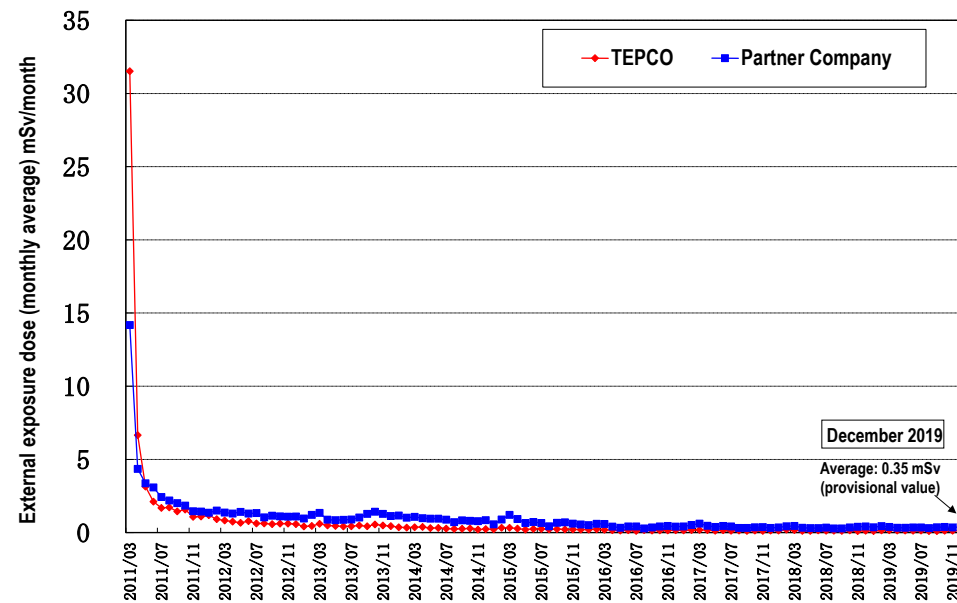
Figure 8: Changes in monthly individual worker exposure dose (monthly average exposure dose since March 2011)

- The monthly average exposure dose of workers remained at approx. approx. 0.39, 0.36 and 0.32 mSv/month during FY2016, FY2017 and FY2018 respectively. (Reference: Annual average exposure dose 20 mSv/year \div 1.7 mSv/month)

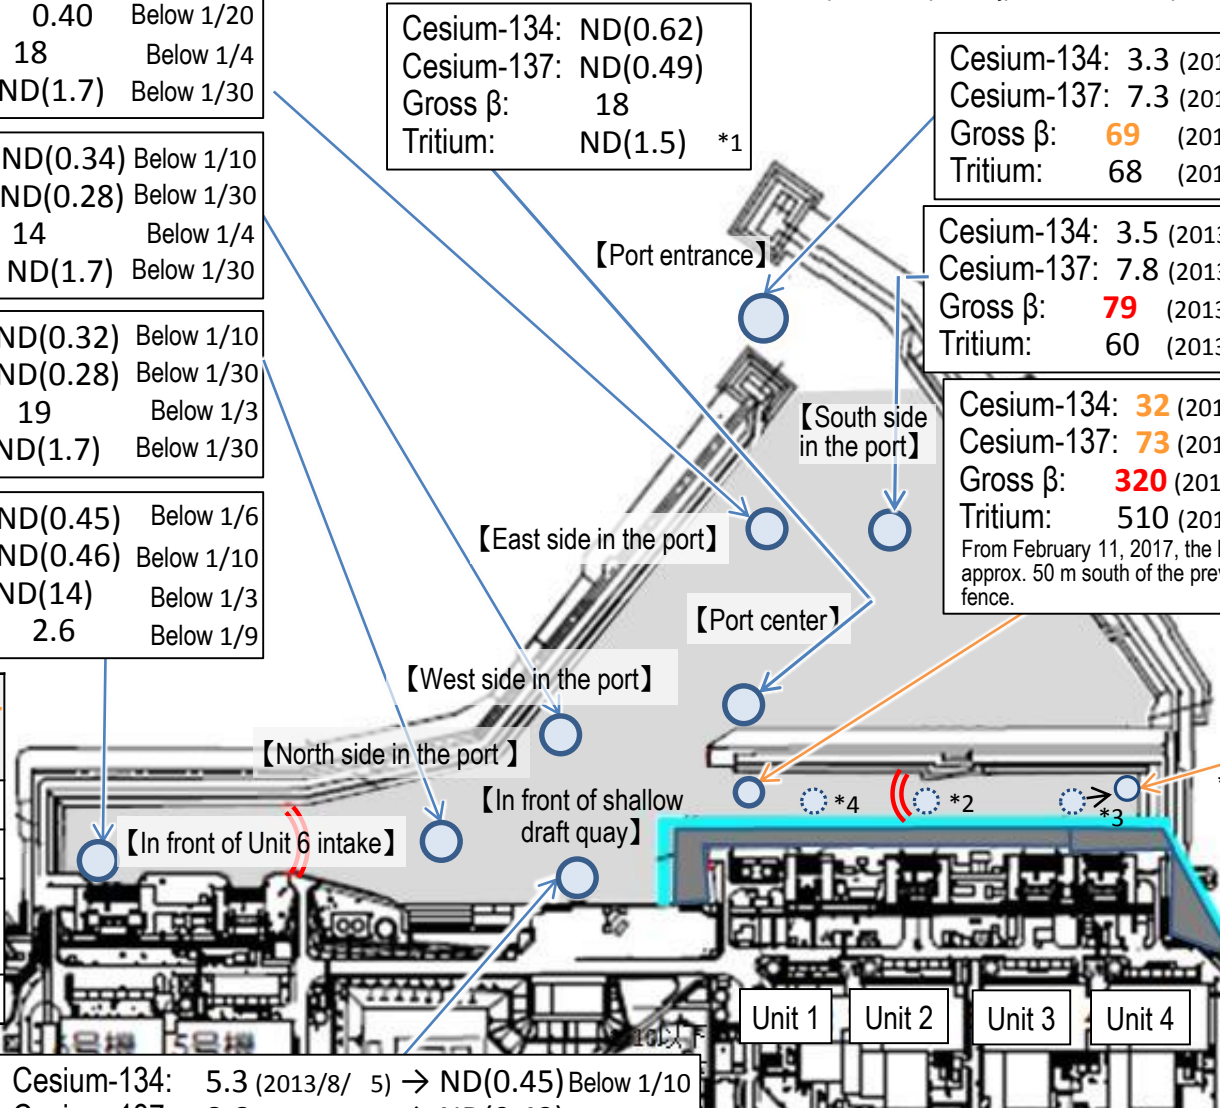
Legal discharge limit	WHO Guidelines for Drinking Water Quality
Cesium-134	60	10
Cesium-137	90	10
Strontium-90 (strongly correlate with Gross β)	30	10
Tritium	60,000	10,000

Cesium-134: 5.3 (2013/8/ 5) → ND(0.45) Below 1/10
Cesium-137: 8.6 (2013/8/ 5) → ND(0.42) Below 1/20
Gross β: **40** (2013/7/ 3) → ND(14) Below 1/2
Tritium: 340 (2013/6/26) → ND(1.5) Below 1/200

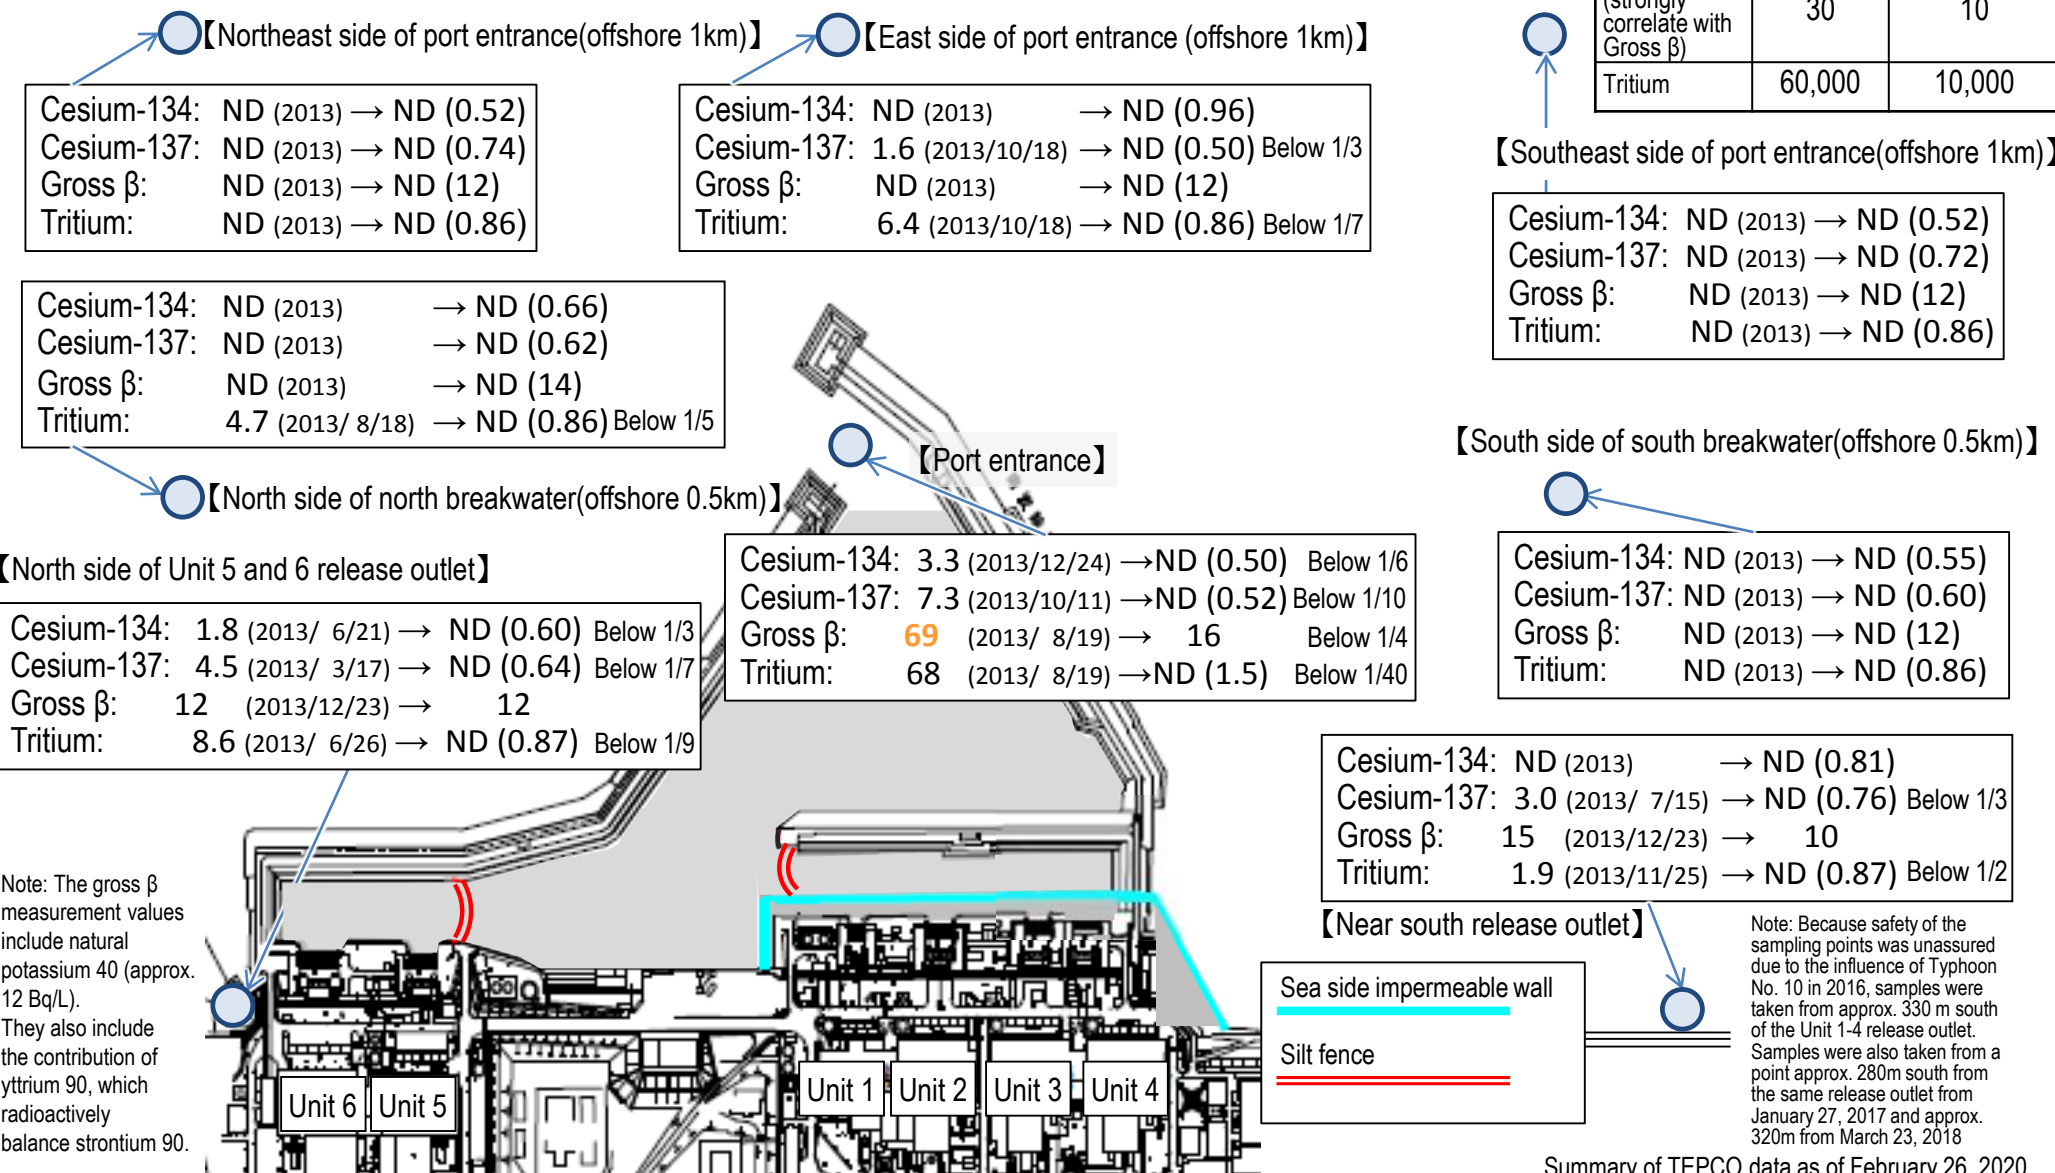
Summary of TEPCO data as of February 26, 2020

Legal discharge limit	WHO Guidelines for Drinking Water Quality
Cesium-134	60	10
Cesium-137	90	10
Strontium-90 (strongly correlate with Gross β)	30	10
Tritium	60,000	10,000

Unit (Bq/L); ND represents a value below the detection limit; values in () represent the detection limit; ND (2013) represents ND throughout 2013

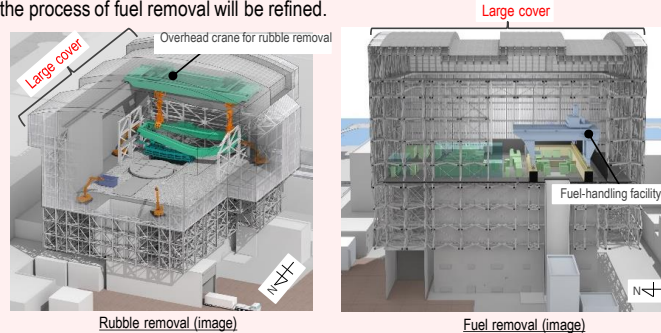
Rubble removal on the north side of the operating floor started from January 2018 and has been implemented sequentially. In July and August 2019, the well plug, which was misaligned from its normal position, was investigated and in August and September, the conditions of the overhead crane were checked. Based on the results of these investigations, as the removal requires more careful work taking dust scattering into consideration, two methods were examined: installing a cover after rubble removal and initially installing a large cover over the Reactor Building and then removing rubble inside the cover.

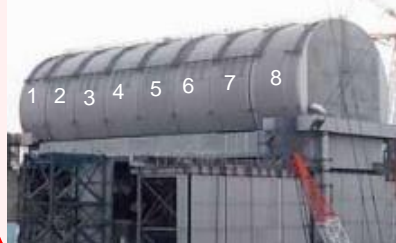
Installation of dome roof (February 21, 2019)

Prior to the installation of a cover for fuel removal, removal of large rubble from the spent fuel pool was completed in November 2015. To ensure safe and steady fuel removal, training of remote control was conducted at the factory using the actual fuel-handling machine which will be installed on site (February – December 2015). Measures to reduce dose on the Reactor Building top floor (decontamination, shields) were completed in December 2016. Installation of a cover for fuel removal and a fuel-handling machine is underway from January 2017. Installation of the fuel removal cover was completed on February 23, 2018. Toward fuel removal, the rubble retrieval training inside the pool, which was scheduled in conjunction with fuel removal training, started from March 15, 2019, and started fuel removal from April 15, 2019.

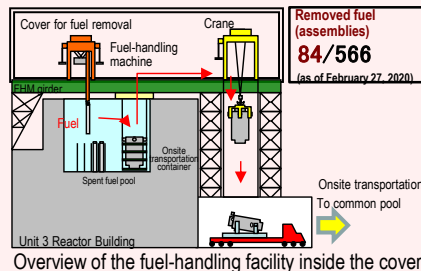
Fuel removal status
(April 15, 2019)

- From July 4, 2019, fuel removal was resumed and up until July 21, 28 of all 566 fuel assemblies had been removed.
 - The periodical inspection of the fuel-handling facility, which started on July 24, 2019, was completed on September 2, 2019. Some defective rotations of the tensile truss and mast were detected during the following adjustment work toward resumption of the fuel removal. In response, parts were replaced and the operation checked to confirm no problem.

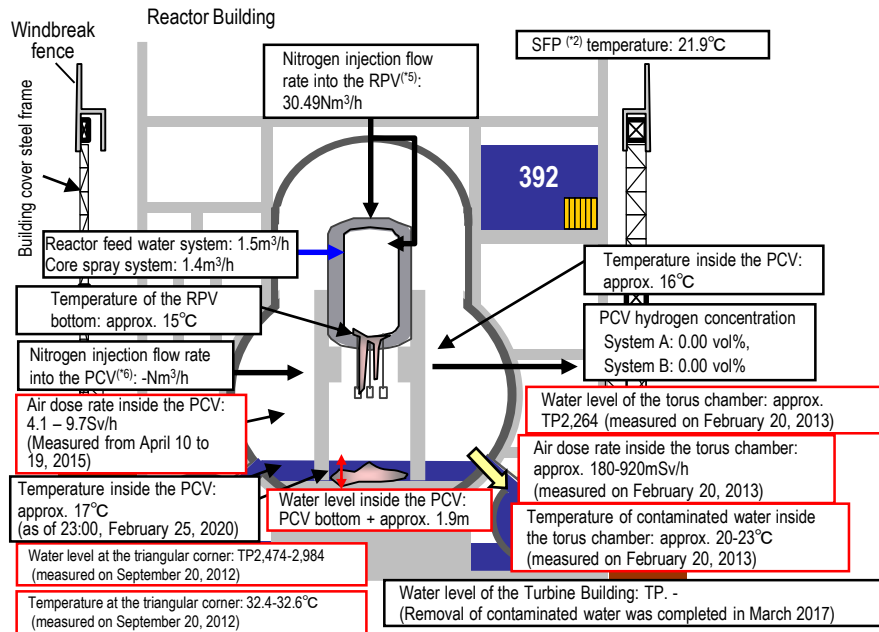
Investigation in the leak point detected in the upper part of Unit 1 S/C from May 27, 2014 from one expansion joint cover among the lines installed there. As no leakage was identified from other parts, specific methods will be examined to halt the flow of water and repair the PCV.

Air dose rate inside the Reactor Building:
Max. 5,150mSv/h (1F southeast area) (measured on July 4, 2012)

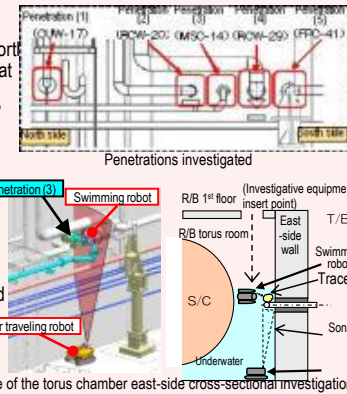
- July 2014, the torus chamber walls were investigated (on the north-east-side walls) using equipment specially developed for that purpose (a swimming robot and a floor traveling robot).
- At the east-side wall pipe penetrations (five points), "the status" and "existence of flow" were checked.
- A demonstration using the above two types of underwater wall investigative equipment showed how the equipment could check the status of penetration.
- Regarding Penetrations 1 - 5, the results of checking the sprayed tracer (*) by camera showed no flow around the penetrations. (investigation by the swimming robot)
- Regarding Penetration 3, a sonar check showed no flow around the penetrations. (investigation by the floor traveling robot)

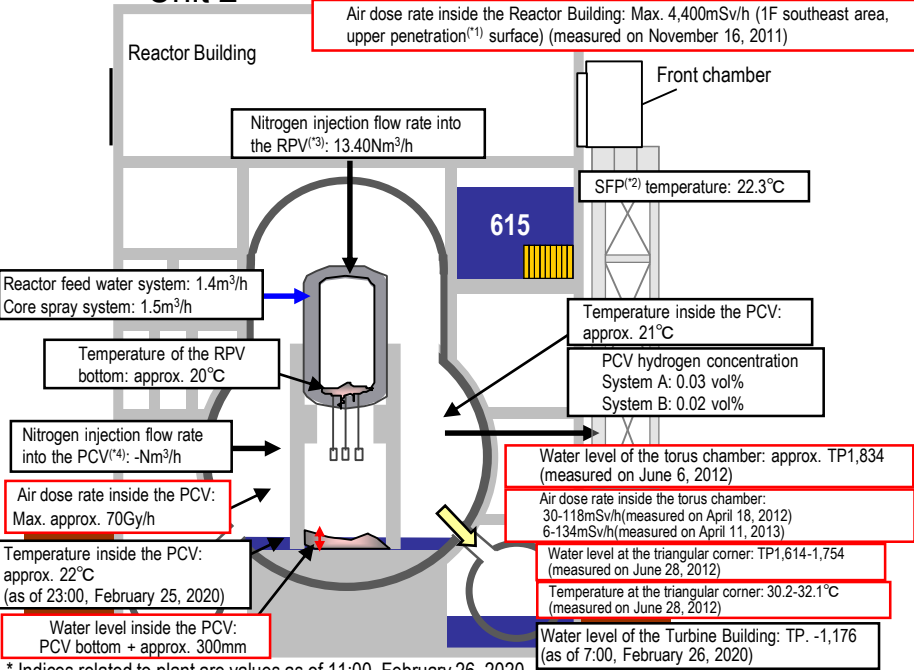
- Replacement of the RPV thermometer
 - As the thermometer installed at the Unit 2 RPV bottom after the earthquake had broken in February 2014, it was excluded from the monitoring thermometers.

- In April 2014, removal of the broken thermometer failed and was suspended. Rust-stripping chemicals were injected and the broken thermometer was removed in January 2015. A new thermometer was reinstalled in March. The thermometer has been used as a part of permanent supervisory instrumentation since April.

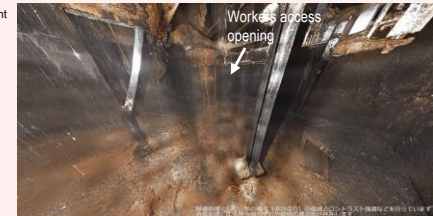
- The results of this series of investigations confirmed fallen and deformed gratings and a quantity of deposit inside the pedestal.
- On January 19, 2018, the status below the platform inside the pedestal was investigated using an investigative device with a hanging mechanism. From the analytical results of images obtained in the investigation, deposits probably including fuel debris were found at the bottom of the pedestal. In addition, multiple parts higher than the surrounding deposits were also detected. We presumed that there were multiple routes of fuel debris falling. Obtained data were processed in panoramic image visualization to acquire clearer images.

- On February 13, 2019, an investigation touching the deposits at the bottom of the pedestal and on the platform was conducted and confirmed that the pebble-shaped deposits, etc. could be moved and that hard rock-like deposits that could not be gripped may exist.

- In addition, images, etc. would help determine the contour and size of the deposits could be collected by moving the investigative unit closer to the deposits than the previous investigation.

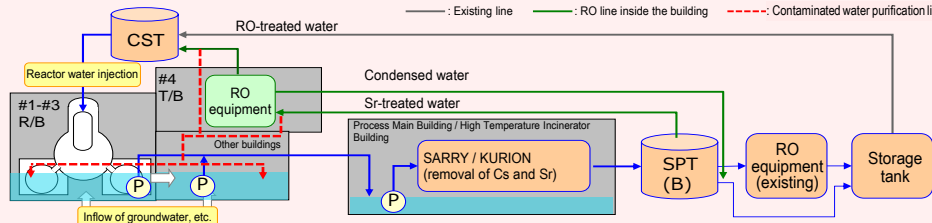
- To reduce the risk of contaminated-water leakage, the circulation loop was shortened by installing a reverse osmosis (RO) device in the Unit 4 Turbine Building within the circulation loop, comprising the transfer of contaminated water, water treatment and injection into the reactors. Operation of the installed RO device started from October 7 and 24-hour operation started from October 20. Installation of the new RO device inside the building shortened the circulation loop from approx. 3 to 0.8 km.

* The entire length of contaminated water transfer pipes is approx. 2.1km, including the transfer line of surplus water to the upper heights (approx. 1.3km).

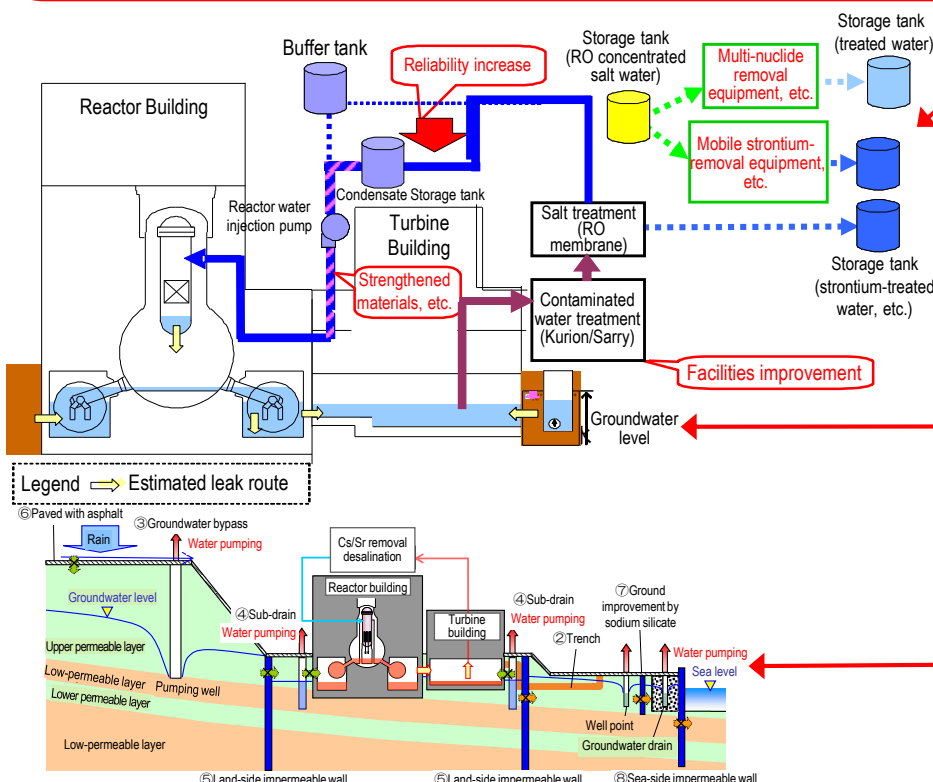
Contaminated water (RO concentrated salt water) is being treated using seven types of equipment including the multi-nuclide removal equipment (ALPS). Treatment of the RO concentrated salt water was completed on May 27, 2015, with the exception of the remaining water at the tank bottom. The remaining water will be treated sequentially toward dismantling the tanks.

The strontium-treated water from other facilities than the multi-nuclide removal equipment will be re-purified in the multi-nuclide removal equipment to further reduce risks.

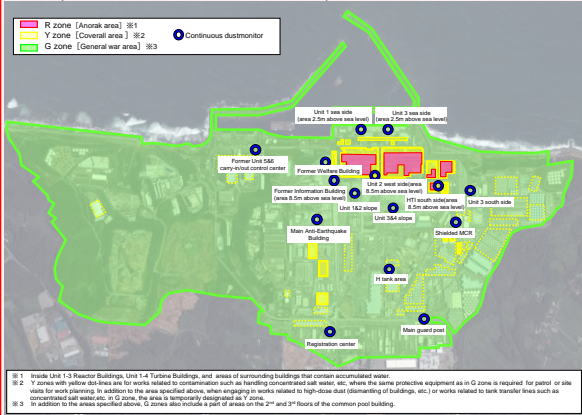
Based on the progress of measures to reduce environmental dosage on site, the site is categorized into two zones: highly contaminated area around Unit 1-4 buildings, etc. and other areas to optimize protective equipment according to each category aiming at improving safety and productivity by reducing load during work. From March 2016, limited operation started. From March and September 2017, the G Zone was expanded.

R zone (Anorak area)	Y zone (Coverall area)	G zone (General wear)
Full-face mask 	Full-face or half-face masks 	Disposable disposable mask
Anorak on coverall Or double coveralls 	Coverall 	General*3 Dedicated on-site wear
