Estimation of accident progression based on the data measured for Unit-1 and the analyses available to date

* This document is generated based on the proposal and evaluation by TEPCO Systems Corporation [1] concerning the changes of water level indicator readings (Unit-1/Issue-3) in Attachment 2 “List of issues”.

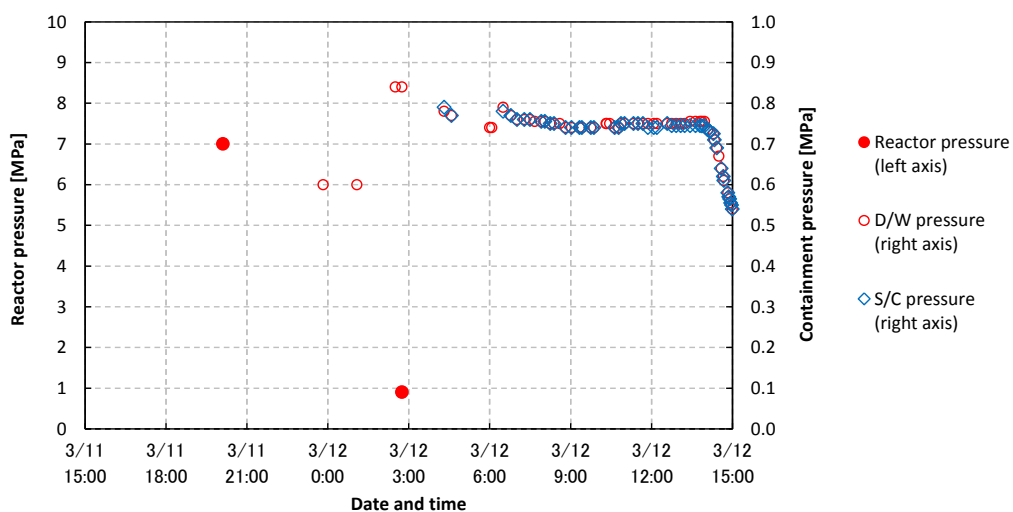
Figure 2 Measured reactor and PCV pressures

Figure 2 shows the reactor pressures and PCV pressures from the station blackout till

about 24 hours later. The measured reactor pressures were 7MPa[abs] at 20:07 on March 11th and 0.9MPa[abs] at 02:45 on March 12th. After the station blackout, the safety function of the safety relief valves (SRV) worked. The working pressure was about 7.7MPa[abs] [9]. The reactor pressure as of 20:07 on March 11th was likely to be slightly below the minimum value of the SRV working pressures. This might indicate the possibility that at this time the RPV was already leaking (Event E3 in Table 1). As possible leakage causes, in-core instrumentation line damage or line melting and main steam line damage have been suggested [3][4][5][6].

The measured PCV pressures were 0.6MPa[abs] at 23:50 on March 11th and 01:05 on March 12th. Such pressures cannot be reached without leakage from the RPV to the D/W, as explained below in Section 2.2, i.e., leakage from the RPV to the D/W seems likely to have occurred by 23:50 on March 11th. Later at 02:30 on March 12th the measured PCV pressure was 0.84MPa[abs], which roughly balanced with the RPV pressure of 0.9MPa[abs] at 02:45 on March 12th. Thereafter, the PCV pressure gradually decreased and then to increase at around 06:00 on March 12th. In the current estimation, the RPV lower head failure was considered to have occurred at around 06:00 on March 12th, and therefore the PCV pressure increase at this time was considered to be caused by the relocation of molten debris to the PCV in the wake of RPV damage. In other words, the pressure increase prior to this time point was estimated to be caused by some other reasons, and the pressure increase at this particular period from 01:05 to 02:30 on March 12th was estimated to be caused by the large amount of molten debris relocation to the lower plenum (Event E8 in Table 1).

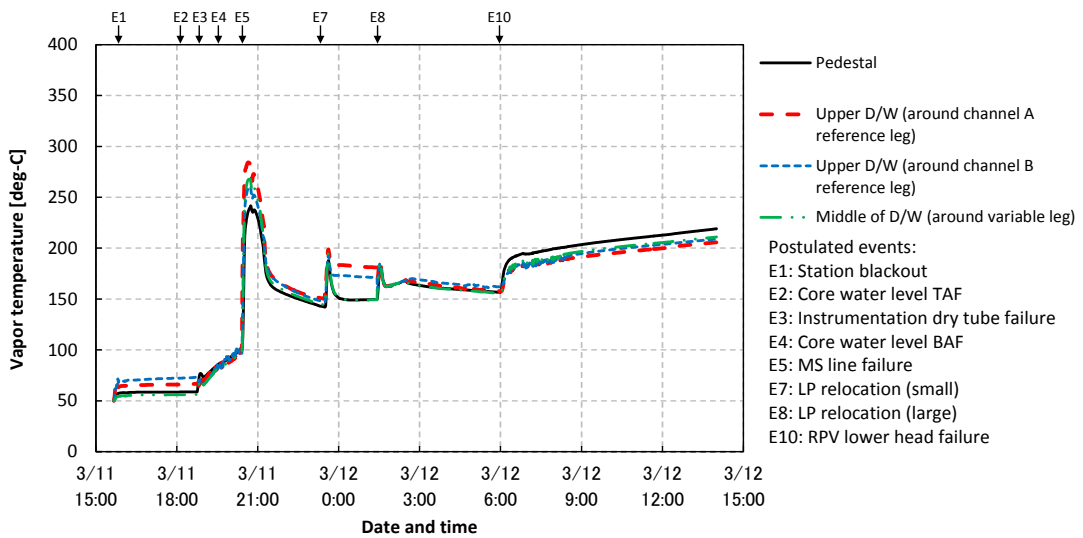
Figure 4 Temperature changes in the D/W (base case)

Figure 4 presents the analysis results of temperature changes in the atmosphere surrounding the pedestal, the upper part of the D/W (near the reference legs of Channel A and Channel B), and the central part of the D/W (near the variable legs)². The temperature increase is relatively gradual until 18:50 on March 11th, when a leak through the in-core instrumentation line was assumed. Further, even after the leak to the pedestal started, the temperature increase in the PCV atmosphere is at most about 100 deg C, not significantly high enough to evaporate water in the water level indicator line. This is because it is hard to increase the atmosphere temperature due to the low heat radiation from the RPV, the limited gaseous leaks to the pedestal, and the large heat capacity of heat structures in the PCV. Thereafter, upon initiation of large quantity, high temperature steam leaks from the main steam line at 20:30, all the PCV temperatures increase quickly. As the leaked amount decreases with time, the atmosphere temperature decreases because heat is absorbed by heat structures therein. Similar temperature changes of a spike-shape increase followed by a decrease are also noticed at 23:30 (March 11th) at the time of debris relocation in a limited amount and 01:30 on March 12th at the time of debris relocation in a big amount. Thereafter at 06:00 on March 12th, when the molten debris relocated because the RPV lower head had failed, heat from the molten debris is directly transferred to the atmosphere and it continues to increase the PCV temperatures.

Upon occurrence of leaks from the main steam line, the peak temperature of Channel A reaches a higher value than that of Channel B. The actual value of their difference is subject to the leak position. The position assumed in the current estimation was the upper side of the main steam line and it was close to the condensing water chamber of Channel B. In other words, in the analysis the leak above the Channel B piping raises the Channel A piping

temperature. This is because the high temperature leaked gas causes upward and horizontal flows of gas above Channel B piping and these gas flows raise the temperature around Channel A piping. Figure 5 shows the temperature distribution in the gas phase in the D/W at 20:35 on March 11th, when the temperatures in the gas phase in the D/W peaked. The area around the variable leg is located at a fairly lower elevation than the leak position and therefore its peak temperature becomes lower than that around the reference leg, because the high temperature leaked gas loses some heat due to the surrounding structures before flowing down to the area around the variable leg.

period remained roughly constant (see Figure 4). This comes from the balanced heat supplied from the leaked steam generated by decay heat and heat loss absorbed by surrounding structures in the PCV. The pressure increases sharply at 01:30 on March 12th, when the debris relocation in a large amount was assumed, but it does not reach 0.84MPa[abs] measured at 02:30. In the current analysis, no hydrogen generation was assumed upon the debris relocation to the lower plenum. This may have led to underestimation of the containment pressures. In another existing analysis, hydrogen was newly generated upon debris relocation [5].

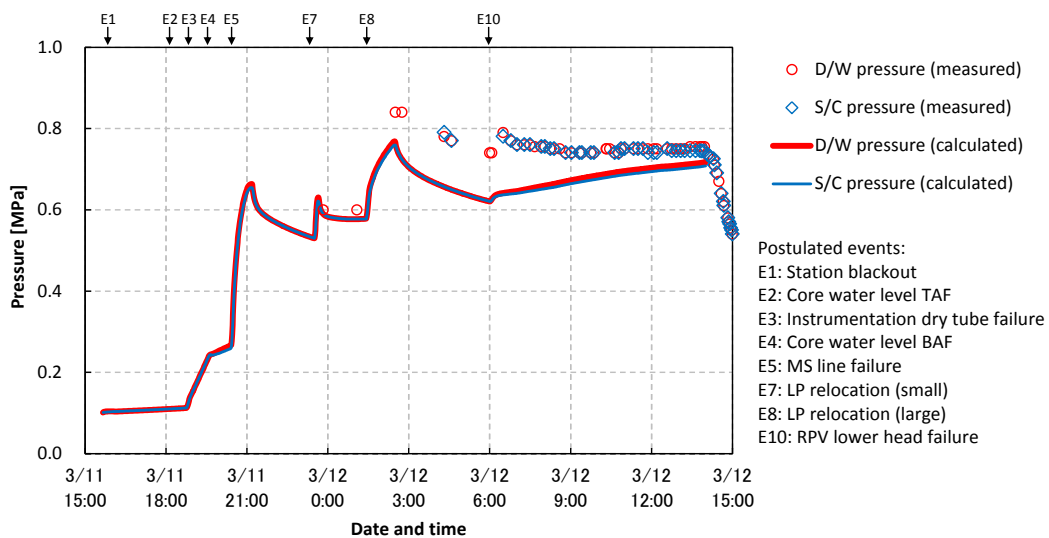
Figure 8 Comparisons between the analysis results and measured values of containment vessel pressures (base case)

Figure 8 compares the analysis results and measured values of D/W pressures and S/C pressures. In the analysis, the PCV pressures show a large increase until 21:15 on March 11th mainly due to hydrogen discharge to the S/C and steam/hydrogen mixture discharge from the main steam line. Thereafter, the pressures decrease in accordance with the ambient temperature (Figure 4). It increases again due to steam generated by the debris relocation (assumed as having occurred at 23:30) in a limited amount to the lower plenum, and then the pressures remain roughly constant due to stable steam leaks by decay heat. The pressures quickly increase after the debris relocation in a large amount to the lower plenum assumed as having occurred at 01:30 on March 12th. The pressures decrease gradually thereafter in accordance with the temperature decrease, and they turn upward due to the temperature increase of the PCV upon the debris relocation at around 06:00.

The comparison in Figure 8 shows the pressures of 0.6MPa[abs] observed at 23:50 on March 11th and 01:05 on March 12th are well reproduced in the analysis. The pressures over this time span remain roughly constant because the ambient temperature in the PCV in this

The observed pressures show an increase, by about 0.05MPa, from 06:00 to 06:30, but the pressure increase by the analysis during that time is less. If the RPV lower head was damaged and molten debris flowed out at this timing, non-condensable gas generated by the molten debris – concrete interaction (MCCI) would increase the pressure. The current analysis did not simulate the gas generation by MCCI, and this may have caused underestimation of the pressure increase. Thereafter the observed pressures remain roughly constant, while the analysis results show an increasing trend. This is probably because no leaks from the PCV were assumed in the analysis.

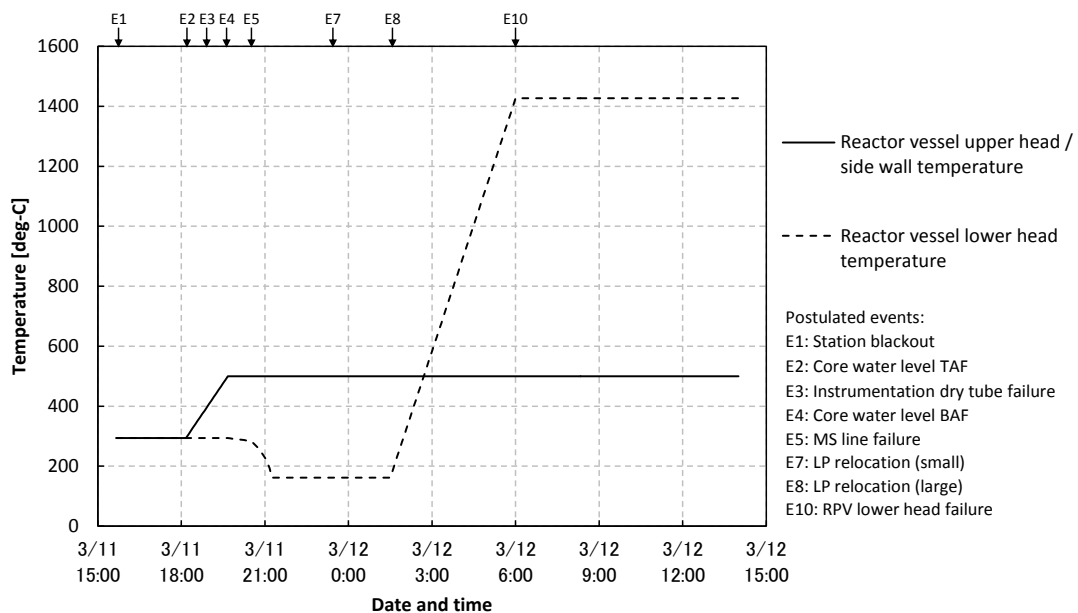
Reference Figure 2 RPV inner wall temperatures

Upon the station blackout, the D/W coolers stopped and the D/W temperatures increased gradually by heat being transferred through the heat insulation material between the RPV wall and D/W atmosphere. Reference Figure 2 shows the RPV inner wall temperatures set in the current analysis. Until 18:10 on March 11th, the reactor water level was above TAF. Therefore, the RPV inner wall temperatures were set as the saturation temperatures corresponding to the RPV pressures. Thereafter, the inner wall temperatures above the reactor water level would increase due to superheated steam or heat radiation from the core. In the current evaluation, reference was made to the MAAP analysis results [3][4] and the RPV side wall temperatures after 19:40 above the lower plenum were assumed as 500 deg C, while from 18:10 to 19:40 they were linearly interpolated. Concerning the lower plenum inner wall, its temperatures were set as the saturation temperatures corresponding to the RPV pressures set above, until 01:30 on March 12th, when the debris relocation in a large amount was estimated to have occurred. After that, the lower plenum temperatures were considered to increase due to the molten debris leaked in. Reference was made to the analysis results [5], and the lower plenum temperatures were assumed to increase linearly

up to 1700 deg K, the melting temperature of stainless steel, till 06:00, when the RPV lower head failure was assumed, and they remained at that temperature thereafter. The heat transfer coefficients of insulation materials were estimated from the heat transfer from the reactor under the normal reactor operation conditions.
