Fukushima Daiichi Nuclear Power Station Unit2 Parameters of Temperature (Typical Points)

Fukushima Daiichi Nuclear Power Station Unit2 Parameters of Temperature

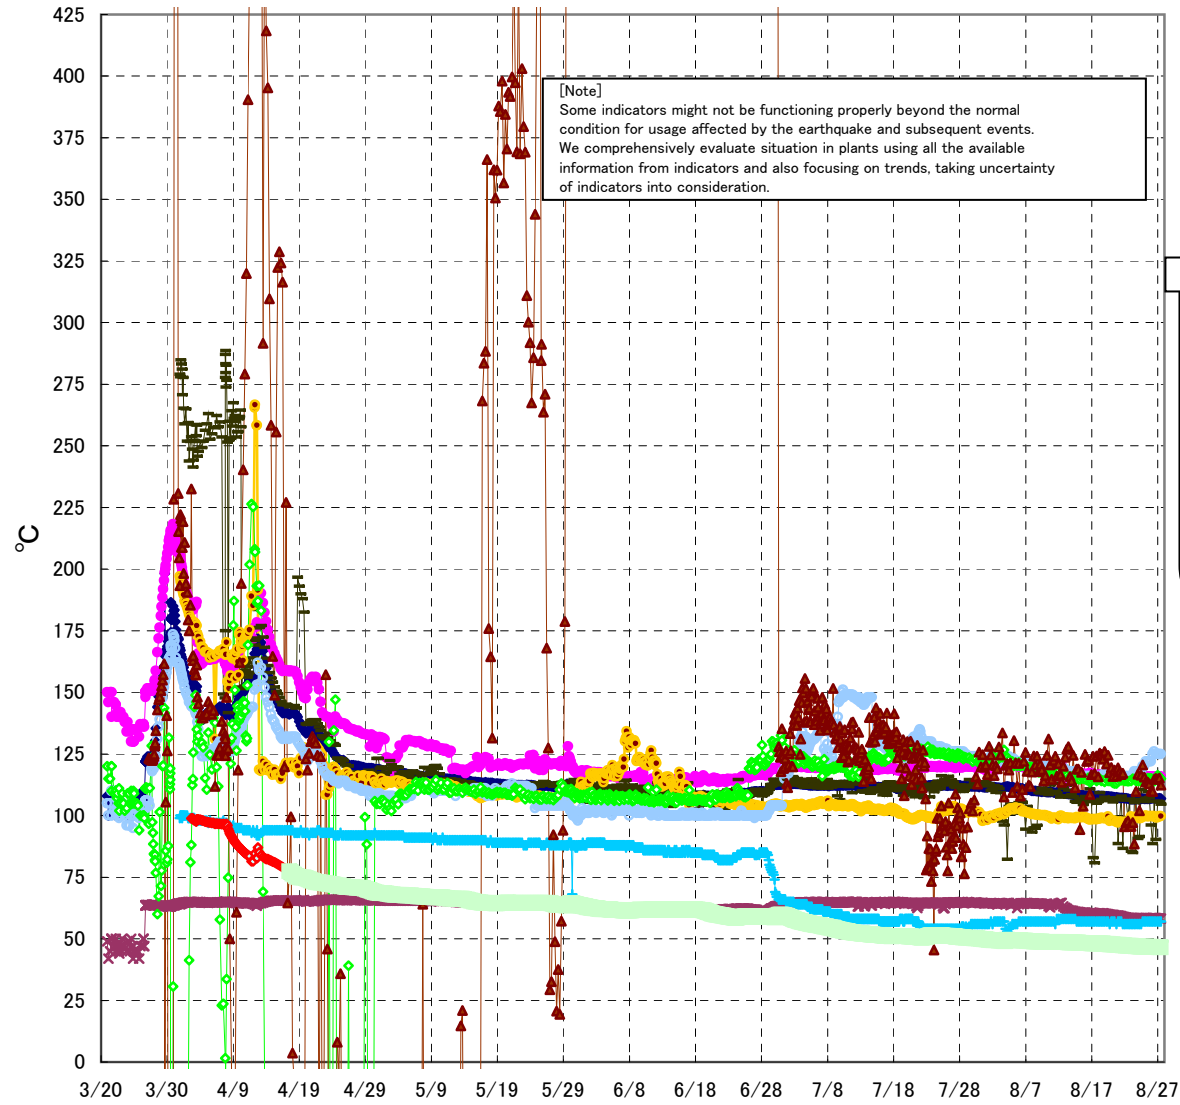
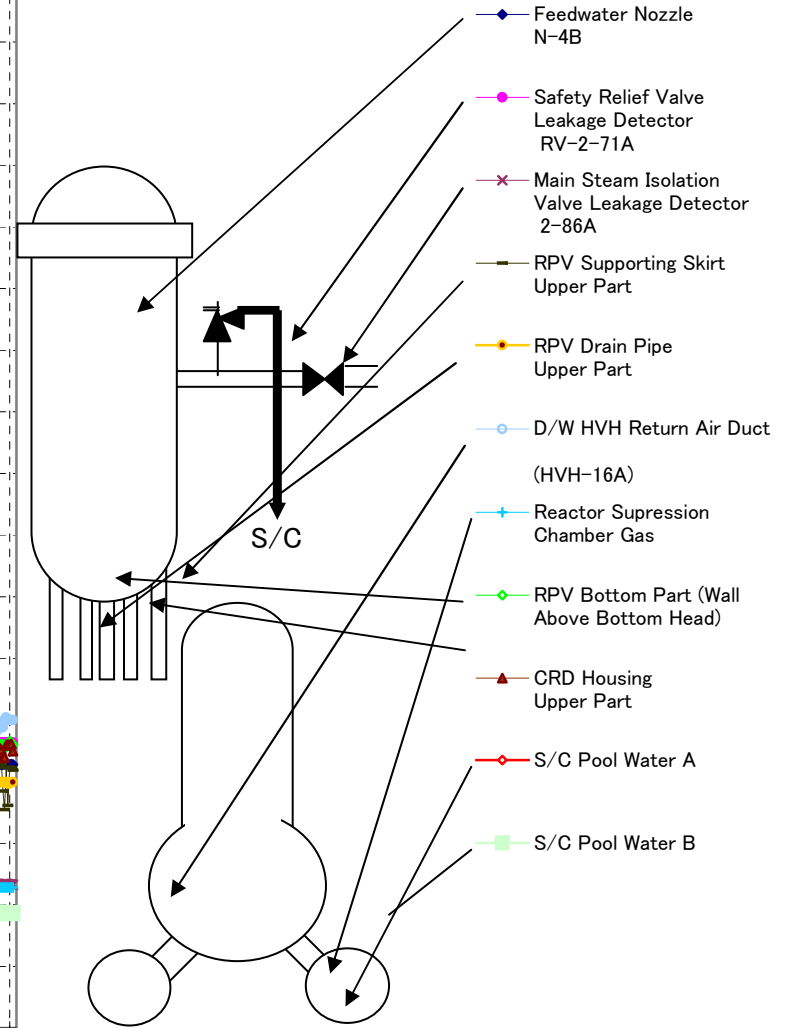
[Note]
 Some indicators might not be functioning properly beyond the normal condition for usage affected by the earthquake and subsequent events.
 We comprehensively evaluate situation in plants using all the available information from indicators and also focusing on trends, taking uncertainty of indicators into consideration.
