### Fukushima Daiichi Nuclear Power Station Unit2 Parameters of Temperature (Typical Points)

Fukushima Daiichi Nuclear Power Station Unit2 Parameters of Temperature

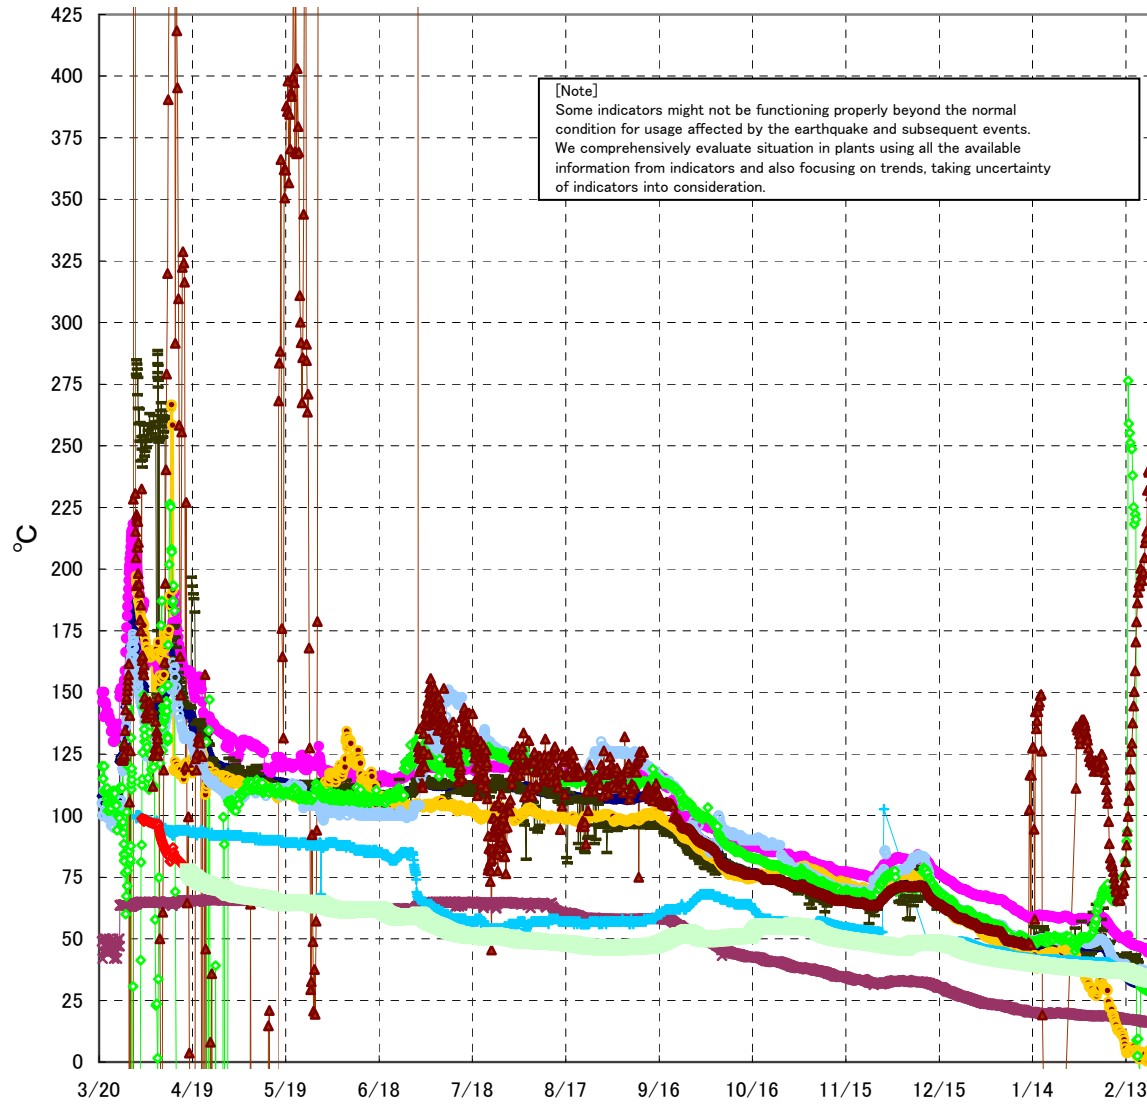
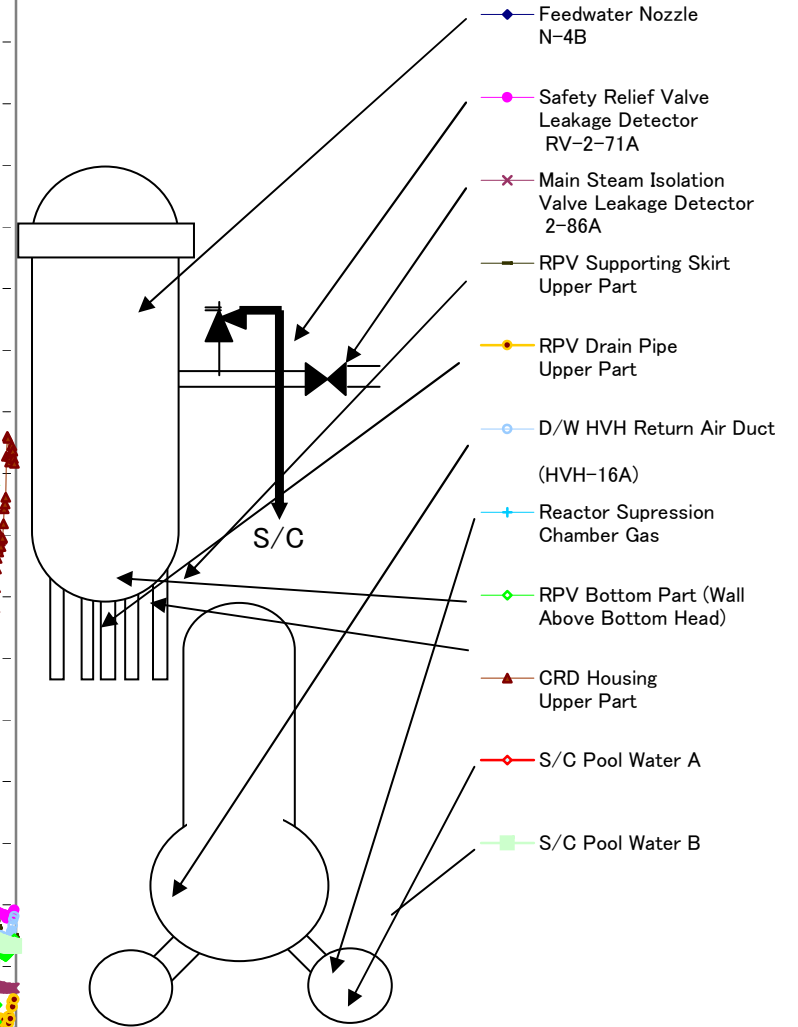
[Note]  
 Some indicators might not be functioning properly beyond the normal condition for usage affected by the earthquake and subsequent events.  
 We comprehensively evaluate situation in plants using all the available information from indicators and also focusing on trends, taking uncertainty of indicators into consideration.
