### Detailed Analysis Results in the Port of Fukushima Daiichi NPS, around Discharge Channel and Bank Protection (Sampling Locations of Underground Water Obtained at Bank Protection)

Detailed Analysis Results in the Port of Fukushima Daiichi NPS, around Discharge Channel and Bank Protection (1/4)  
Underground Water Obtained at Bank Protection

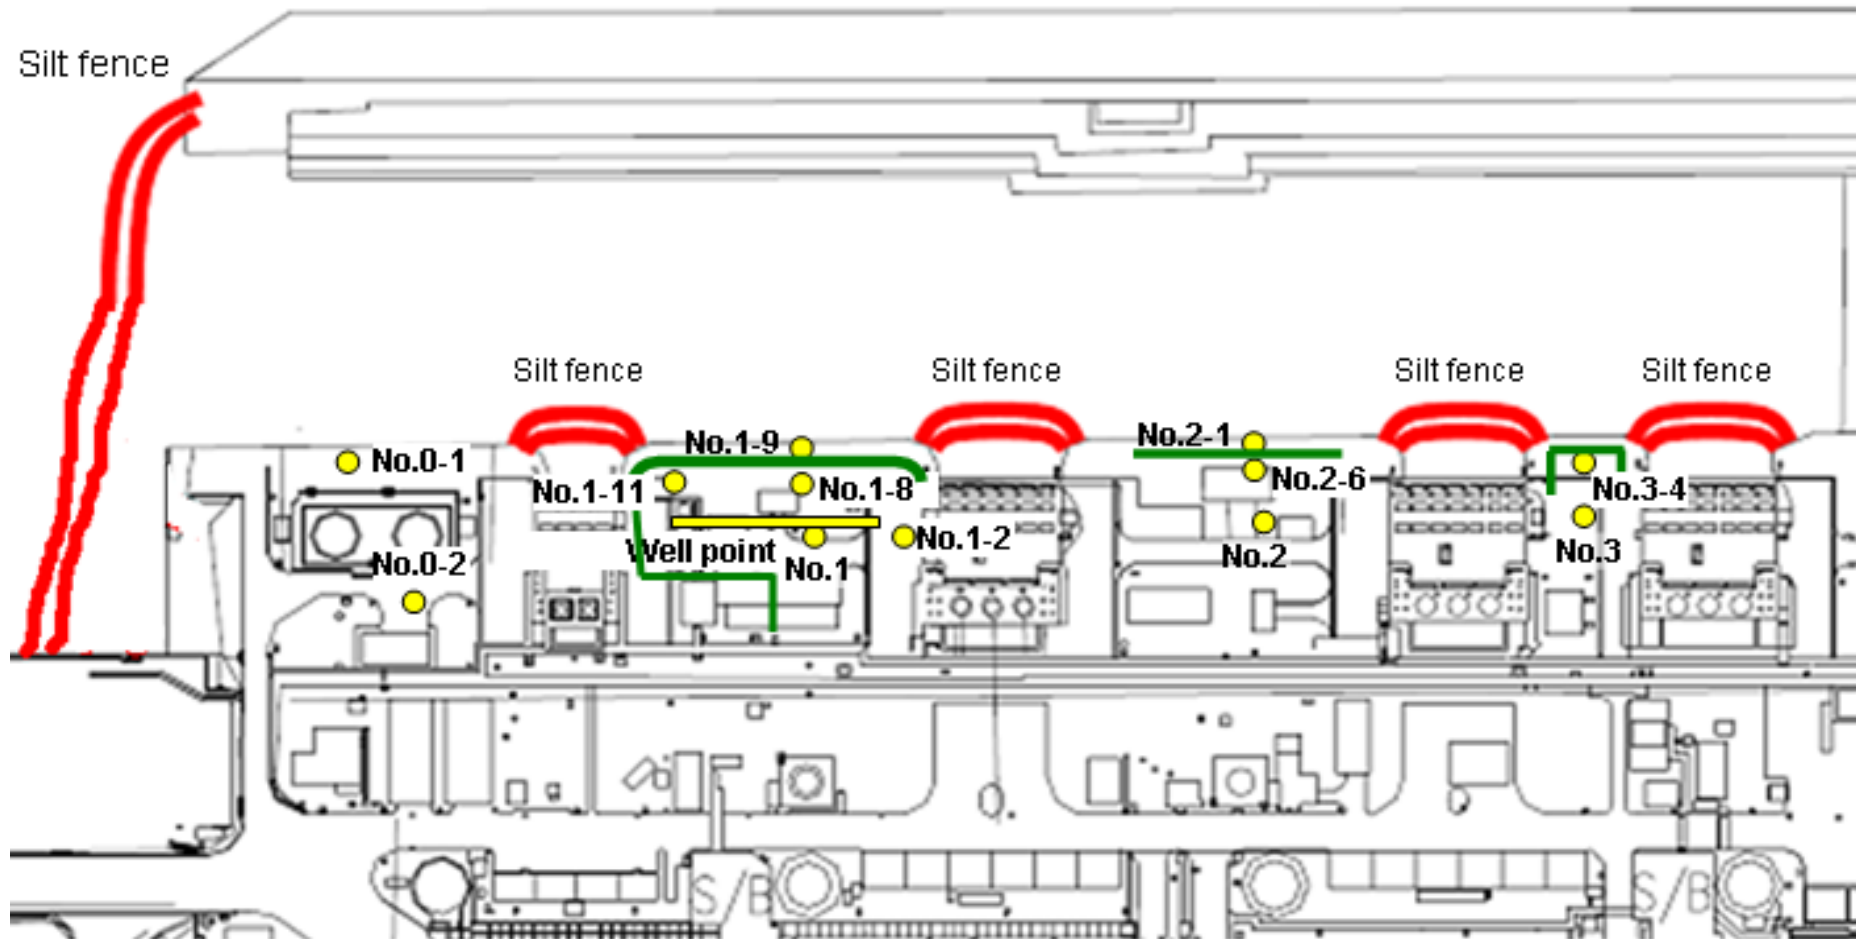
● Sampling locations of underground water obtained at bank protection

East seawall break

— : Location where ground improvement work was completed, or being implemented (as of September 20)

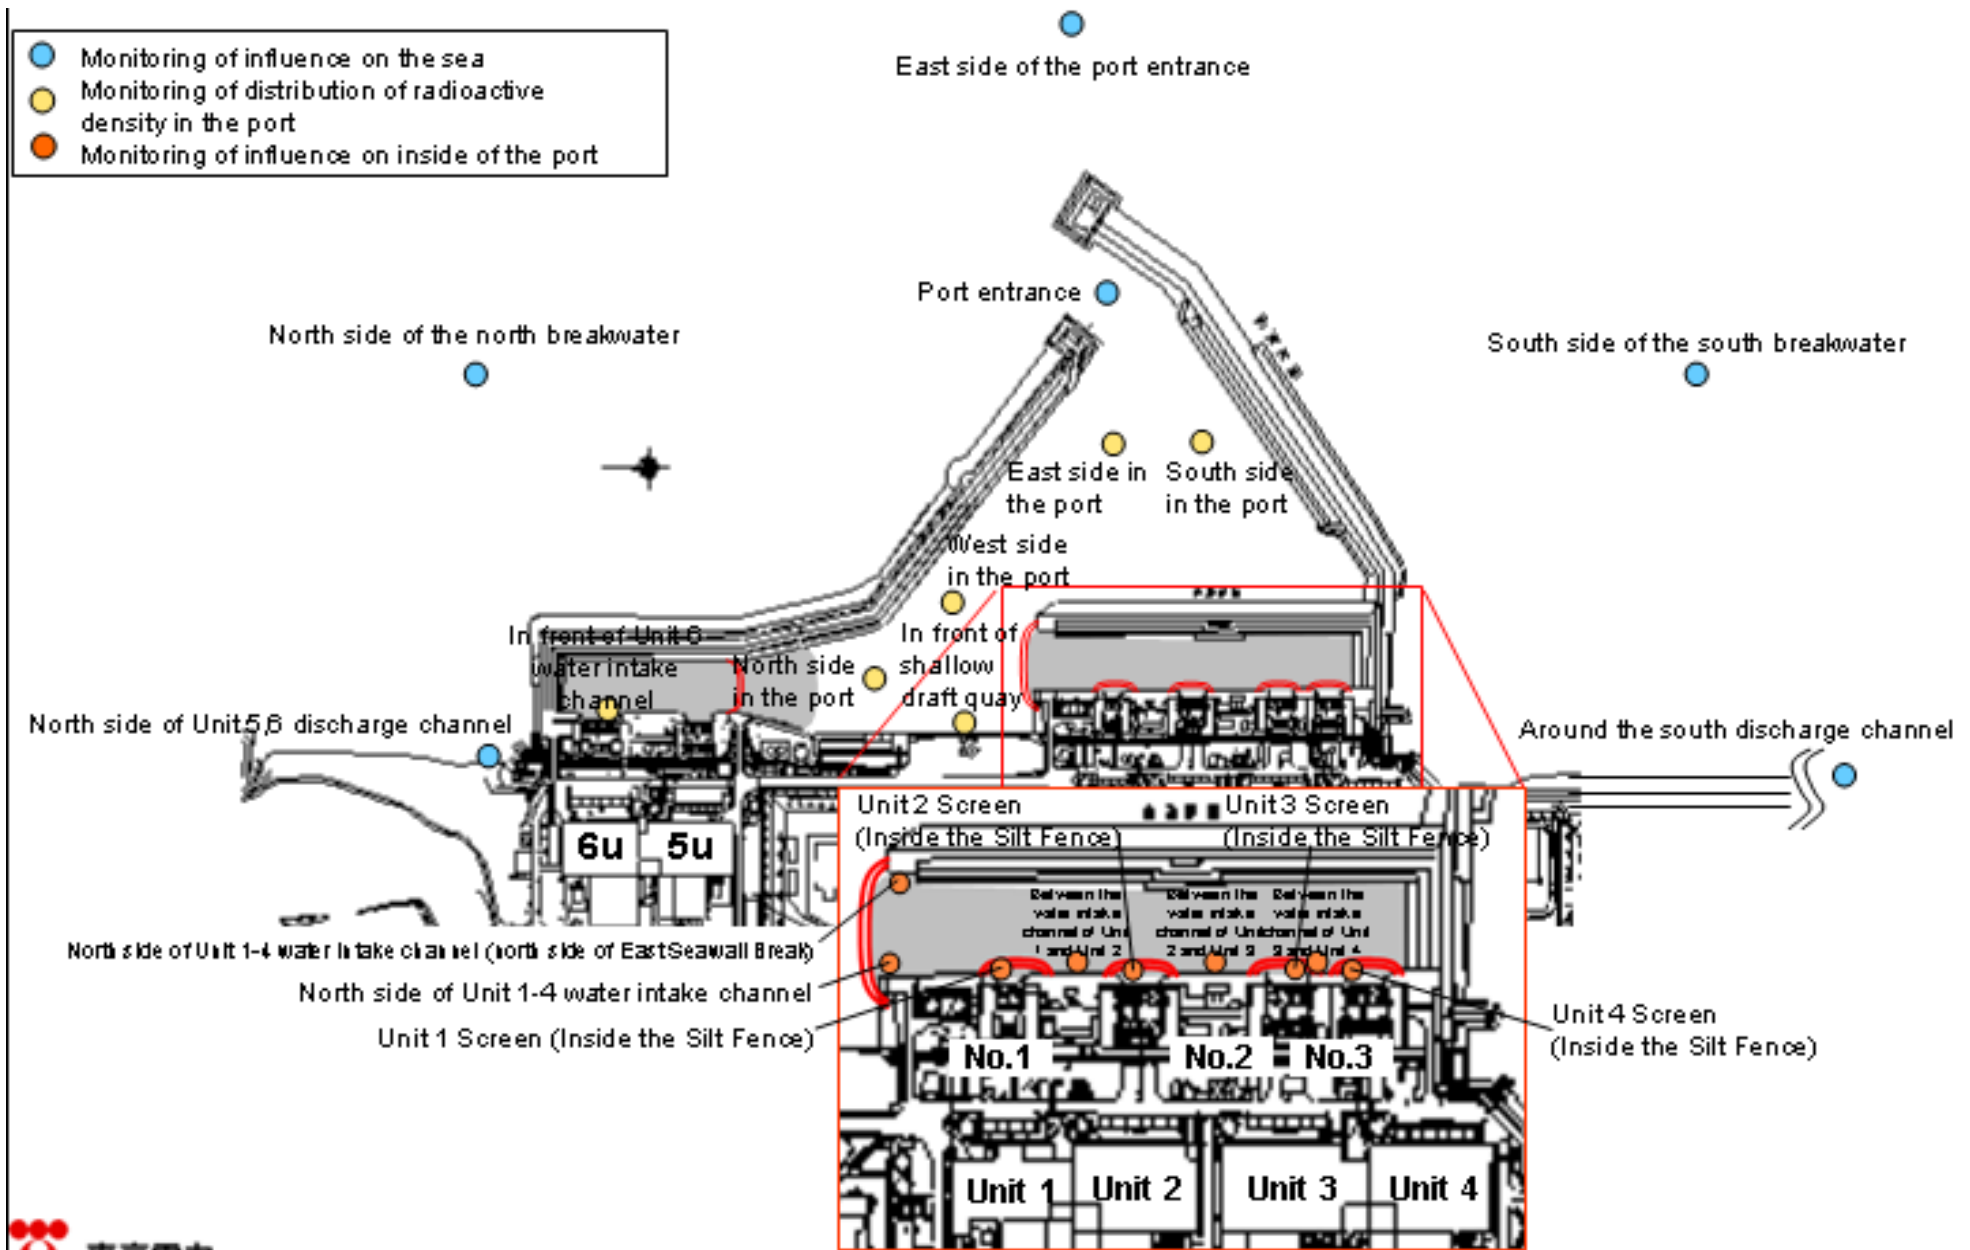
# Detailed Analysis Results in the Port of Fukushima Daiichi NPS, around Discharge Channel and Bank Protection (Sampling Locations of Seawater)
