Detailed Analysis Results in the Port of Fukushima Daiichi NPS, around Discharge Channel and Bank Protection (Sampling Locations of Underground Water Obtained at Bank Protection)

Detailed Analysis Results in the Port of Fukushima Daiichi NPS, around Discharge Channel and Bank Protection (1/4)
Underground Water Obtained at Bank Protection

Detailed Analysis Results in the Port of Fukushima Daiichi NPS, around Discharge Channel and Bank Protection (3/4)
Seawater

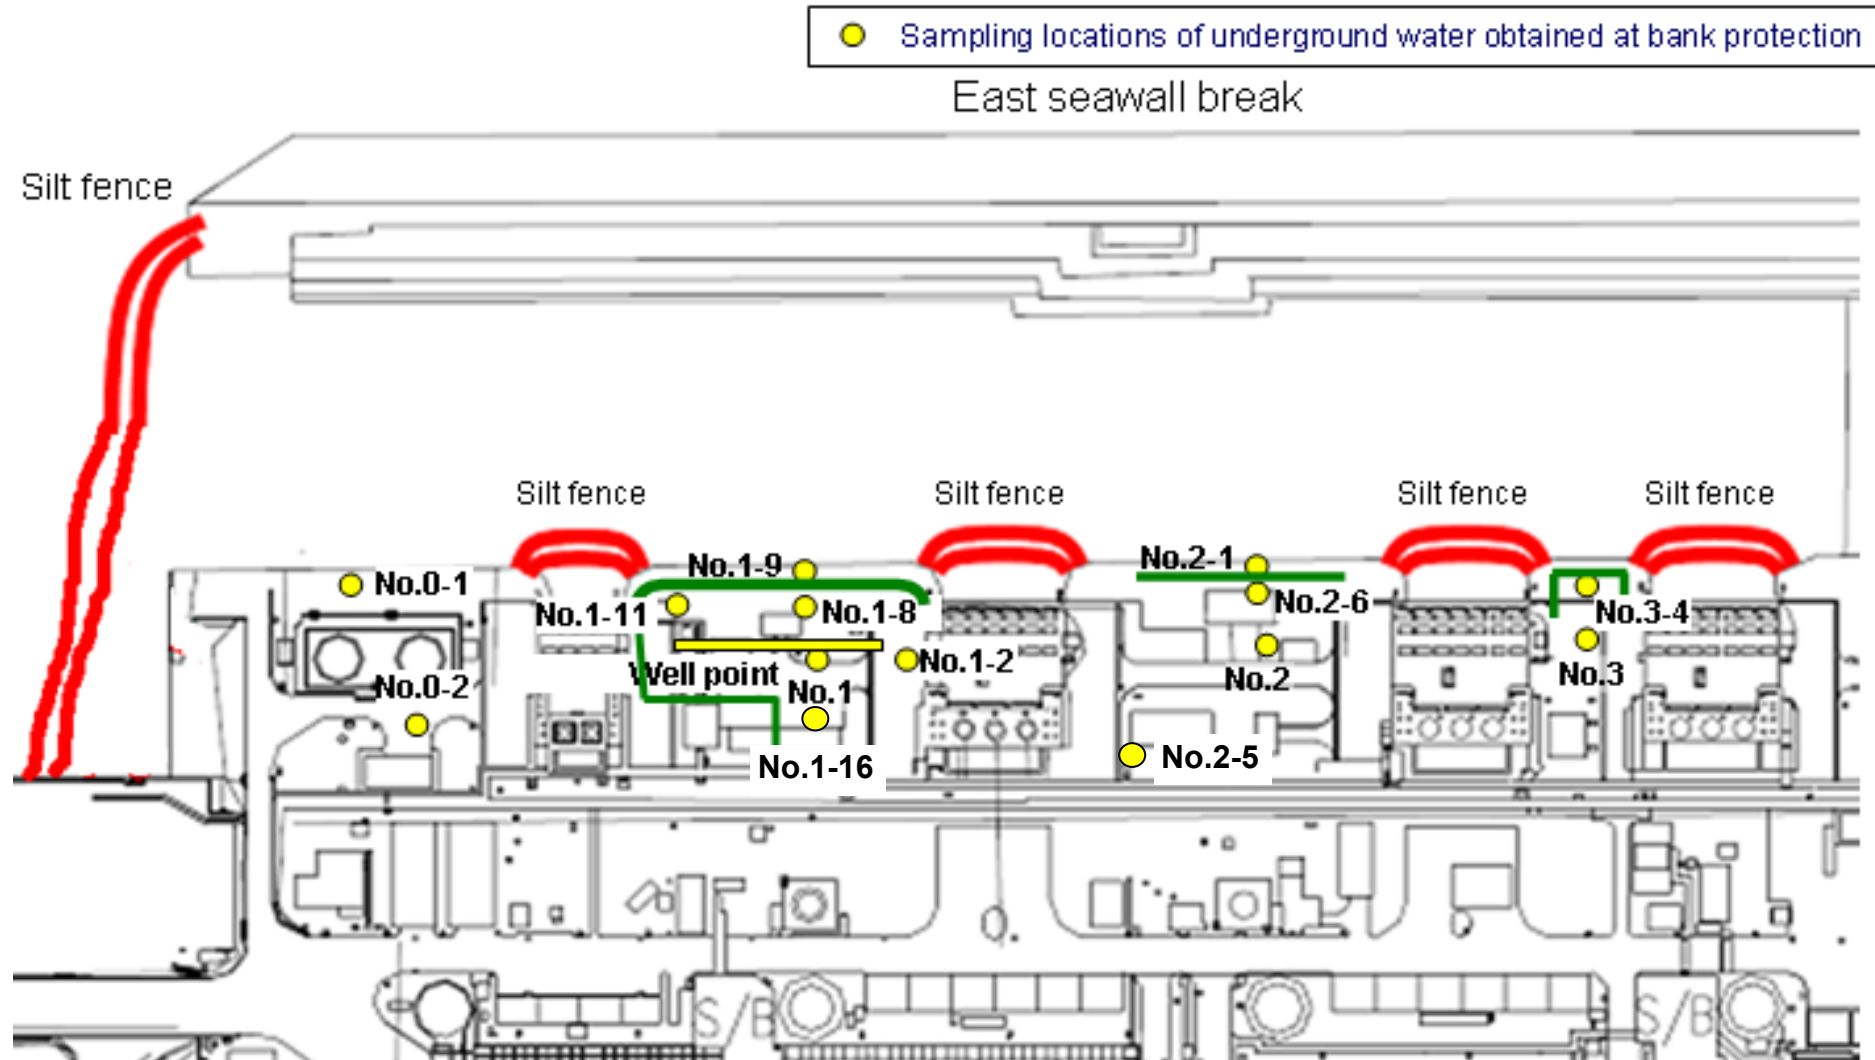
● Sampling locations of underground water obtained at bank protection

— : Location where ground improvement work was completed, or being implemented (as of September 27)

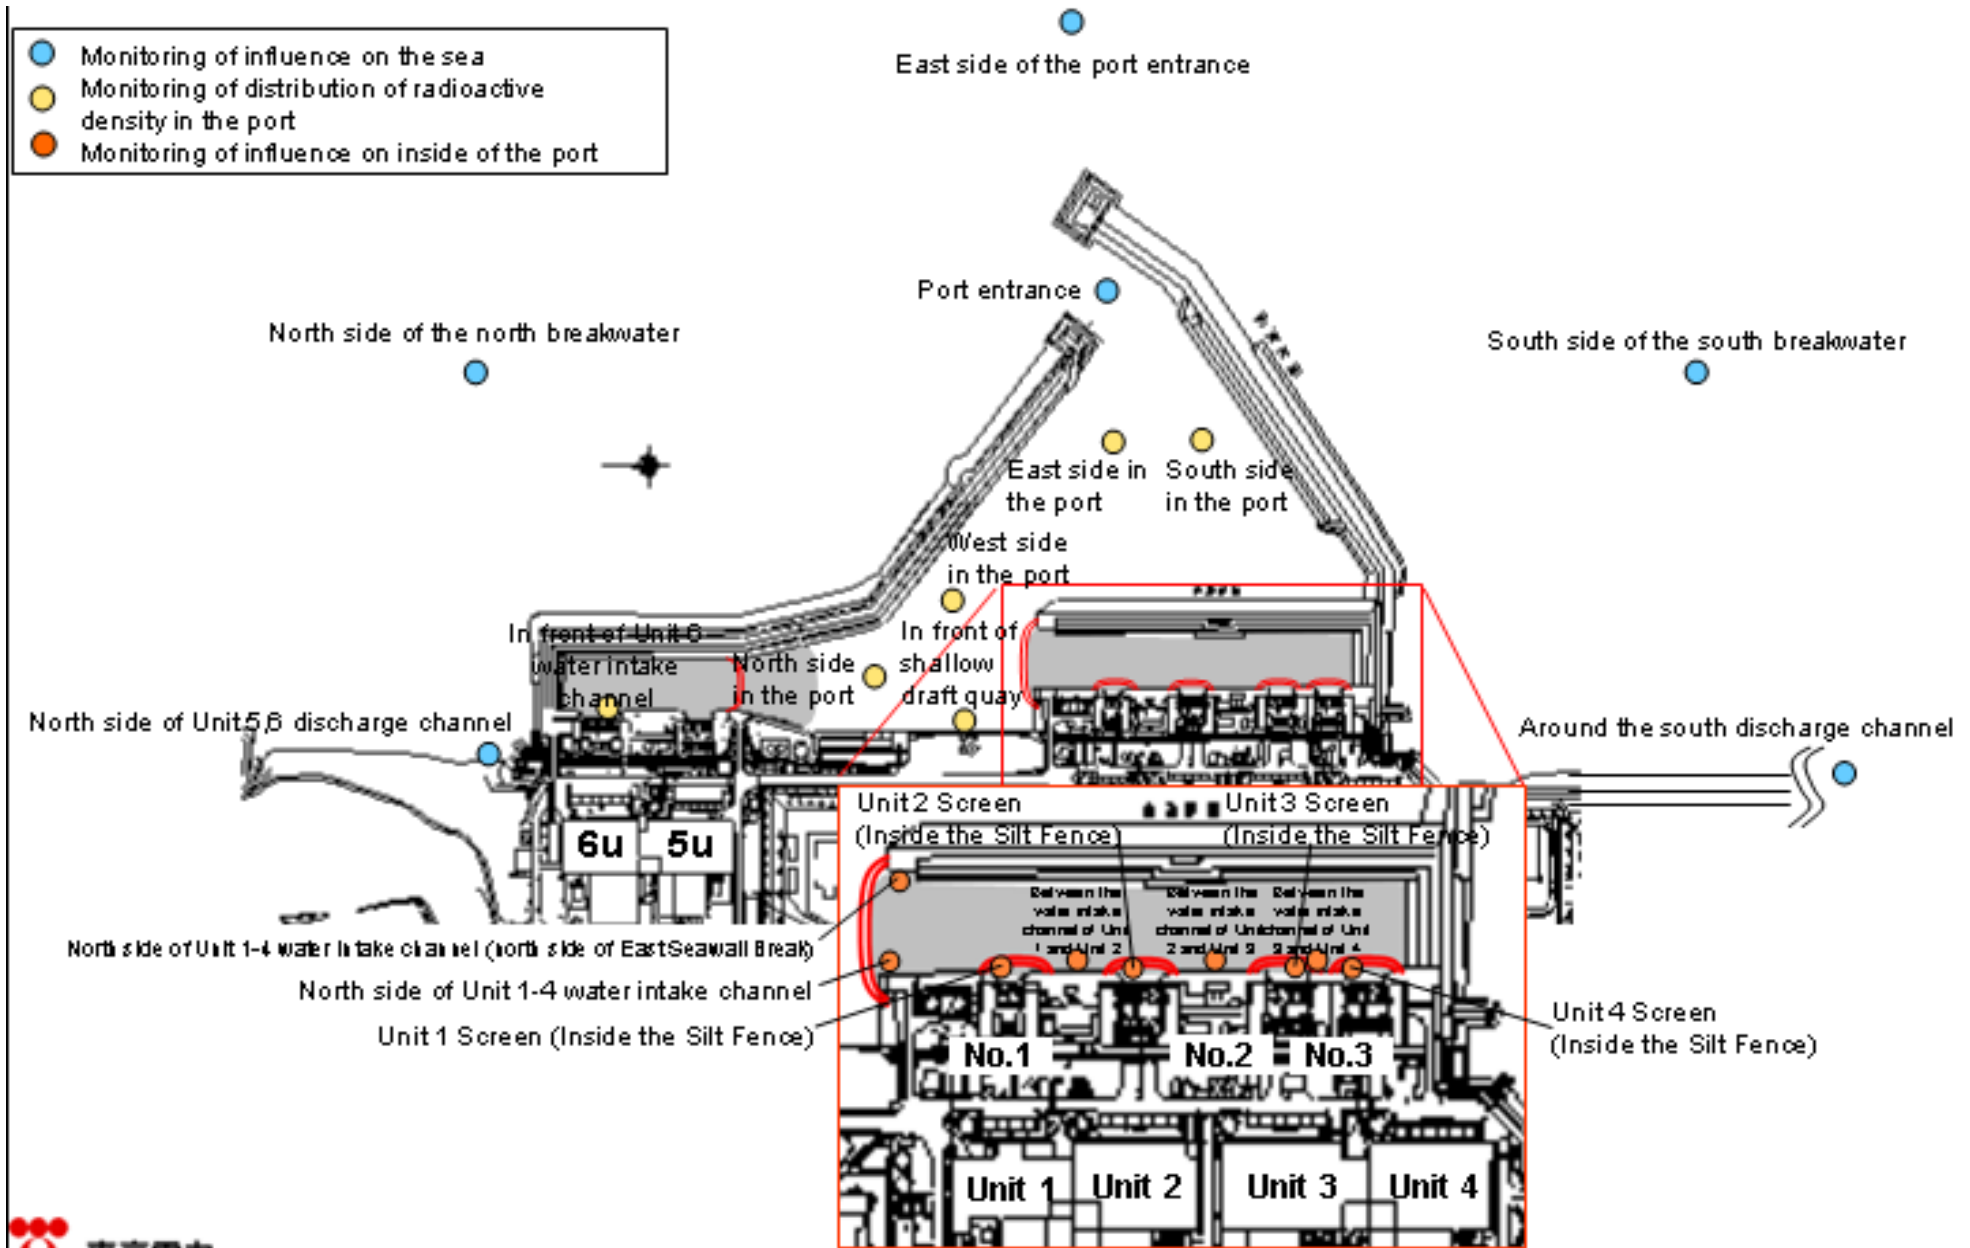
Detailed Analysis Results in the Port of Fukushima Daiichi NPS, around Discharge Channel and Bank Protection (Sampling Locations of Seawater)
