### Detailed Analysis Results in the Port of Fukushima Daiichi NPS, around Discharge Channel and Bank Protection (Sampling Locations of Underground Water Obtained at Bank Protection)

## Detailed Analysis Results in the Port of Fukushima Daiichi NPS, around Discharge Channel and Bank Protection (1/4) Underground Water Obtained at Bank Protection

# Detailed Analysis Results in the Port of Fukushima Daiichi NPS, around Discharge Channel and Bank Protection (Sampling Locations of Seawater)

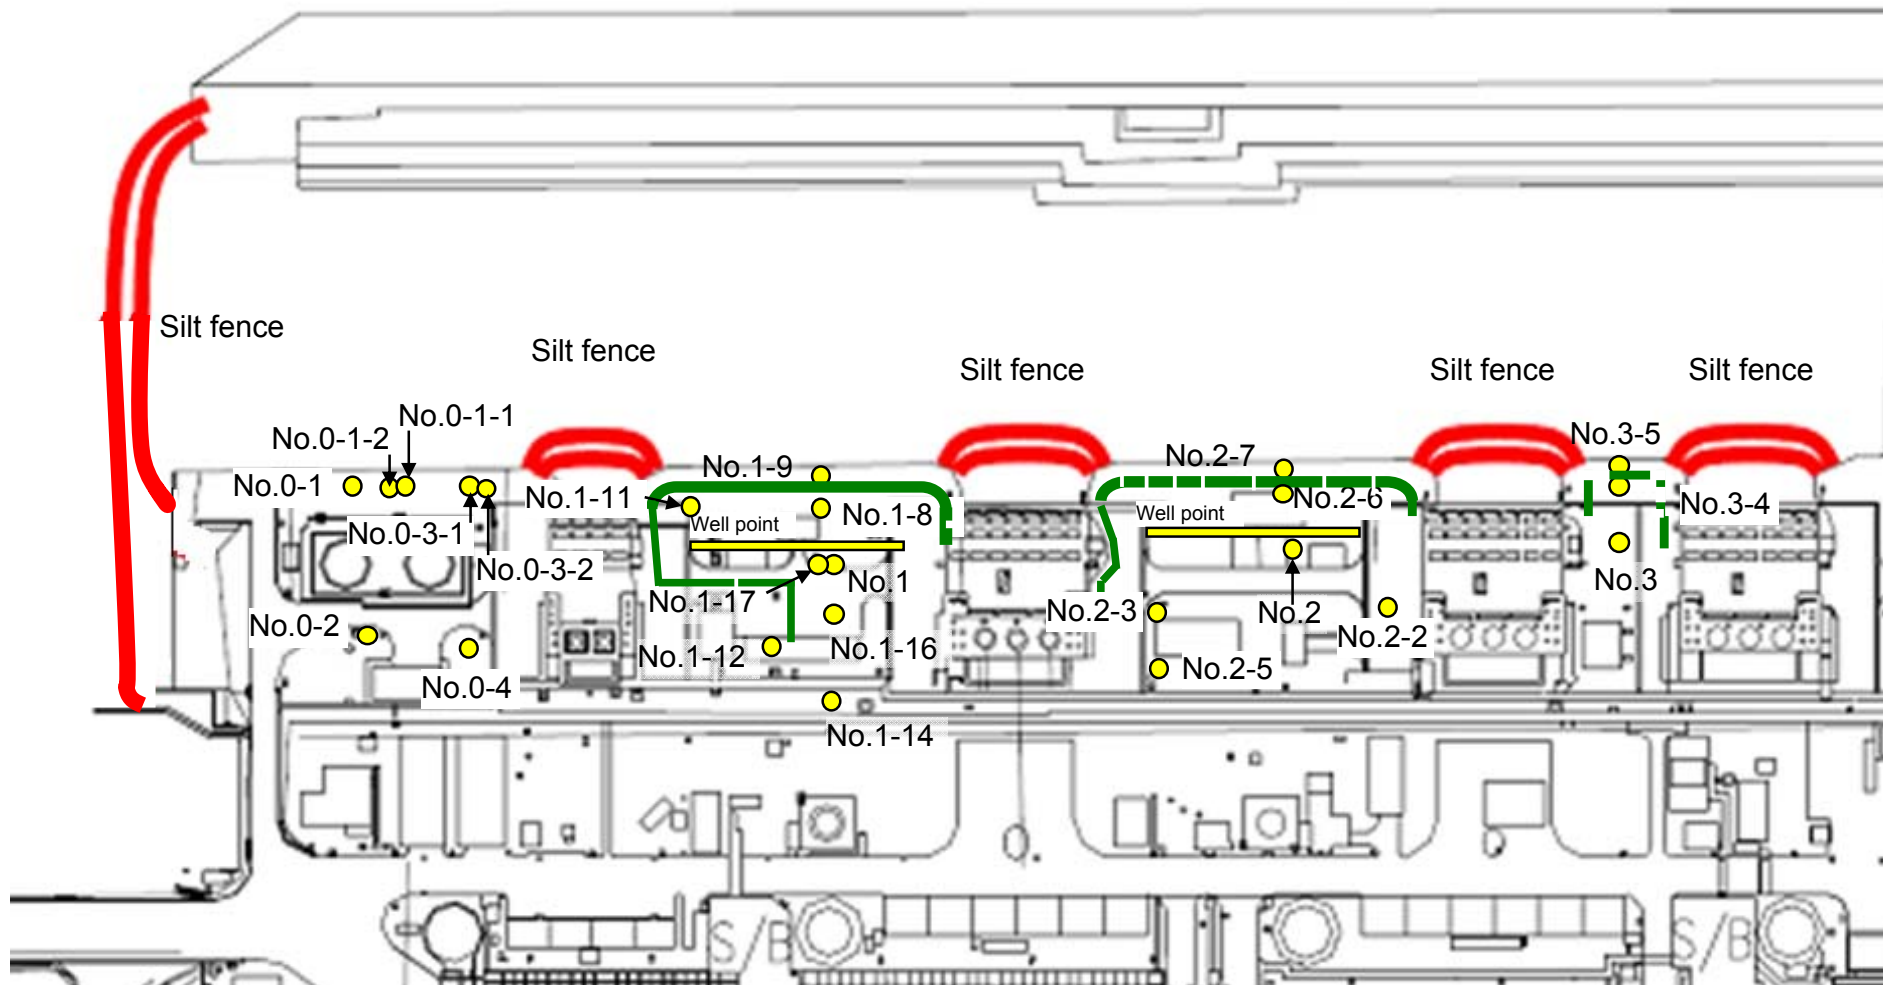
● Sampling locations of underground water obtained at bank

East seawall break

— : Location where ground improvement construction was completed, or being implemented (as of December 27)
