Radioactivity Density of the Seawater in the Port of Fukushima Daiichi NPS < 1/2 >

Radioactivity Density of the Seawater in the Port of Fukushima Daiichi NPS < 2/2 >

Result of Pu Nuclide Analysis of Seawater at Fukushima Daiichi Nuclear Power Station <1/2>

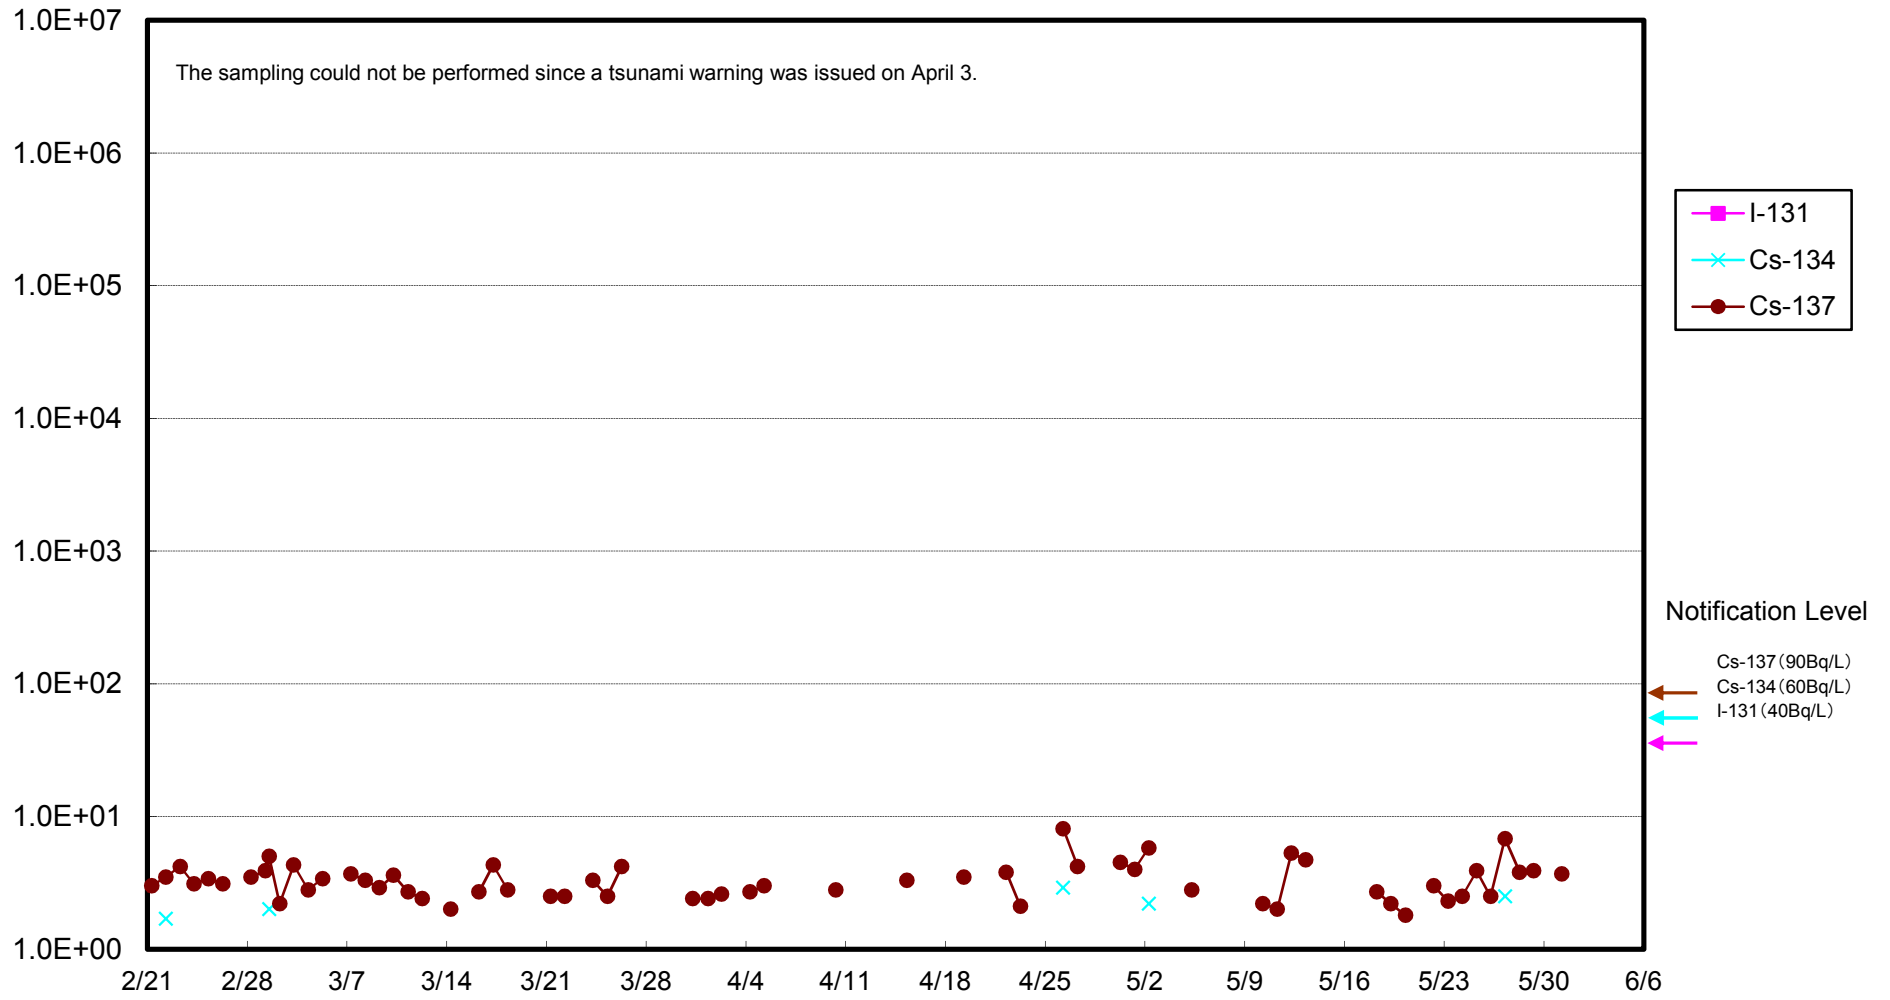
Radioactivity Density of the Seawater in Front of the Shallow Draft Quay at 1F (Bq/L)

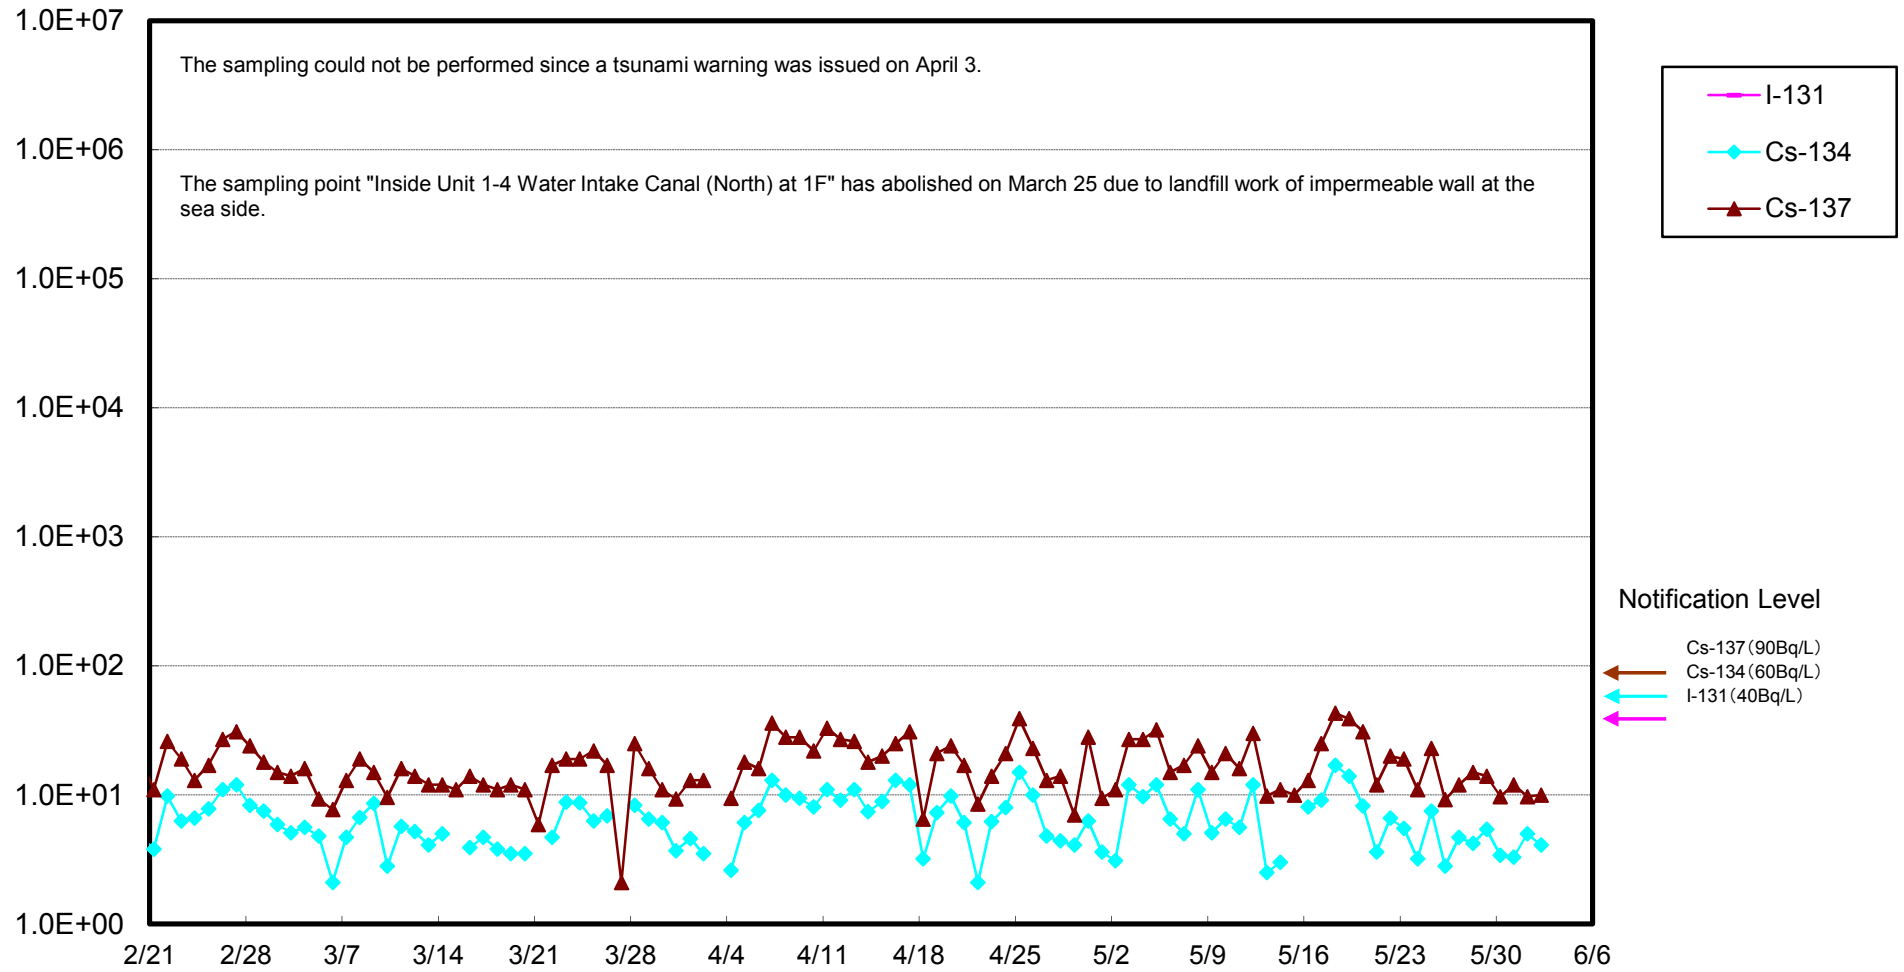
Radioactivity Density of the Seawater at the North of Unit 1-4 Water Intake (North of East Seawater Break of Fukushima Daiichi NPS (Bq/ L)

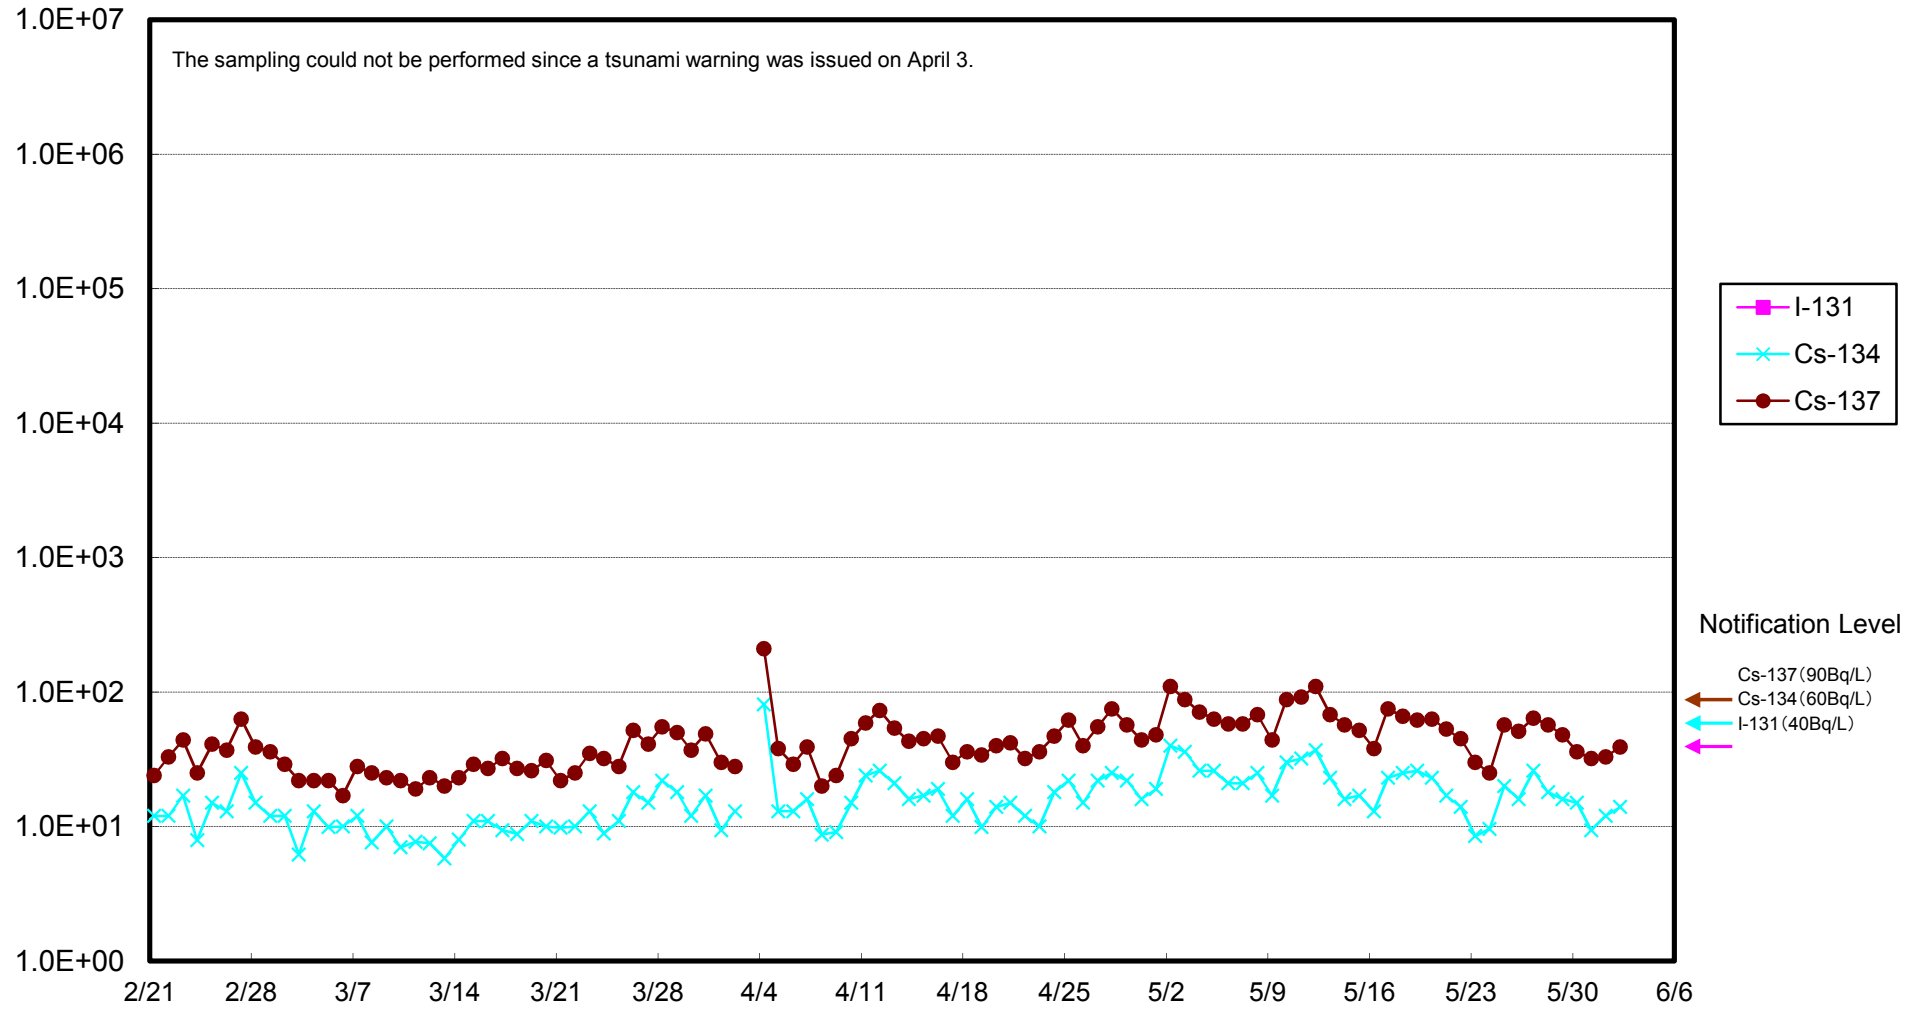
Radioactivity Density of the Seawater at Unit 4 Screen at 1F (Outside the Silt Fence) (Bq/L)

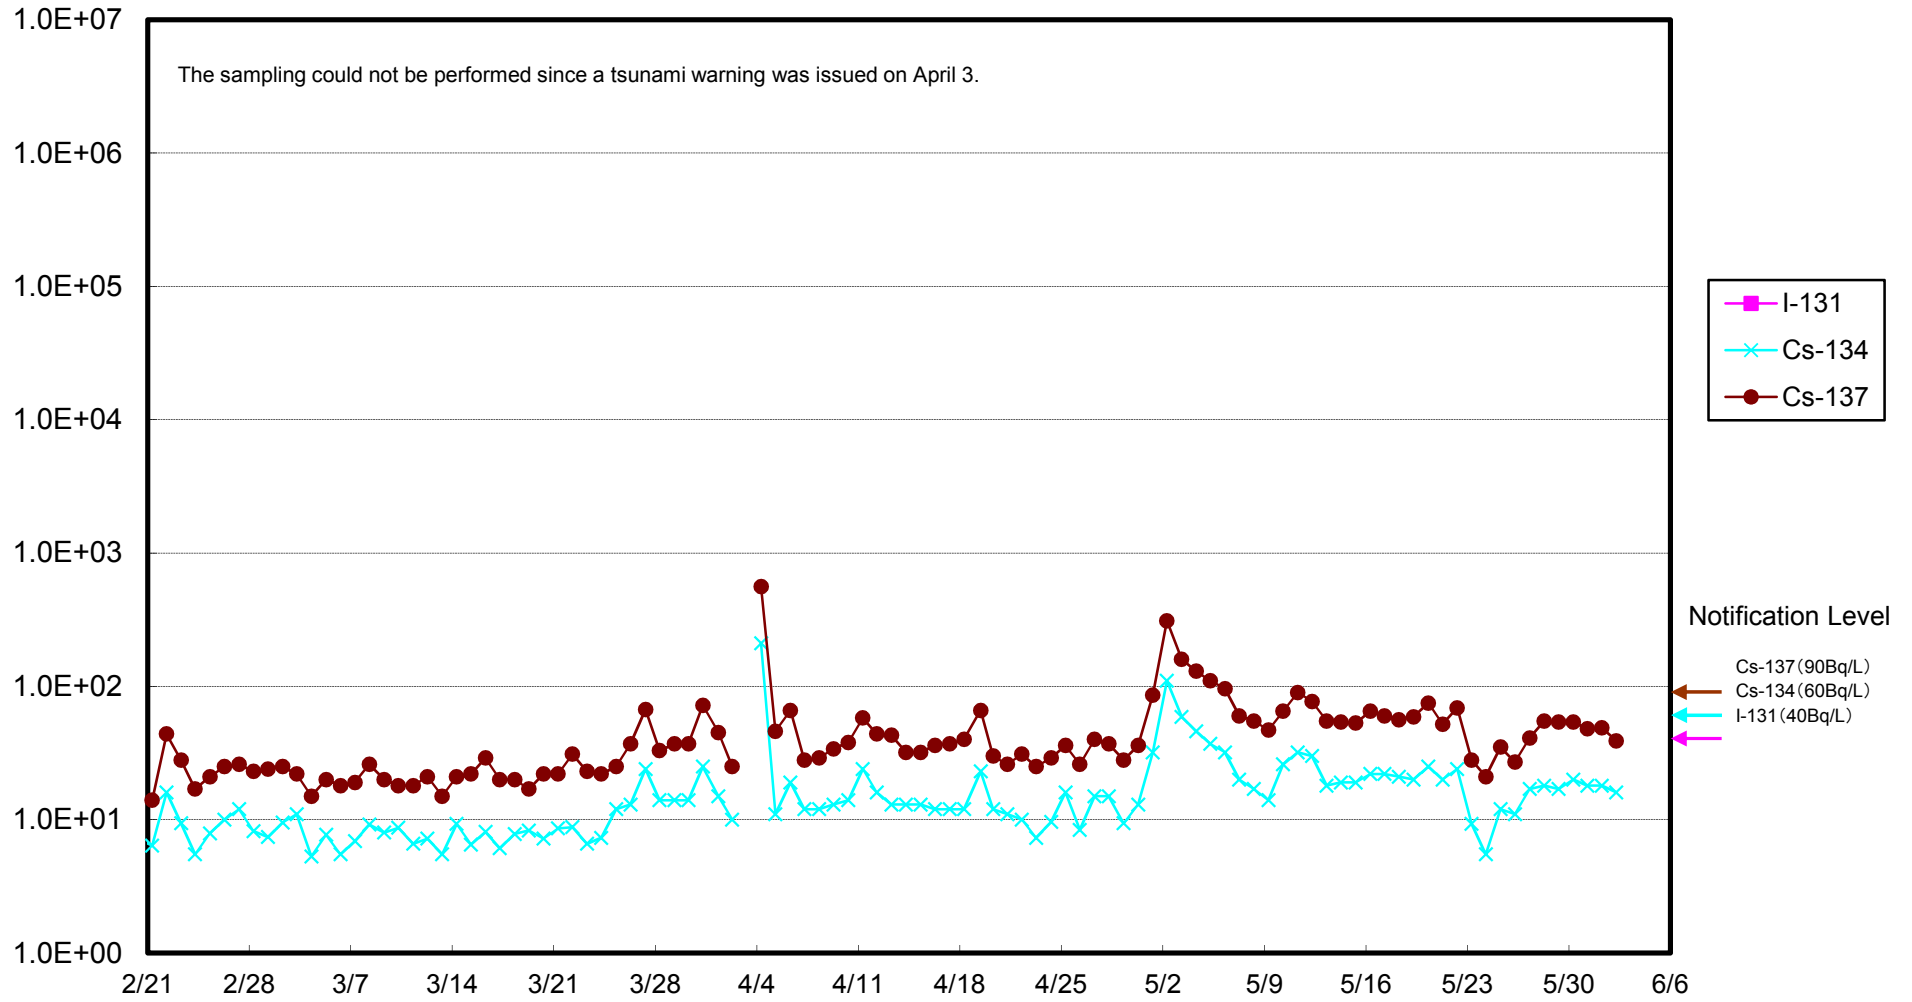
Radioactivity Density of the Seawater at Unit 4 Screen at 1F (Inside the Silt Fence) (Bq/L)

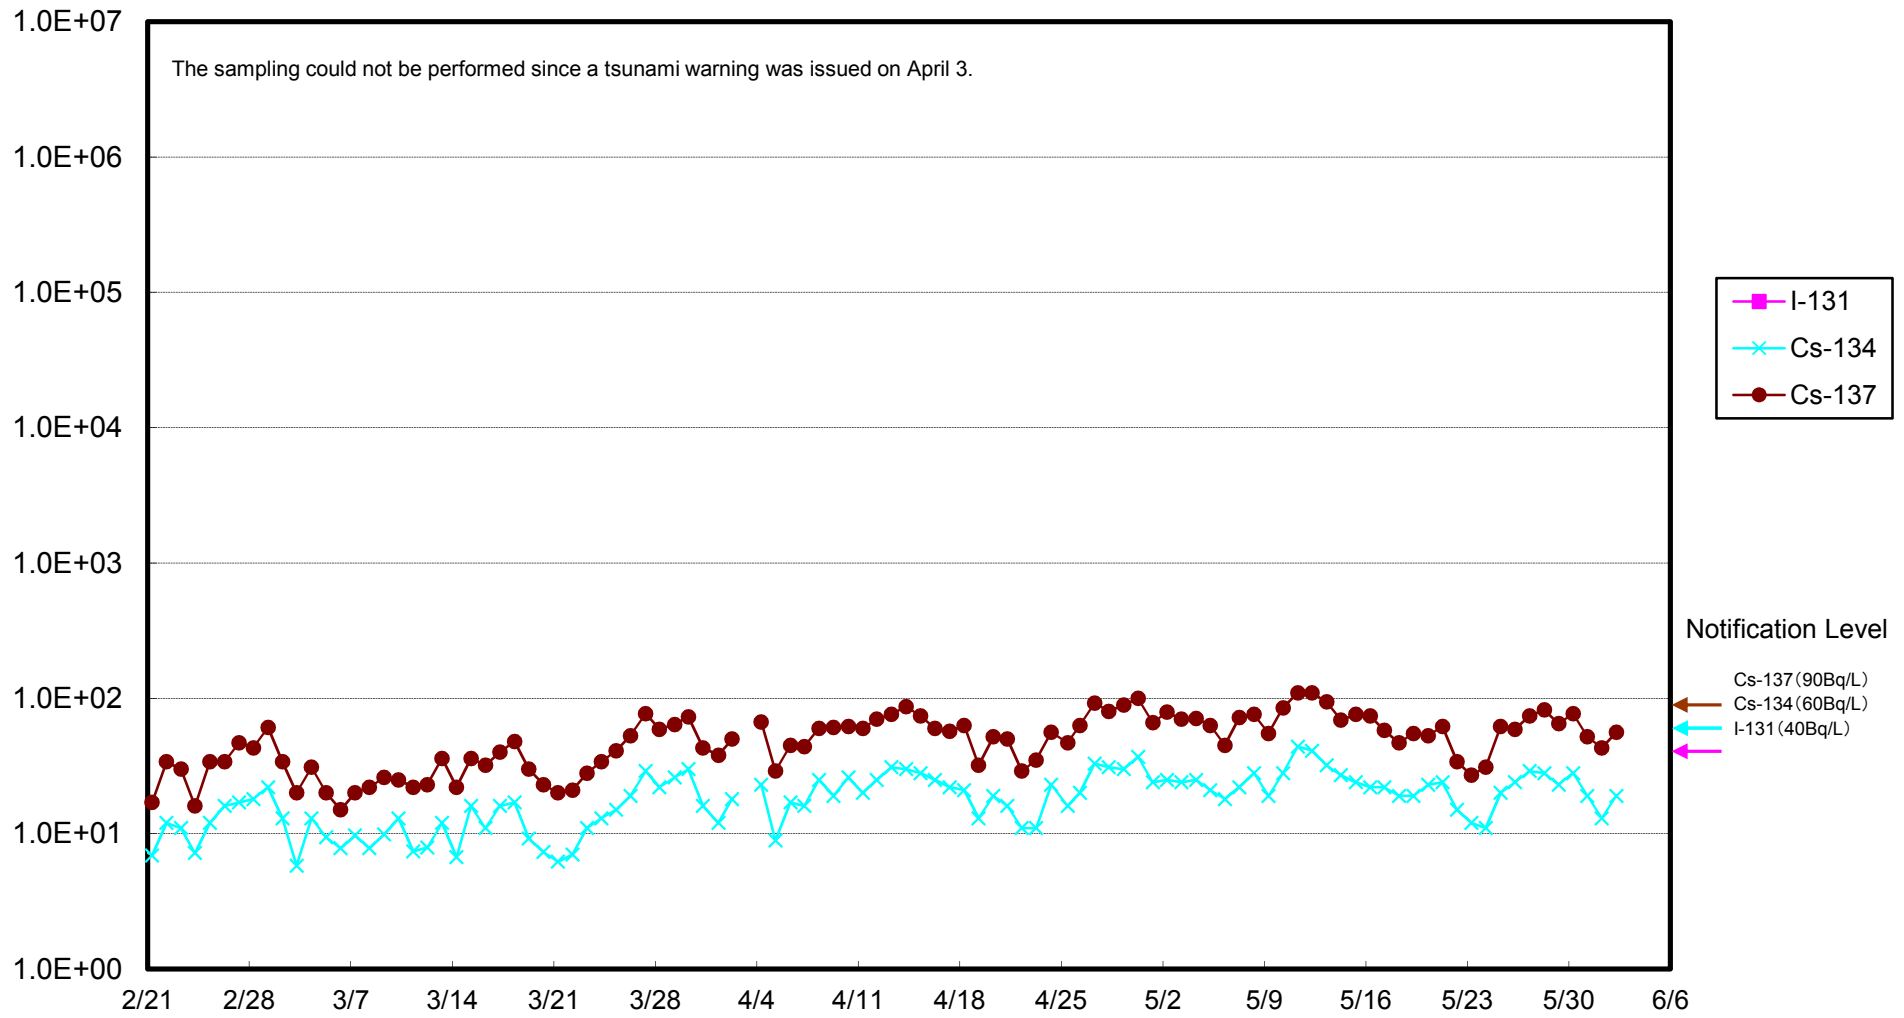
Radioactivity Density of the Seawater at the South of Unit 1-4 Water Intake of Fukushima Daiichi NPS (Bq/L)

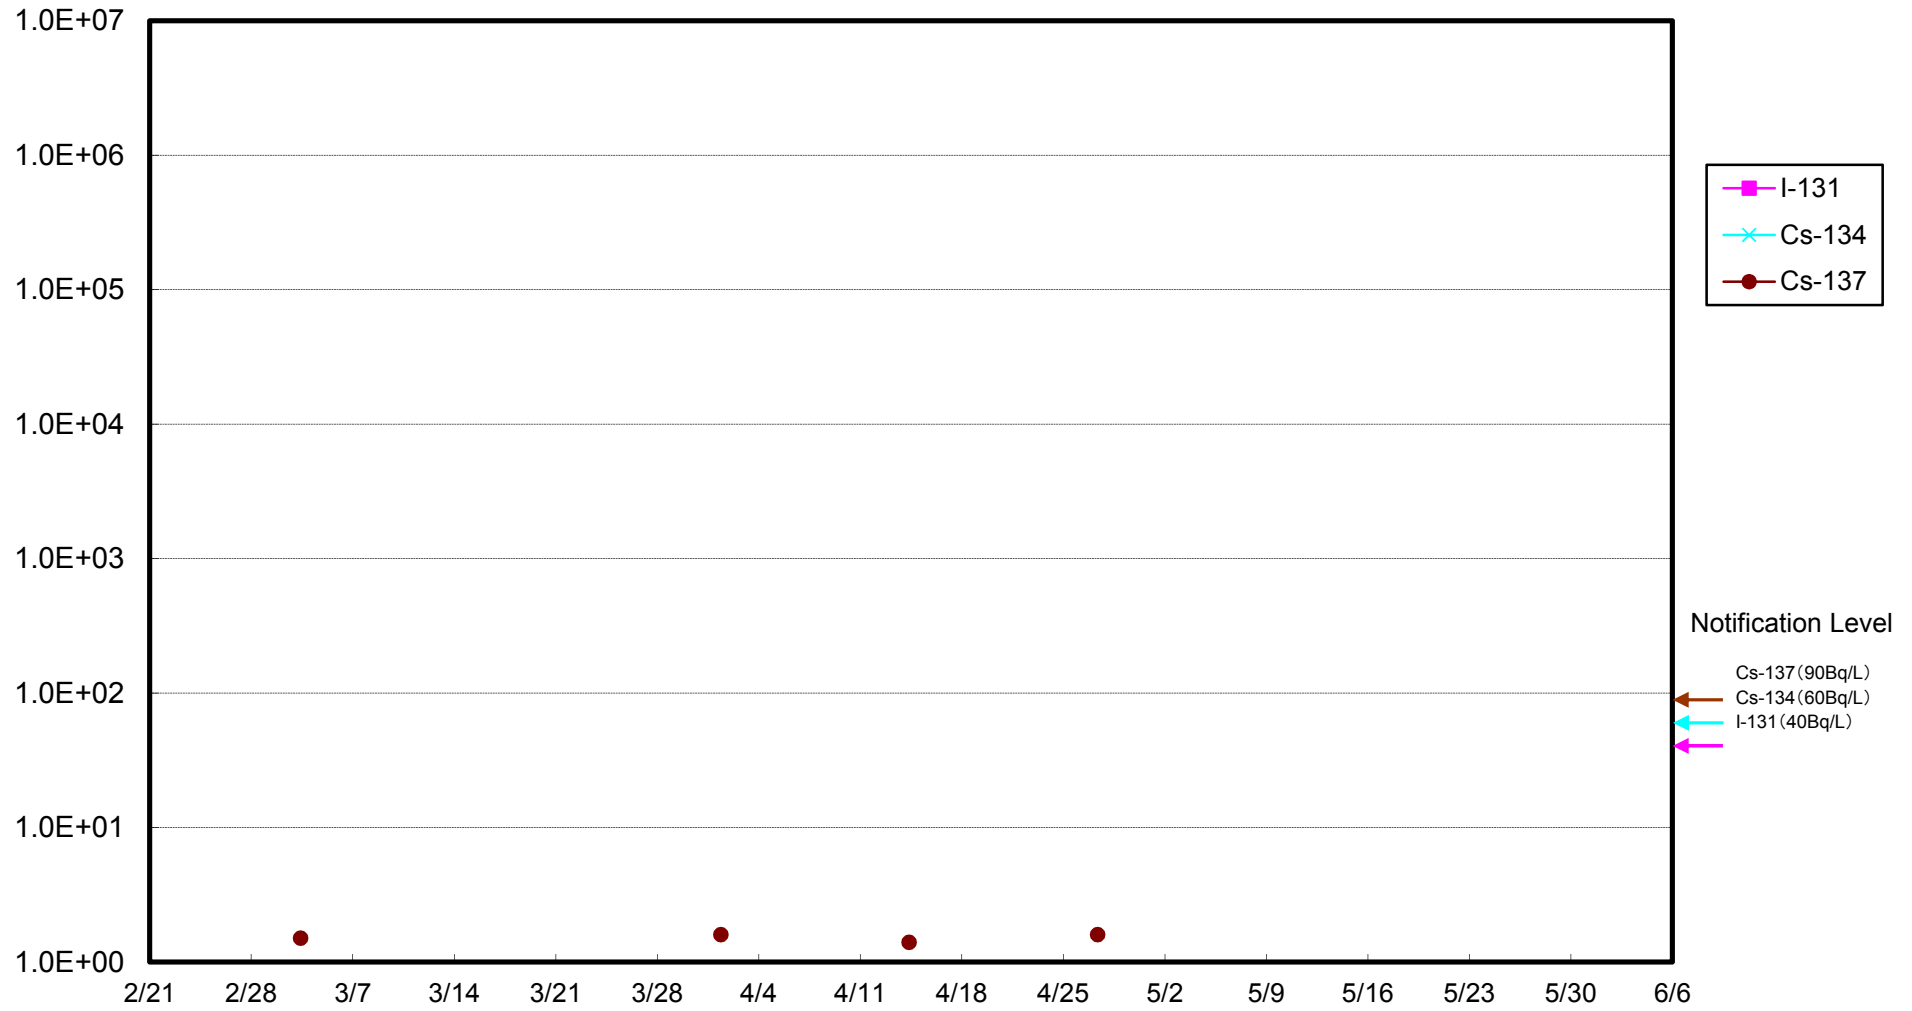
Radioactivity Density of the Seawater at the Port Entrance of Fukushima Daiichi NPS (Bq/L)

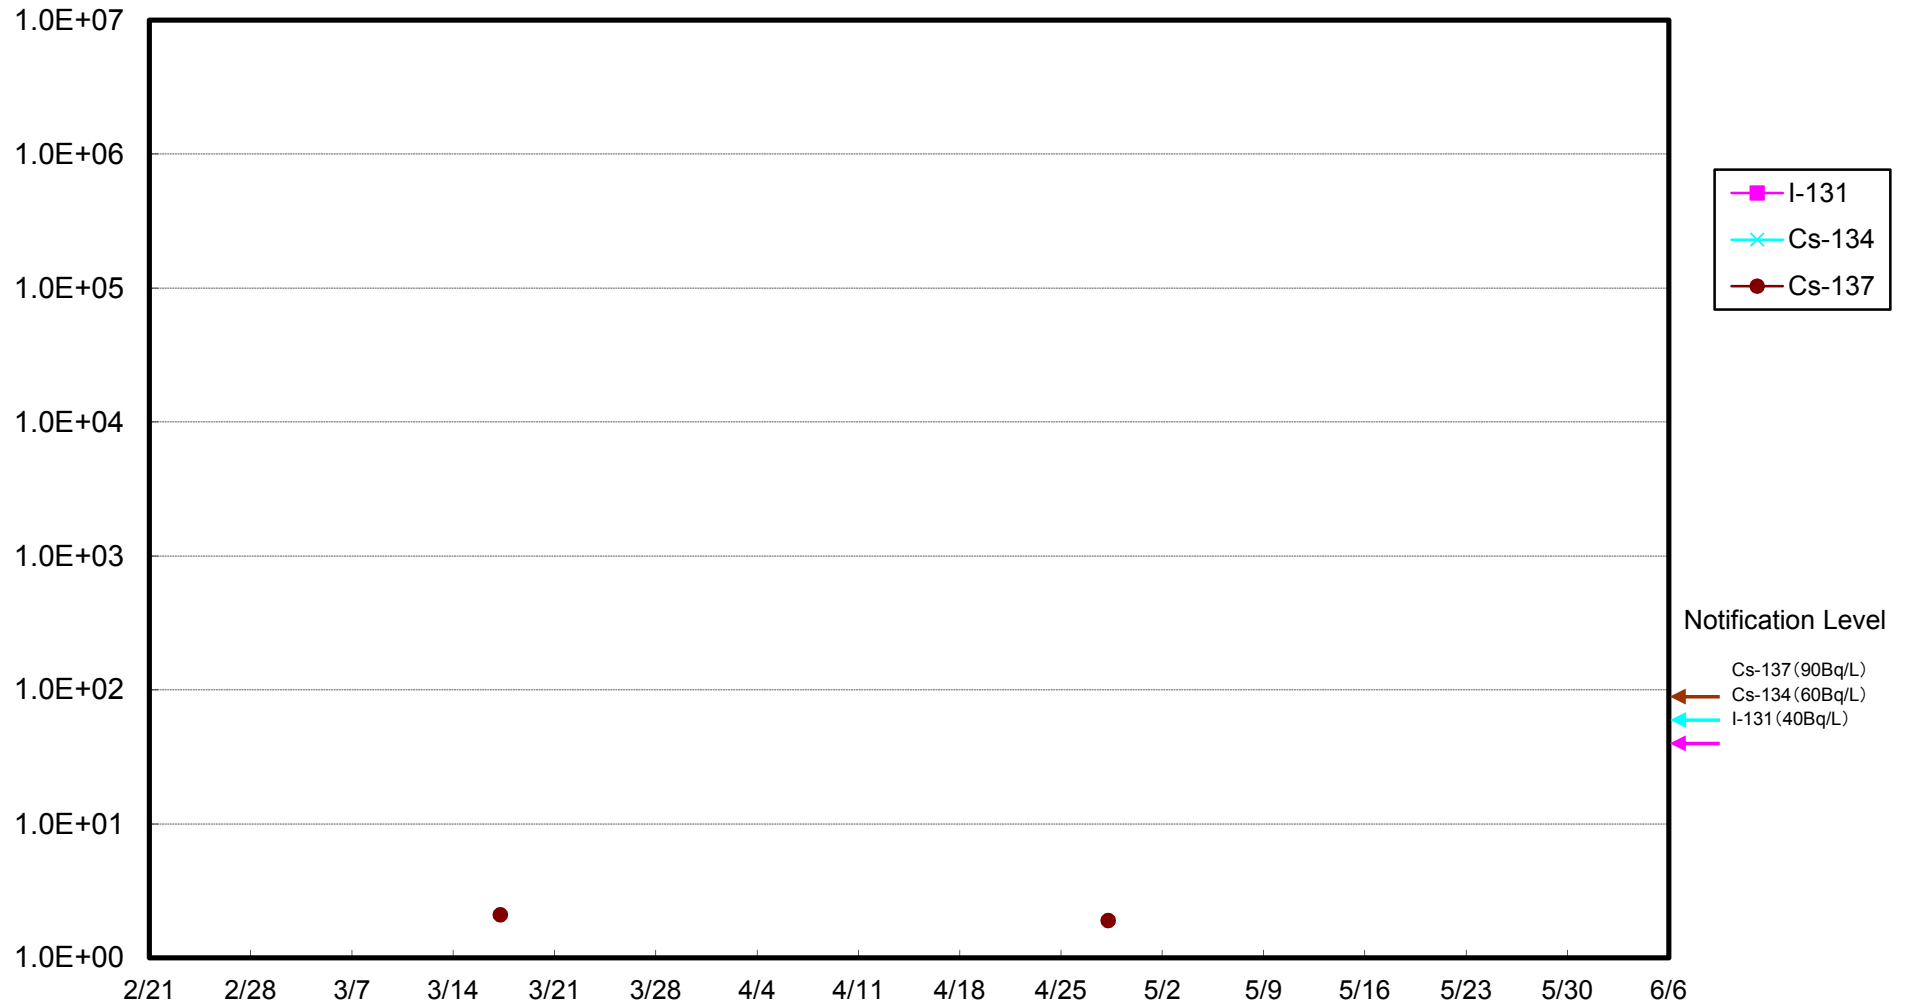
Radioactive Density of the Seawater in Front of Unit 6 Water Intake at Fukushima Daiichi NPS (Bq/L)
