Note 1: Approx. 330m south from Unit 1-4 water outlet (T-2)

## <Reference> The Highest Dose Until the Previous Measurement

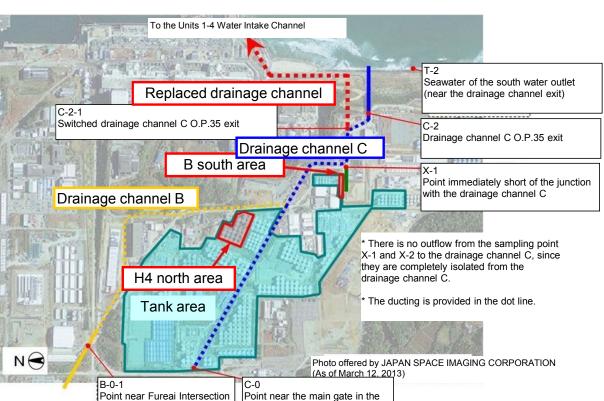
Note 2: Water inflow location of drainage channel to the tank area

drainage channel C

in the drainage channel B
