Dead Mice Found in the Outdoor Transformer Box for Unit 2 Spent Fuel Pool Alternative Cooling System at Fukushima Daiichi Nuclear Power Station

April 22, 2013
Tokyo Electric Power Company

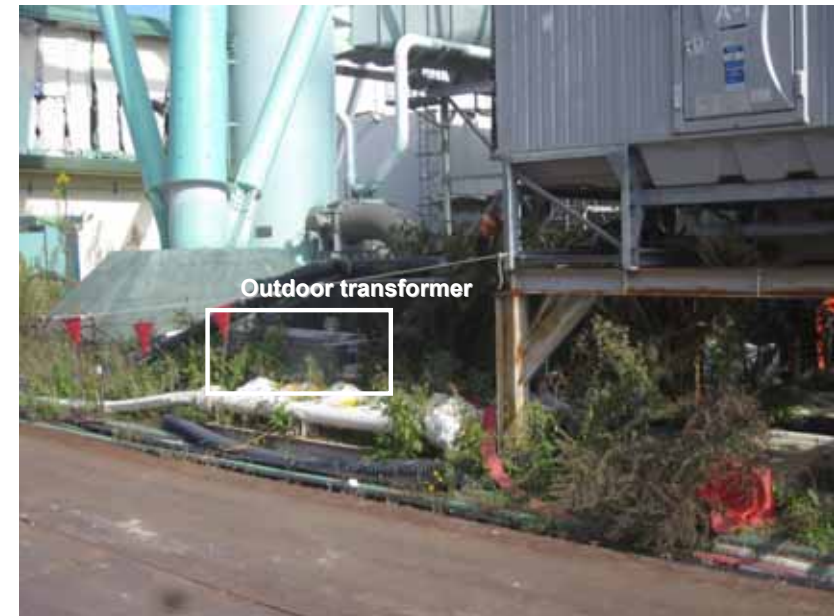
Photo 1: Outdoor transformer for Unit 2 spent fuel pool alternative cooling system at Fukushima Daiichi Nuclear Power Station

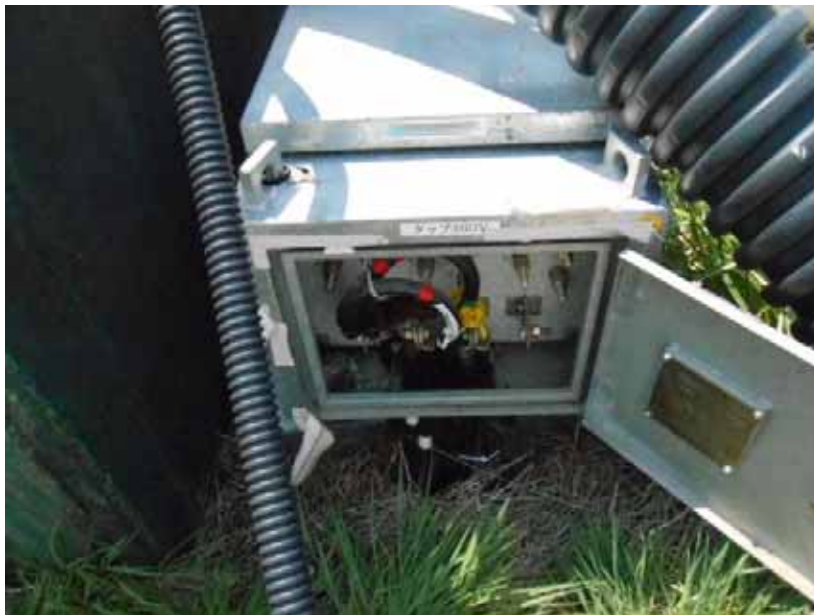
Photo 2: Outdoor transformer (Appearance)

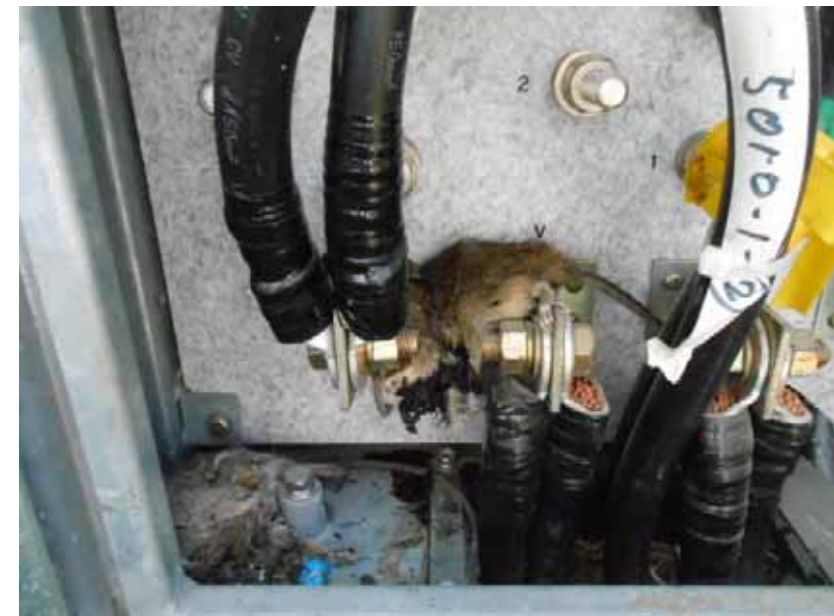
During the patrol performed by the Electrical Equipment Countermeasure Team of the Emergency Response Headquarters for Reliability Improvement at Fukushima Daiichi Nuclear Power Station, dead mice (two of them) were found in the outdoor transformer box for Unit 2 spent fuel pool alternative cooling (no facility/equipment was suspended due to the incident). In order to remove the dead mouse and perform an inspection of the transformer, Unit 2 spent fuel pool alternative cooling system primary system was suspended at 11:36 AM.

Photo 3: Outdoor transformer (Inside)
