Work Performed Today (April 25) in Response to the Leakage from the Underground Reservoirs

<Reference>
April 25, 2013
Tokyo Electric Power Company

Measures to Prevent the Expansion of Contaminated Water Leakage from the Underground Reservoirs

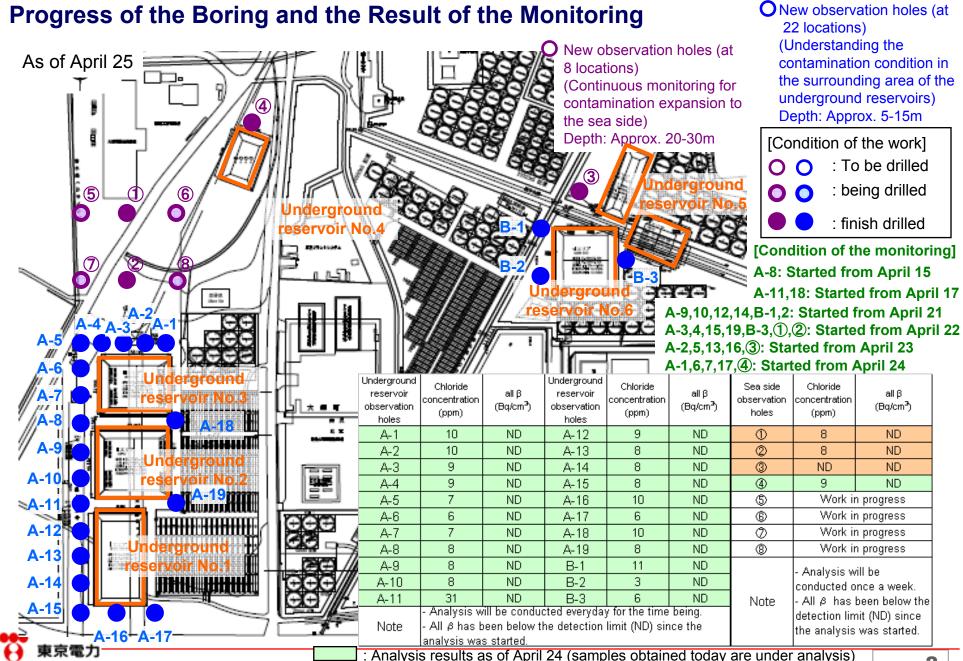
Monitoring of the Impact of the Leakage on the Surrounding Environment:

: Analysis results as of April 22 and 23
