Outline of Leakage from Waterpipes of Outlet of Temporary RHR Pump at Unit 5, Fukushima Daiichi Nuclear Power Station

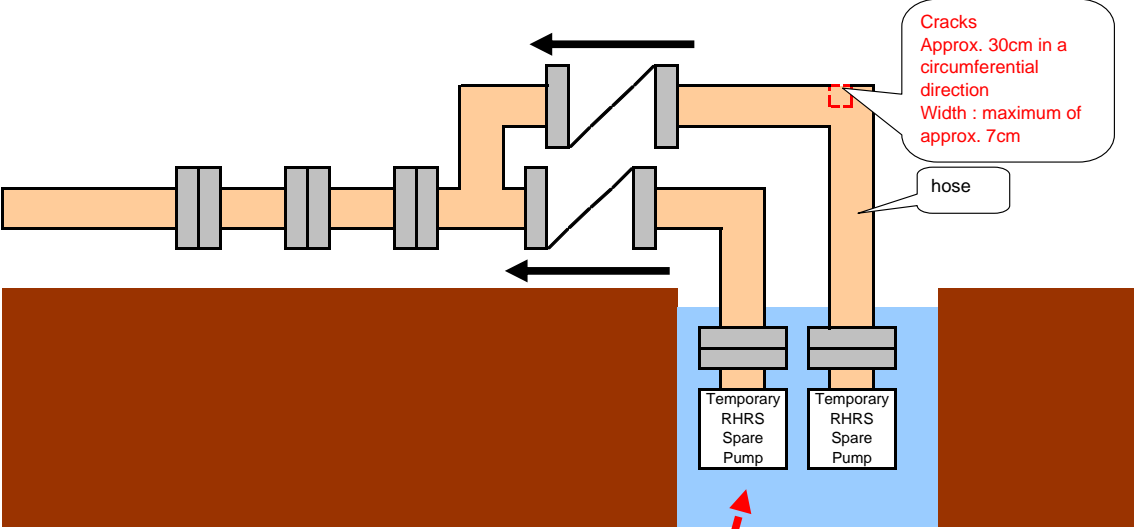
Layout Temporary RHR Pumps at Unit 5
