Debris Removal from the Upper Part of Unit 3 Reactor Building at Fukushima Daiichi Nuclear Power Station [Removal of the Debris Under Water]

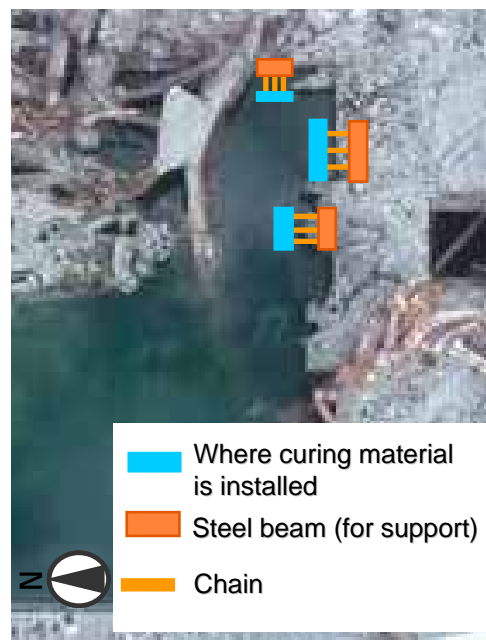
Area where curing material is installed

In order to improve the visibility of Unit 3 spent fuel pool, the cooling pump has been suspended since November 6, 2012. As a result of visibility evaluation, the visible distance* remained to be approx. 2.5m. In prior to removing the steel beam which fell into the spent fuel pool on September 22, 2012, liner curing of the pool will be implemented in mid November once the preparation is complete. The underwater debris removal is planned to be carried out in late November to early December after a mockup test based on the visibility evaluation result.
