West Gate of Fukushima Daiichi Nuclear Power Station  
Results of Dust Nuclide Analysis (Bq/cm<sup>3</sup>)

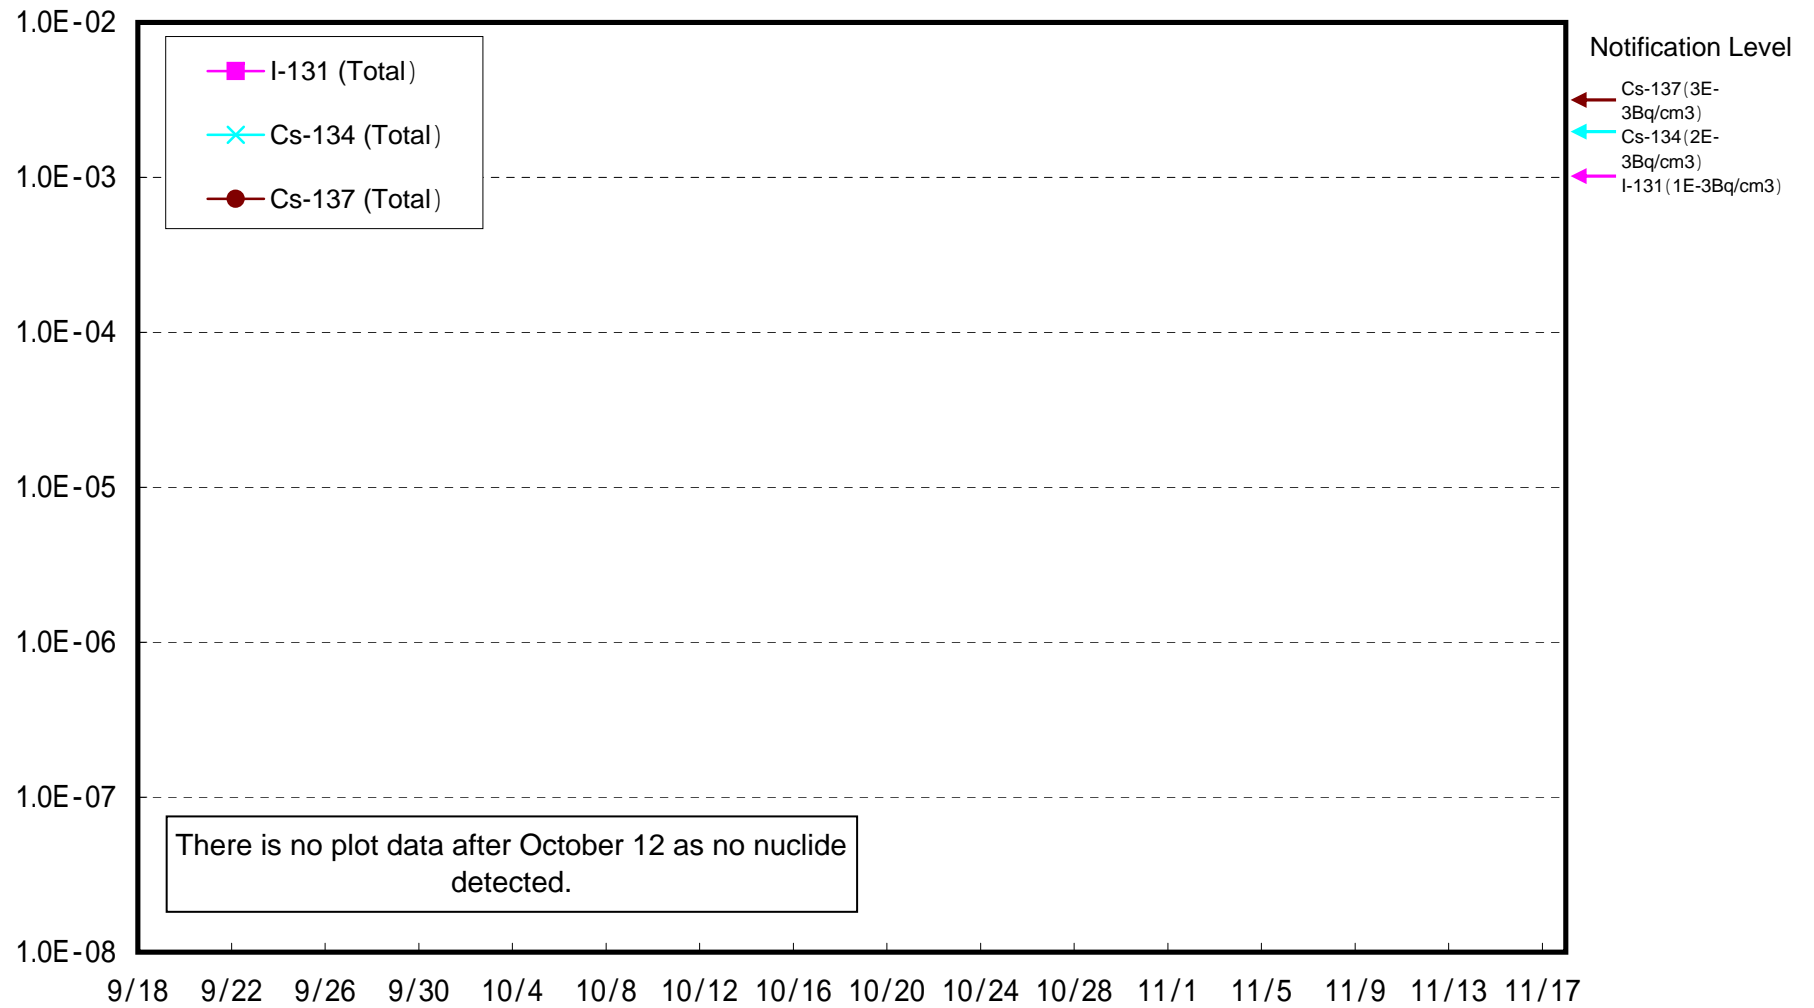
# Environment Monitoring Building of Fukushima Daiichi Results of Dust Nuclide Analysis (Bq/cm<sup>3</sup>)

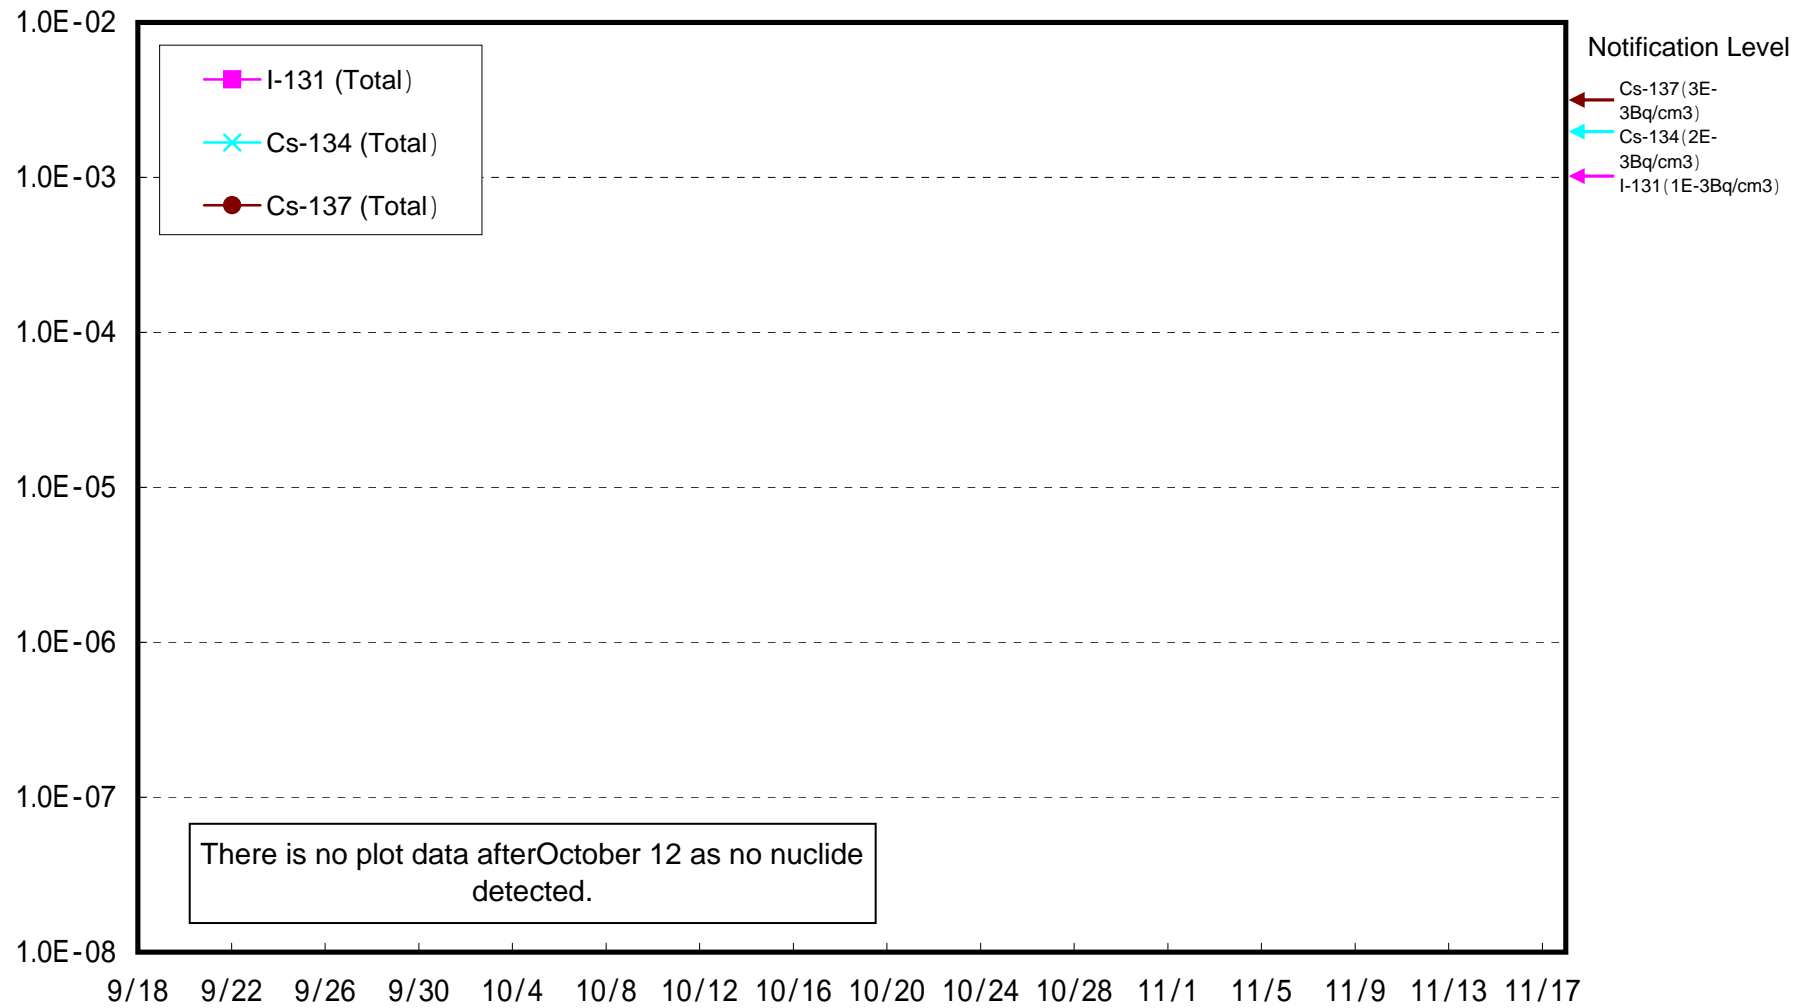
Water Treatment Building of Fukushima Daiichi Results of Dust Nuclide Analysis (Bq/cm<sup>3</sup>)

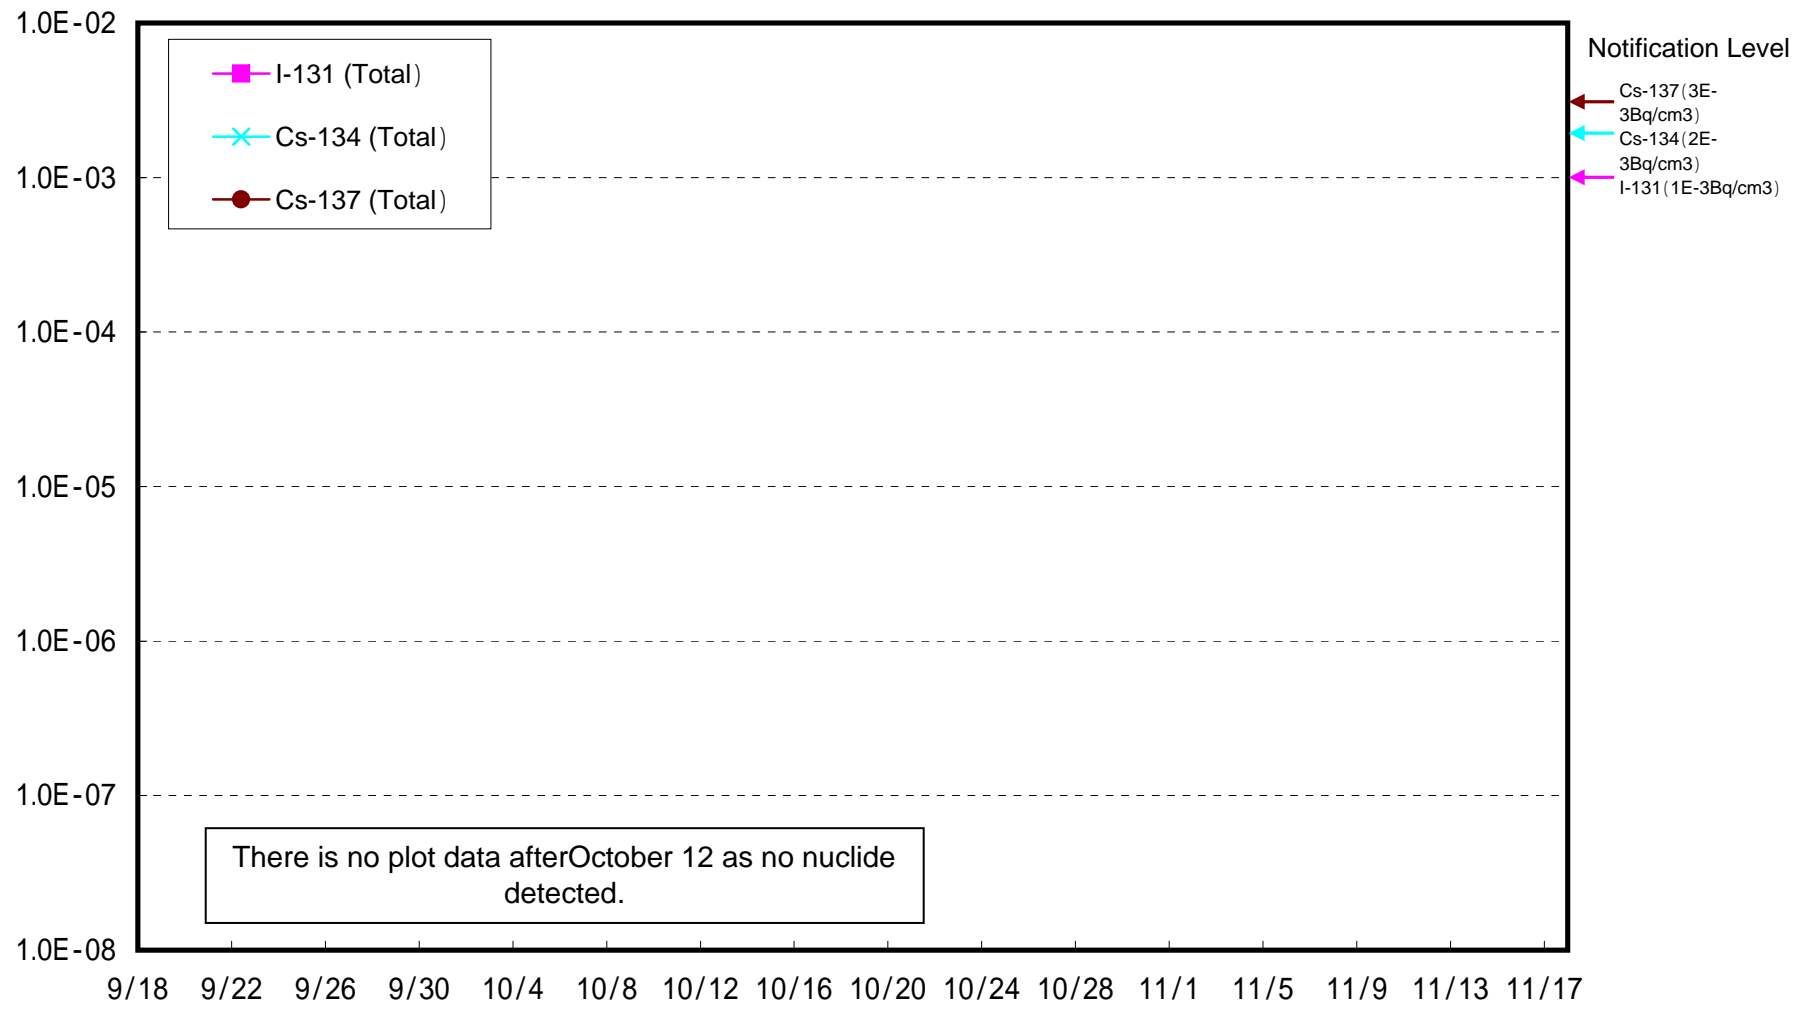
Switching Yard of Unit 5 and Unit 6, Fukushima Daiichi Results of Dust Nuclide Analysis (Bq/cm<sup>3</sup>)
