Containment vessel pressure behaviors at Unit-2

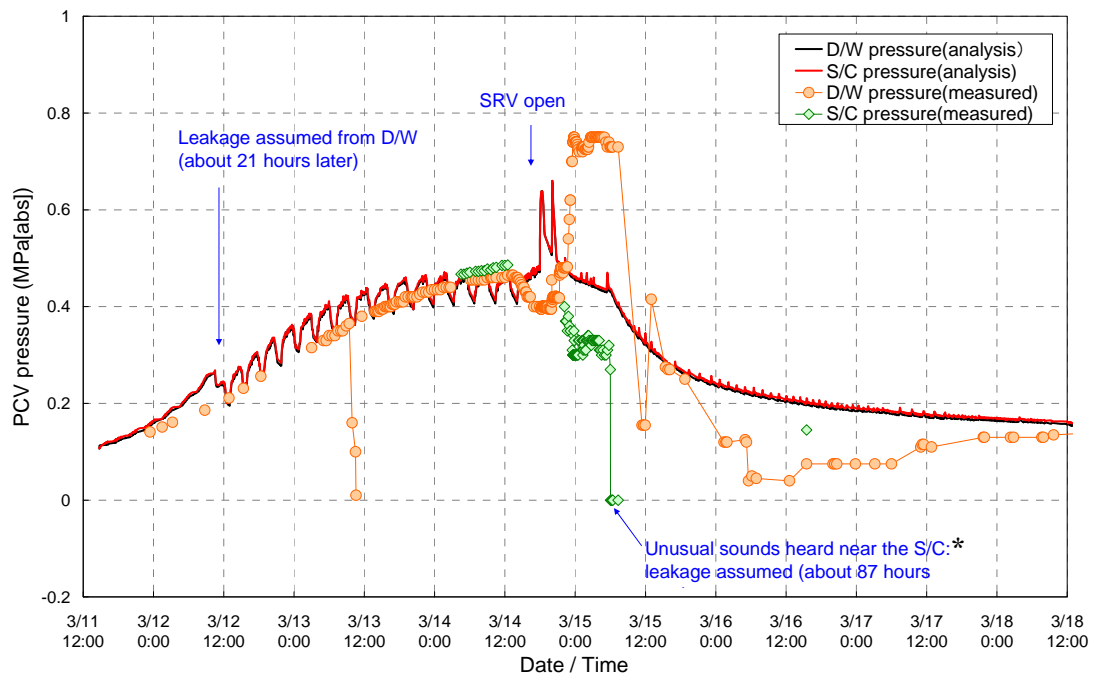
Figure 1 PCV pressure changes at Unit-2
(MAAP results case-1 Figure 3.2.2.3 in the May 2011 report)

The measured values and analysis results of containment vessel (PCV) pressure changes at Unit-2 were inconsistent in the earlier report*¹ submitted to the Nuclear Industry and Safety Agency on May 23rd, 2011. The following items are the estimated causes of these discrepancies and the phenomena assumed in the present MAAP analysis reported in March 2012. Figure 1 and Figure 2 present the PCV pressure changes obtained in the May 2011 analysis. The red frame in each figure shows where the measured values and analysis results were not consistent.

In the May 2011 analysis (Figures 1 and 2), leakage from the D/W was assumed, which is unlikely to occur in reality, in order to simulate this slow PCV pressure increase for the circumstance of only limited information available. The timing of leakage was set as the time when the PCV temperature obtained in the analysis reached the design temperature (138 deg C).

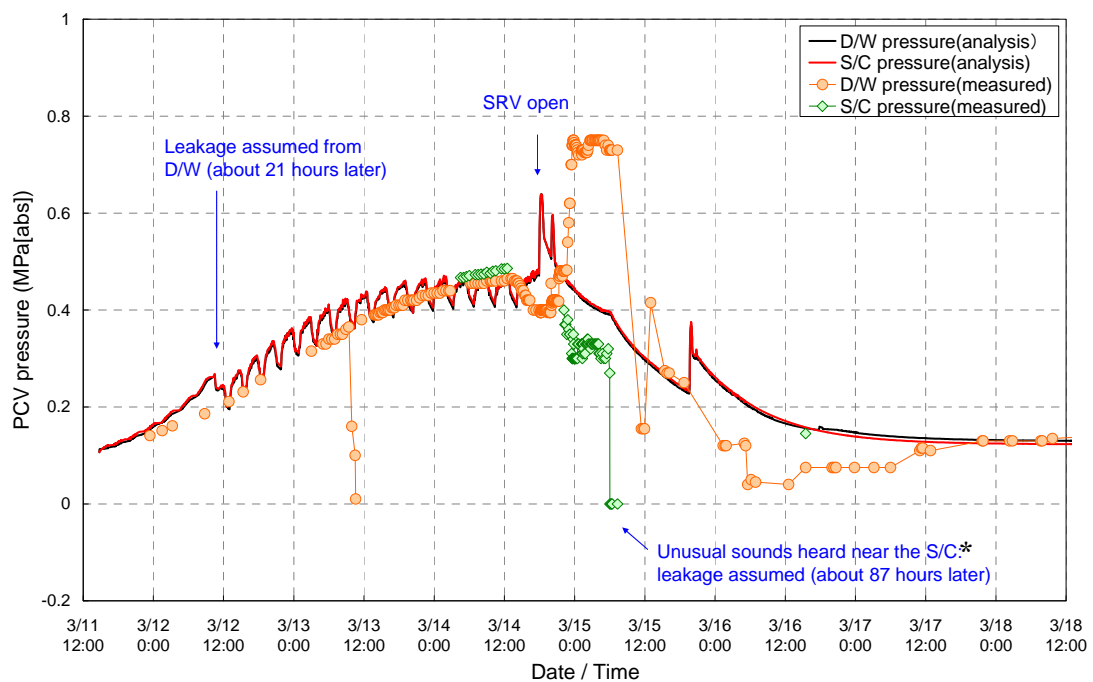
Figure 2 PCV pressure changes at Unit-2
(MAAP results case-2 Figure 3.2.1.2 in the May 2011 report)

*) Note: It is inferred that the unusual sounds was caused by Unit-4 reactor building explosion and not related to Unit-2 S/C.

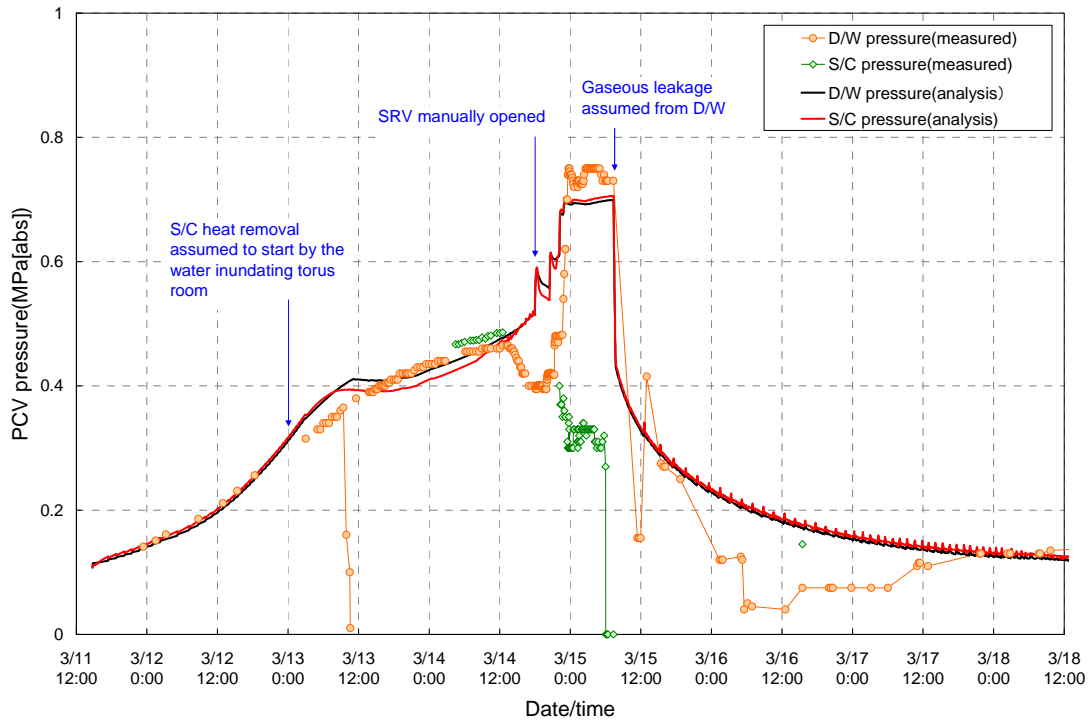
Figure 3 PCV pressure changes at Unit-2 (MAAP results reported in March 2012)

Based upon this scenario, MAAP analysis was conducted assuming that the torus room had been gradually inundated by seawater (with a temperature of about 10 deg C), which finally reached the level of about a half of the S/C elevation. MAAP could roughly reproduce the slow pressure increase from about 00:00 on March 12th to about 14:00 on March 14th. The sharp pressure increase after about 22:40 on March 14th and the increased PCV pressure staying there thereafter could be roughly reproduced in the analysis (Figure 3), by assuming no leakage.

The new analysis, which assumed that the PCV heat had been removed by the water retained in the torus room, could reproduce more appropriately the slow pressure increase from about 00:00 on March 12th to about 14:00 on March 14th, and the sharp pressure increase after about 22:40 on March 14th. It can be considered, therefore, the D/W pressure increase was prevented by the mechanism assumed in the new analysis.

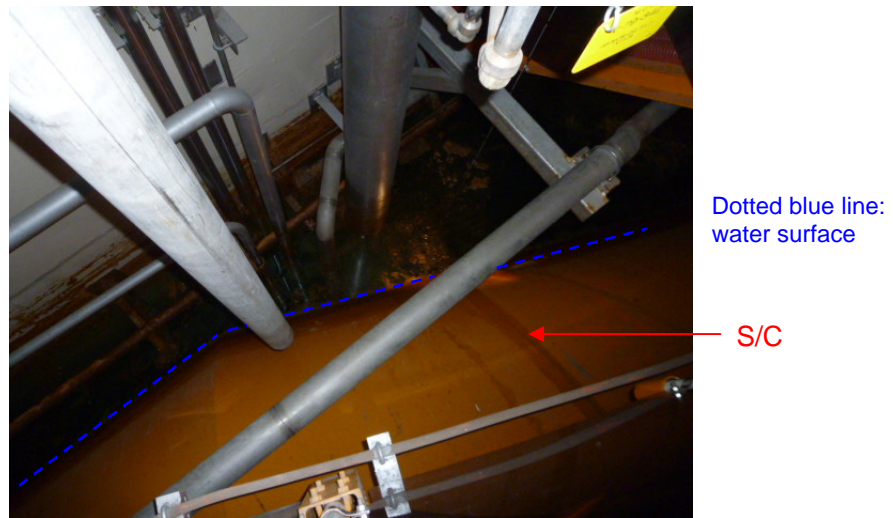
Figure 4 Photograph taken from the Unit-4 torus room catwalk, looking straight down

It is known that the torus room of Unit-4, which has a similar layout to that of Unit-2, was inundated to a depth of about half the S/C elevation (Figure 4). This suggests that the Unit-2 torus room could be similarly inundated like the Unit-4 torus room, although the operating
