Containment vessel pressure behaviors at Unit-2

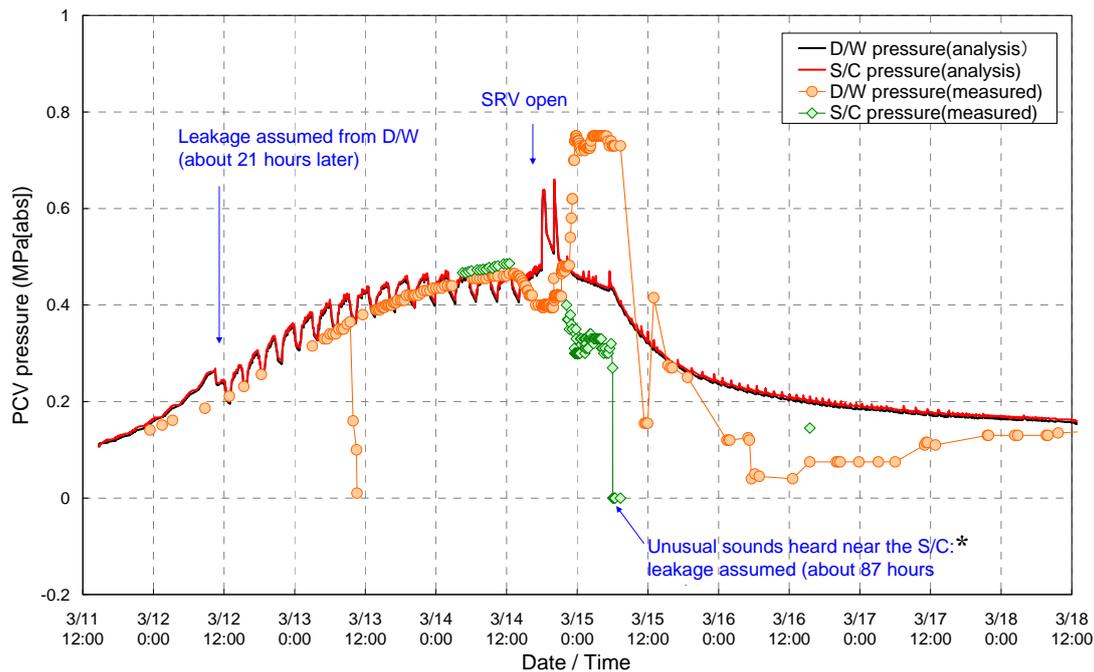
Figure 1 PCV pressure changes at Unit-2
(MAAP results case-1 Figure 3.2.2.3 in the May 2011 report)

In the May 2011 analysis (Figures 1 and 2), leakage from the D/W was assumed, which is unlikely to occur in reality, in order to simulate this slow PCV pressure increase for the circumstance of only limited information available. The timing of leakage was set as the time when the PCV temperature obtained in the analysis reached the design temperature (138 deg C).

However, leakage from the PCV due to overheating is likely to occur at the gaskets, etc. and the temperature then is about 300 deg C, according to the existing knowledge*². Leakage from the PCV is unlikely to occur at the timing when the PCV temperature reaches the design temperature (138 deg C). Further, the sharp increase of PCV pressure after about 22:40 on March 14th and stable pressure thereafter at a higher level could not have been reproduced in the analysis.

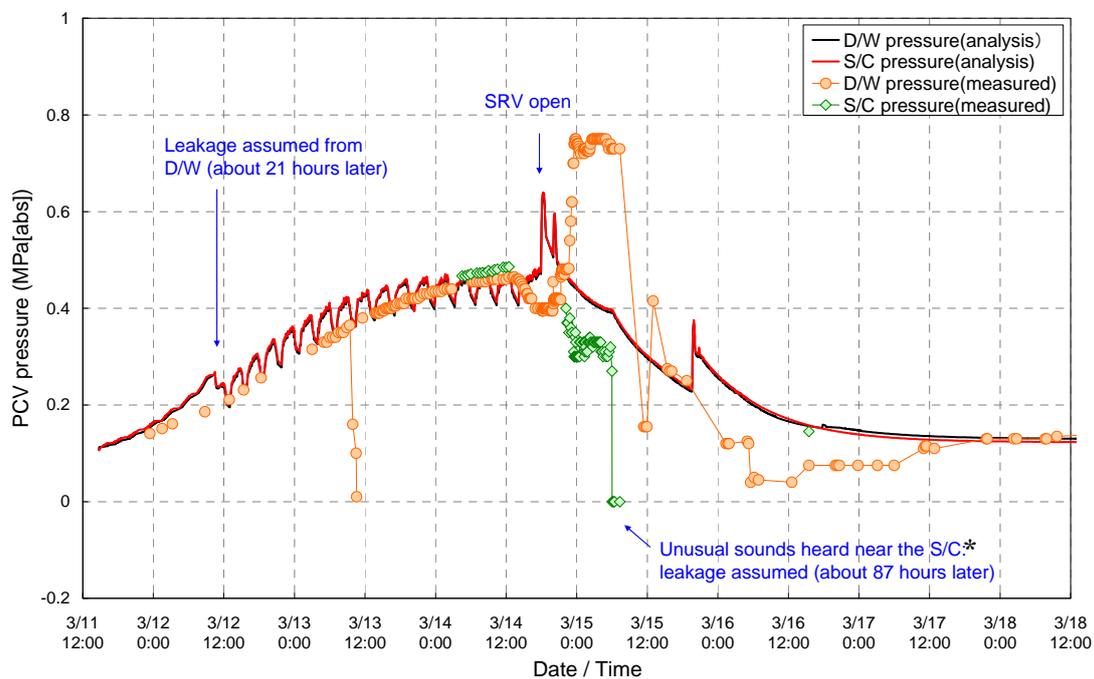
Figure 2 PCV pressure changes at Unit-2
(MAAP results case-2 Figure 3.2.1.2 in the May 2011 report)

*) Note: It is inferred that the unusual sounds was caused by Unit-4 reactor building explosion and not related to Unit-2 S/C.

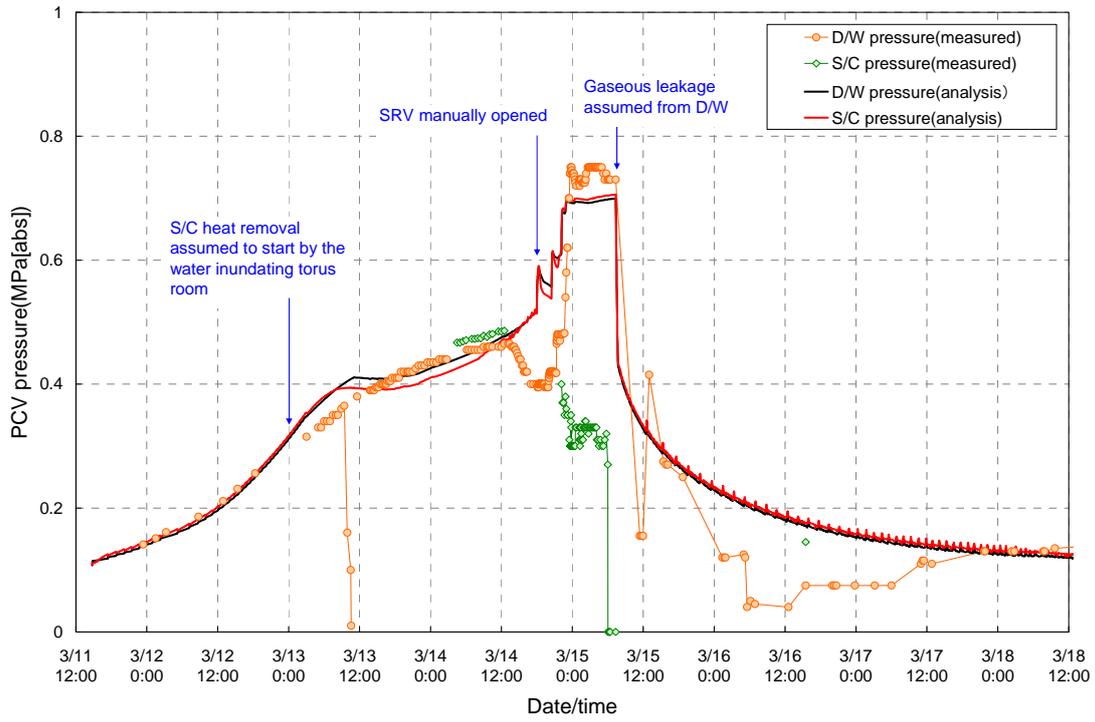
Figure 3 PCV pressure changes at Unit-2 (MAAP results reported in March 2012)

Based upon this scenario, MAAP analysis was conducted assuming that the torus room had been gradually inundated by seawater (with a temperature of about 10 deg C), which finally reached the level of about a half of the S/C elevation. MAAP could roughly reproduce the slow pressure increase from about 00:00 on March 12th to about 14:00 on March 14th. The sharp pressure increase after about 22:40 on March 14th and the increased PCV pressure staying there thereafter could be roughly reproduced in the analysis (Figure 3), by assuming no leakage.

The new analysis, which assumed that the PCV heat had been removed by the water retained in the torus room, could reproduce more appropriately the slow pressure increase from about 00:00 on March 12th to about 14:00 on March 14th, and the sharp pressure increase after about 22:40 on March 14th. It can be considered, therefore, the D/W pressure increase was prevented by the mechanism assumed in the new analysis.

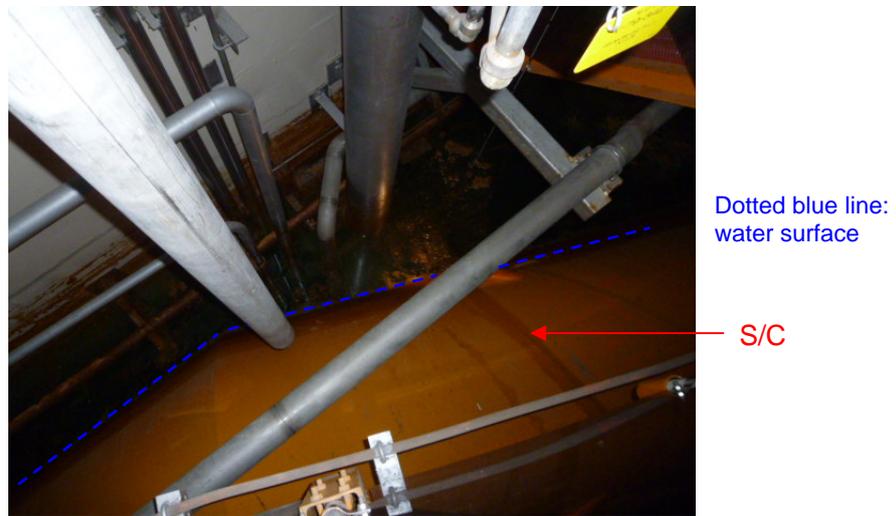
Figure 4 Photograph taken from the Unit-4 torus room catwalk, looking straight down

It is known that the torus room of Unit-4, which has a similar layout to that of Unit-2, was inundated to a depth of about half the S/C elevation (Figure 4). This suggests that the Unit-2 torus room could be similarly inundated like the Unit-4 torus room, although the operating
